# Evaluating the Role of Internal Factors in the Damage and the Methods of Treatment of the Limestone of Emir Hasan Mosque in Akhmim, Sohag, Egypt

Elashmawy A. Abd-Elkareem

**How to cite this paper:** Abd-Elkareem, E.A. (2020) Evaluating the Role of Internal Factors in the Damage and the Methods of Treatment of the Limestone of Emir Hasan Mosque in Akhmim, Sohag, Egypt. *Open Journal of Geology*, 10, 1280-1295.  
<https://doi.org/10.4236/ojg.2020.1012064>

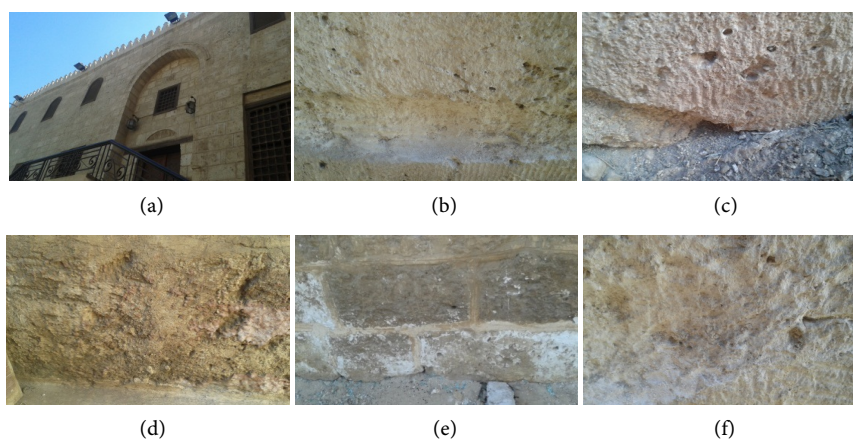
**Figure 1.** (a) A general view of Emir Hasan Mosque; (b, c, and d) The presence of cracking, pitting, loosening, and deformation of the limestone surface; (e and f) salt efflorescence leading to the deterioration of limestone.

of a salt crust. It causes the color change of the surface of the limestone in the study area (**Figure 1(e)**).

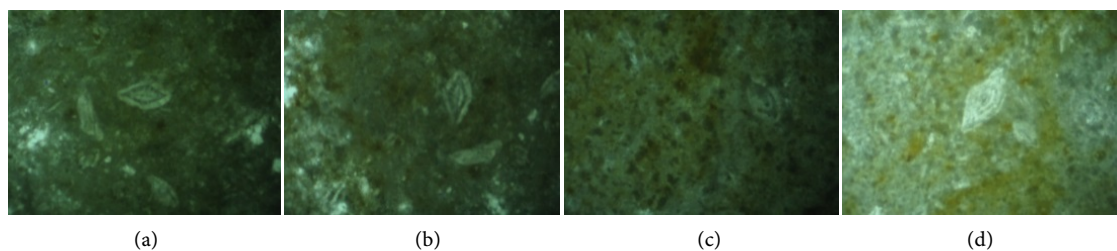
The microscopic study of the limestone samples under the polarized microscope showed the surface shape of the grains and some fine cracks, as well as some of the grains in powder form (**Figure 2**). Some details about the porosity were also shown.

**Figure 2.** (a, b, c & d) shows the presence of some or parts of fossils, especially the nemolite, which consists of calcite between grains of limestone. Dolomite was found filling some cracks. Gypsum and calcite are the main mineral compounds.

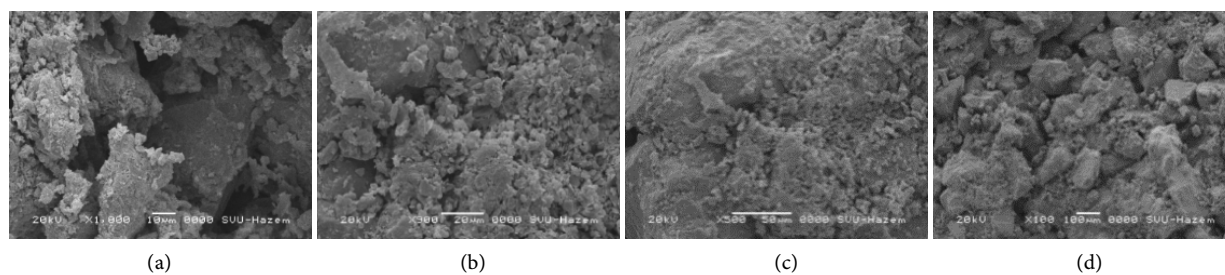
**Figure 6(a)** and **Figure 6(b)** show the details of the outer surface. Small and semi-round white particles were found. The initial analysis showed the presence of calcium, oxygen, and carbon in most of the molecules, which is likely to be calcium carbonate, **Figure 6(c)** and **Figure 6(d)**. Also, these particles appeared in a degraded and weak state as they do not bind to the cement to a large extent. The ADS analysis revealed a high percentage of chloride and sodium **Figure 6(a)**.

Silicon and aluminum were also observed, indicating aluminum silicate minerals, clay minerals, in the form of flakes between the white particles. Some parts of the fossils spread in all parts of the texture of the limestone, indicating the origins of the limestone as confirmed by the petrographic study of limestone sectors using the polarized microscope, **Figure 6(c)**. Calcium was also evident in the white areas, indicating the presence of calcite, as shown in **Figure 6(a)**. The presence of calcium and silicon suggests clay mineral particles.

**Figure 6.** (a) The presence of secondary calcite as a result of the dissolution process, (b) The resulting damage and new layers covering the pores with limestone, (c) Salt crystals on limestone and deformation of the incident crystals, (d) Micropores and internal damage to limestone granules.
