# Examination and Conservation of Helal El-Beah Mosque, Dakahlia, Egypt

Nabil A. Bader<sup>1</sup>, Ragab Abu El-Hassan<sup>2</sup>

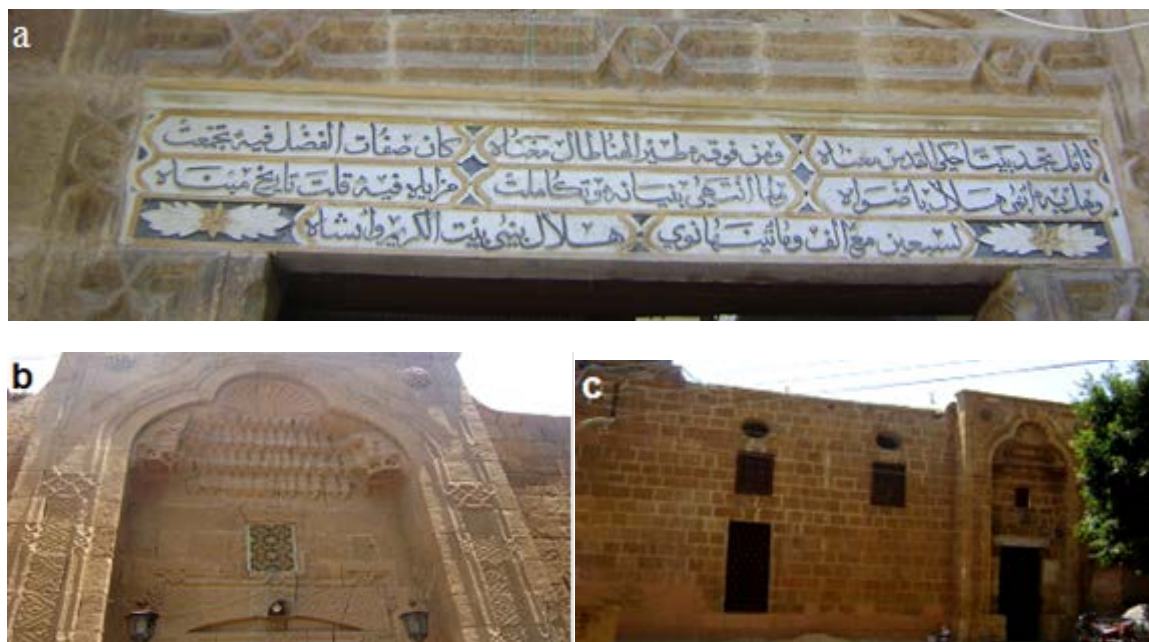
**Figure 1.** The façade of Helal Mosque. a—Founding text shows the erection and the date of the mosque erection; b—The tall portal of the mosque with Islamic decoration; c—The rest of the façade of the mosque.

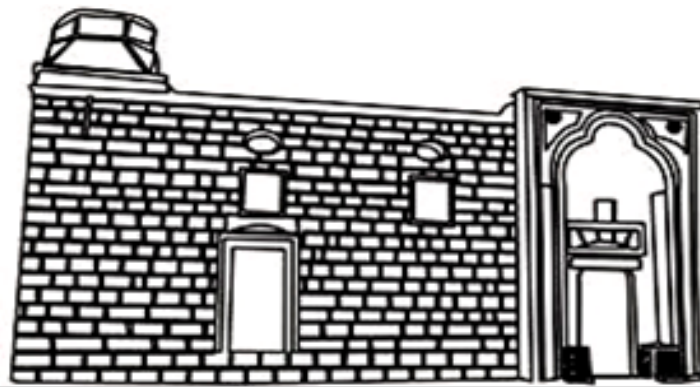
**Figure 2.** Plan of the façade of Helal mosque shows the main and secondary rectangular entrance.

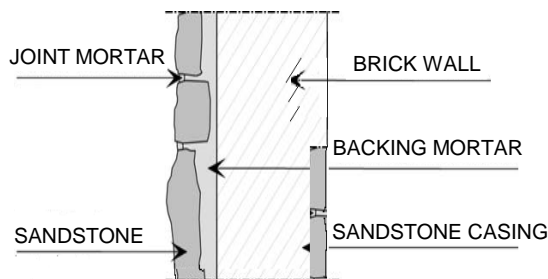
**Figure 4.** Building materials of Helal mosque, external wall assembly consists of sandstone, joint mortar, backing mortar, external wall from brick wall, sandstone cladding at the low part from brick wall with height 120 cm.

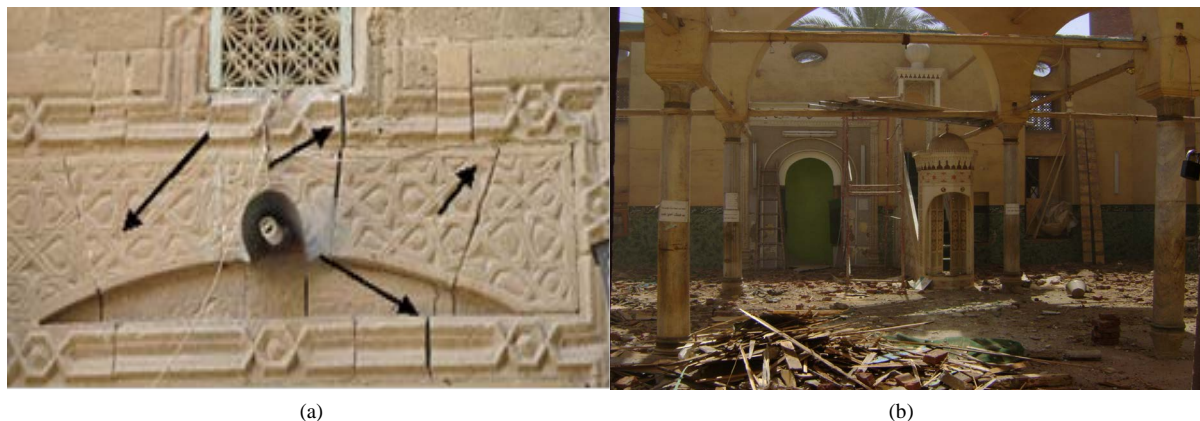
**Figure 5.** a—Cracks and macro cracks at the entrance of Helal mosque; b—Collapse of large parts of the ceiling of the mosque, especially north arcade.

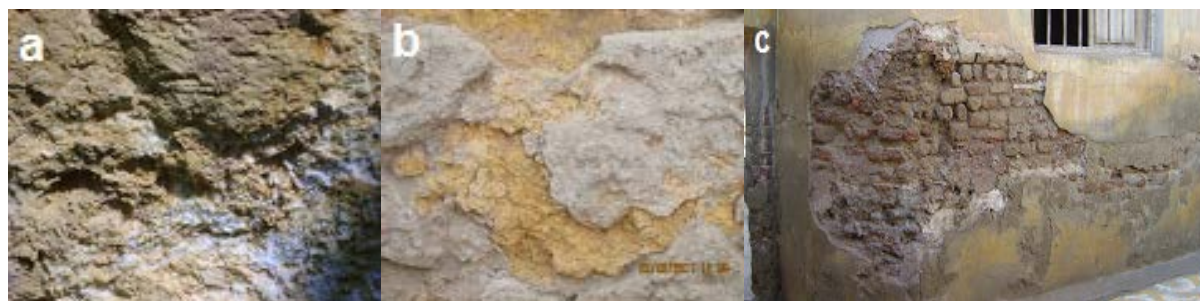
**Figure 6.** Photograph of decay features common at the Helal mosque. a—Efflorescence's to light-colored crust tracing the surface; b—Scars of flaking, c—Lost in brick, detachment of plaster and soiling by groundwater at the lower part of the mosque.

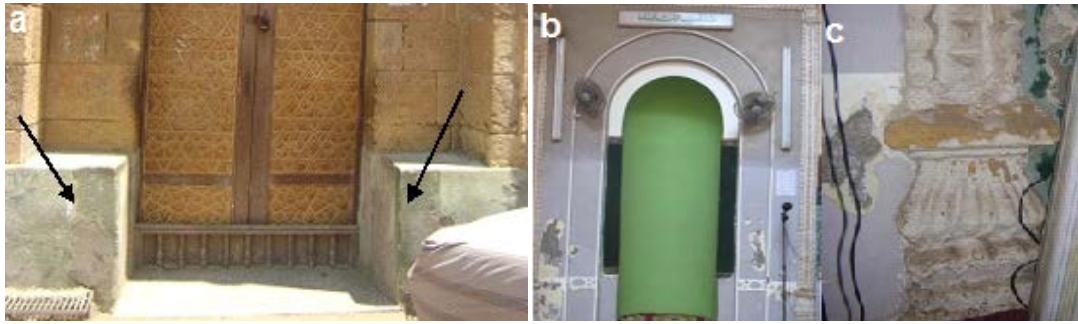
**Figure 7.** Old faulty restorations by Portland cement. a—Disappeared of Islamic decorations in the mosque façade by cement; b—Old restoration around mihrab which covered the decoration with Portland cement, industrial lacquers and carpet; c—The decoration was covered with lime and gypsum. Collapse of large parts of the ceiling of the mosque, especially north arcade.

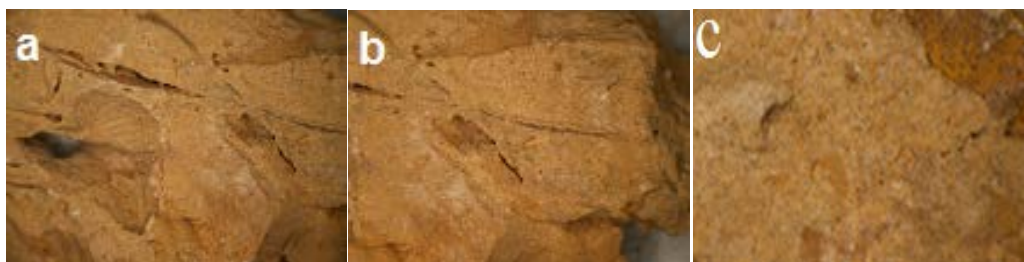
**Figure 8.** LOM microscopically image of the surface of sandstone samples shows, cavities, cracks and macrocracks, fossils and iron concentration.

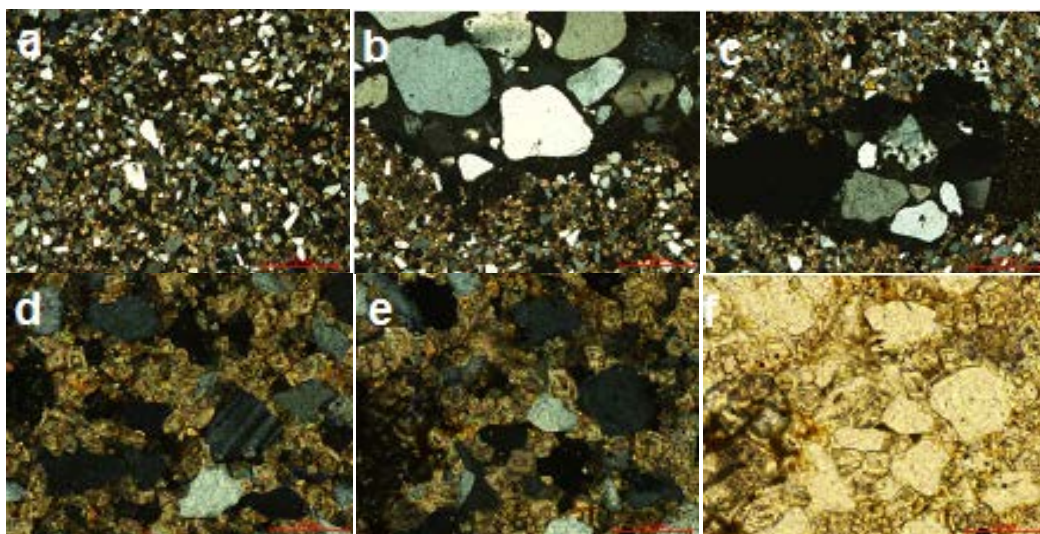
**Figure 9.** Mineralogical characteristics of the sandstone in the façade of Helal mosque. a—Minerals content of sandstone samples; b—Subrounded grains of calcite; c—Turbid color of quartz grains by clay minerals; d, e—Crystal of dolomite between quartz grains; f—Rhombohedral twins of dolomite grains.

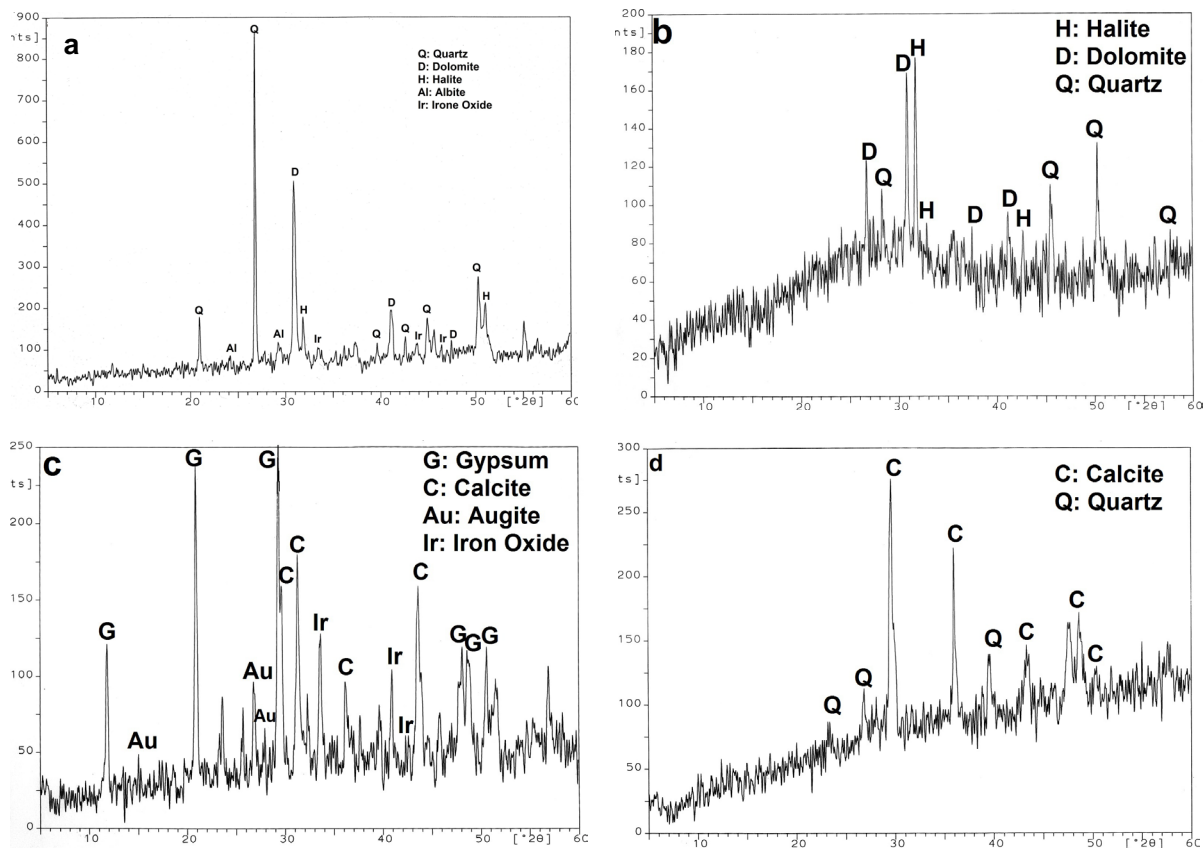
Figure 10. XRD pattern of building materials of Helal mosque. a—Sandstone samples; b—Salt samples; c, d—Mortar samples.

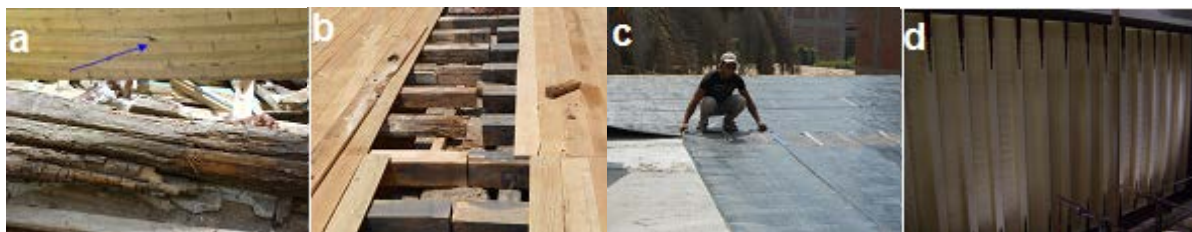
Figure 18. Restoration steps of the ceiling of Helal mosque. a—Deteriorated ceiling wood; b—New wooden panels during restoration process; c—Certekt layer; d—The ceiling after repaired.

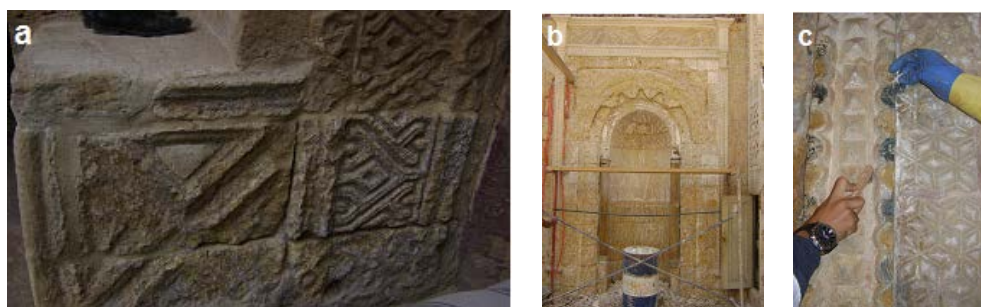
Figure 19. a, b, c—Removing the old restoration with Portland cement and lacquers and revealed the Islamic decoration by mechanical cleaning.

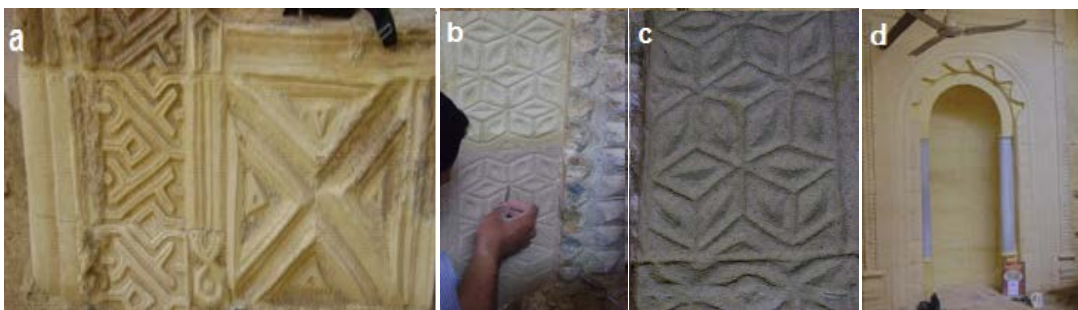
**Figure 20.** Completing the missing parts of decoration at the entrance of Helal mosque and around Mehrab by reproduction process and engraving methods.

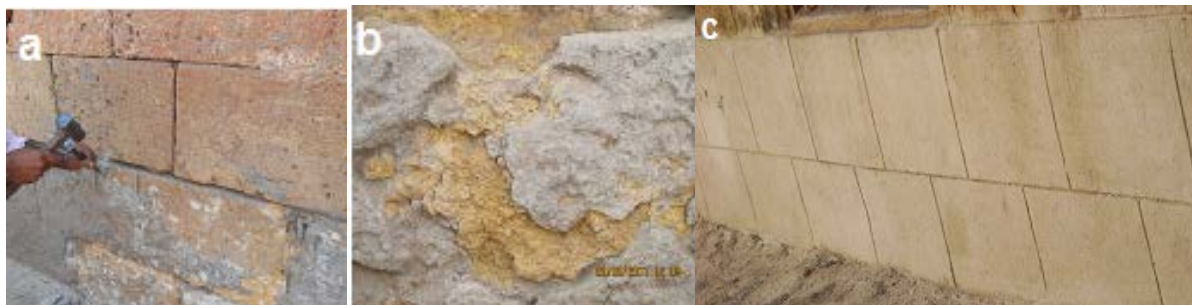
**Figure 21.** Completing the missing parts of decoration at the entrance of Helal mosque and around Mehrab by reproduction process and engraving methods.

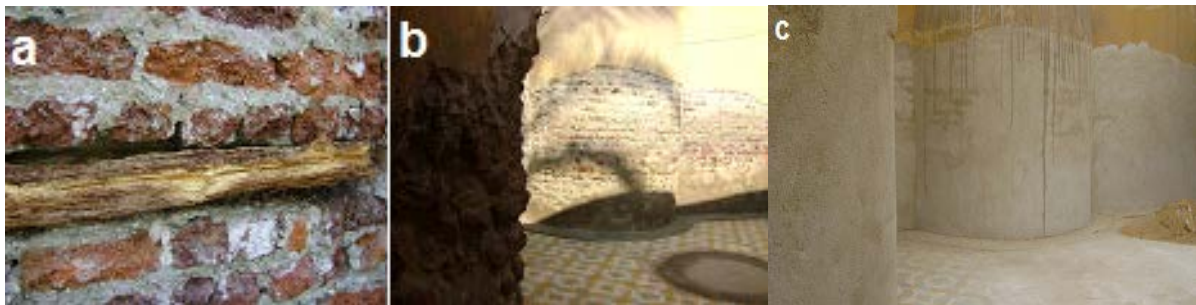
**Figure 23.** The restoration intervention at the brick walls. a, b—The brick wall after removing the deteriorated old mortar with salts; c—After restoration.
