# Visual Inspection of Heritage Mosques Using Unmanned Aerial Vehicle (UAV) and Condition Survey Protocol (CSP) 1 Matrix: A Case Study of Tengkeru Mosque and Kampung Kling Mosque, Melaka

Masiri Kaamin, Nor Farah Atiqah Ahmad, Siti Noorain Mohd Razali, Mardiha Mokhtar, Norhayati Ngadiman, Dewi Mustika Masri, Intan Afifah Hussin, Laila Husna Mohd Asri

Department of Civil Engineering, Centre for Diploma Studies,  
Universiti Tun Hussein Onn Malaysia

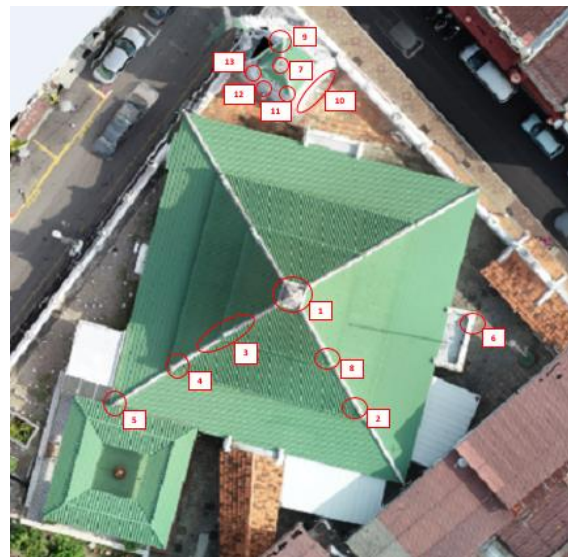
**Figure 5.** Kampung Kling Mosque

From image processing, the total number of defect can be identified. Figure 5 and Figure 6 show the location of the roof and tower defects of the Kampung Kling Mosque and Tengkerah Mosque that has been marked. Therefore, defects will be easily identifiable and referenced.

No.	Component	Defect	Condition assessment	Priority assessment	Matrix analysis
			(a)	(b)	C= (axb)
1	Roof	Corrosion	3	2	6
2	Roof	Vegetation growth	3	2	6
3	Roof	Corrosion	2	2	4
4	Roof	Vegetation growth	3	3	9
5	Roof	Corrosion	2	1	2
6	Roof	Damage	3	3	9
7	Roof tower	Corrosion	2	1	2
8	Roof	Vegetation growth	2	3	6
9	Wall tower	Vegetation growth	2	3	6
10	Wall tower	Corrosion	3	3	9
11	Roof tower	Vegetation growth	3	3	9
12	Wall tower	Vegetation	2	3	6

Building classification rating,  $d/e = 83/13 = 6.4$

Building rating = Fair

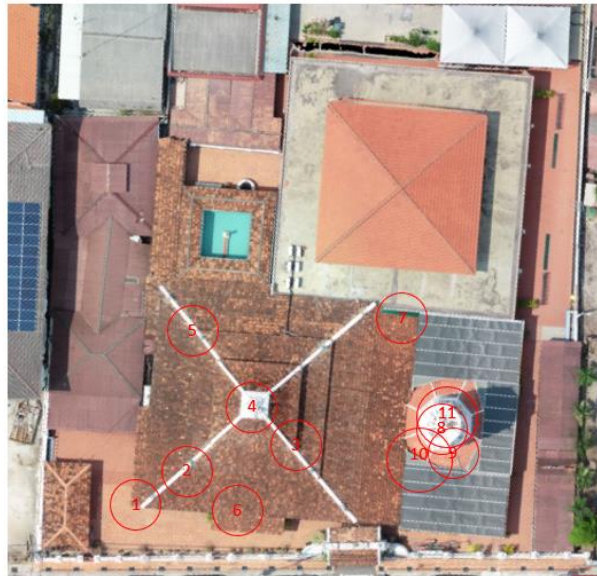
Figure 6. Tengker Mosque

No.	Component	Defect	Condition assessment (a)	Priority assessment (b)	Matrix analysis C= (axb)
1	Roof	Rust effect	1	1	1
2	Roof	Cracked	3	2	6
3	Roof	Cracked	3	2	6
4	Roof	Vegetation growth	1	2	2
5	Roof	Rust effect	1	1	1
6	Roof	Missing	1	2	2
7	Roof	Cracked	1	2	2
8	Towers	Others	1	1	1
9	Towers	Cracked	1	2	2
10	Towers	Vegetation growth	2	2	4
11	Towers	Vegetation growth	2	2	4

Building classification rating,  $d/e = 31/11 = 2.82$

Building rating = Good
