## SEISMIC SOIL-STRUCTURE INTERACTION OF A MASONRY STRUCTURE: SUNGURBEY MOSQUE

Original scientific paper

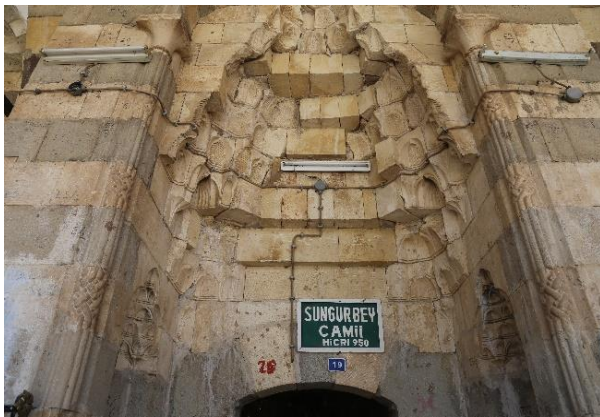
**Assembly Problems:** The decorations on the crown door of the mosque also showed defects in application and workmanship (Figure 3). In addition, some gaps were found in the joint fillings between the decorations. Especially as a result of the repetitive temperature changes of the settlement area, regional defects may occur in the decorations. In addition, significant manufacturing defects were detected at the stone joints in the interior (Figure 4).

Figure 3. Assembly problems of the crown door

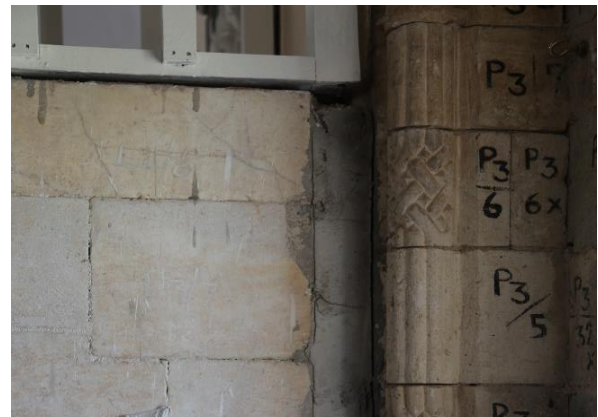
Figure 4. Stone wall joints problem in the interior.

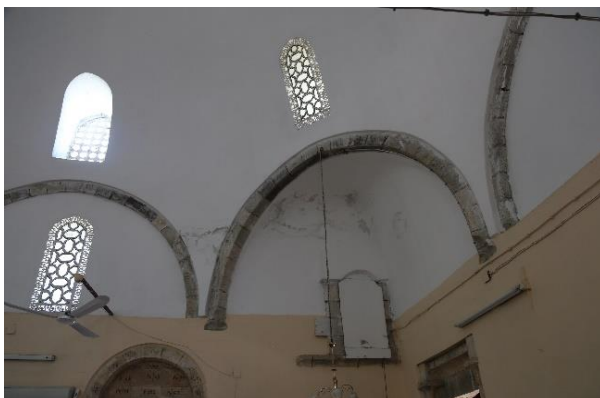
part of the arch elements. In addition, insulation problems and plaster spills were detected in certain areas on the walls, under the windows and inside the dome (Figure 5). If preventive measures are not taken, this may lead to significant structural problems in the future. There are cracks in the lintel above the window that is suitable for capillary and development (Figure 6).

Figure 5. An example for Insulation problem.

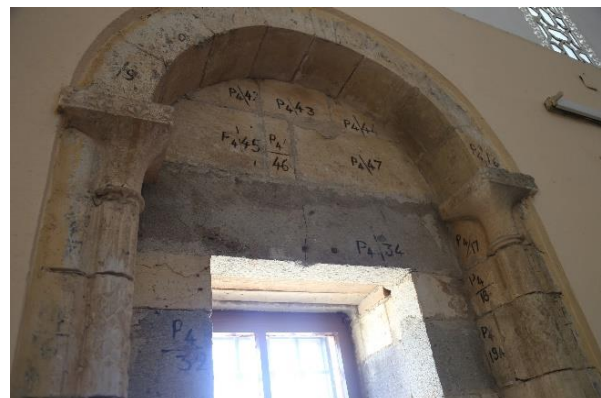
Figure 6. Cracks in the lintel above the window.

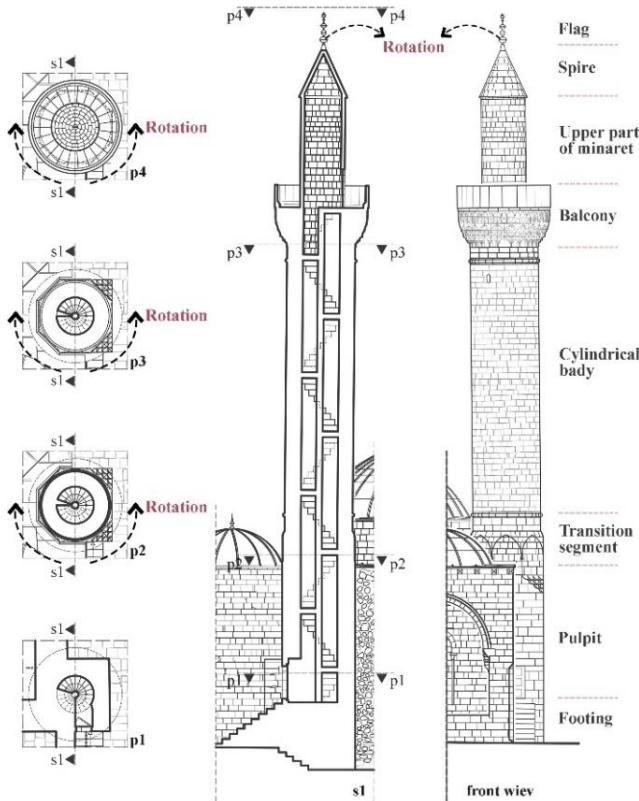
Significant deflections were detected on the basis of the single-story WC structures, which were built separately in the mosque yard. It is thought that this situation occurred as a result of differential settlements on the ground. In the body of the mosque minaret, a visible deviation from the vertical axis is observed at the exit level of the roof of the prayer hall. It is thought that this deviation will cause an important structural problem in the future. However, there is no clear information about whether this deviation occurred after the earthquake. (Figure 7).

Figure 7. Deviation observed in the minaret.

acceleration values increase as the considered nodal points get higher in terms of their elevation with respect to the base of the structure. The deflection observed on the minaret are attributed to the amplified accelerations along the cross-section.
