Structural analysis of Küçük Ayasofya Mosque in İstanbul

ABSTRACT: The paper describes a preliminary structural analysis of Küçük Ayasofya Mosque in İstanbul carried out by means of a continuum damage formulation specifically developed for the study of large buildings made of brittle material such as masonry. A discussion of the results obtained in the simulation of different actions such as gravity loads, differential settlements and earthquake, is presented.

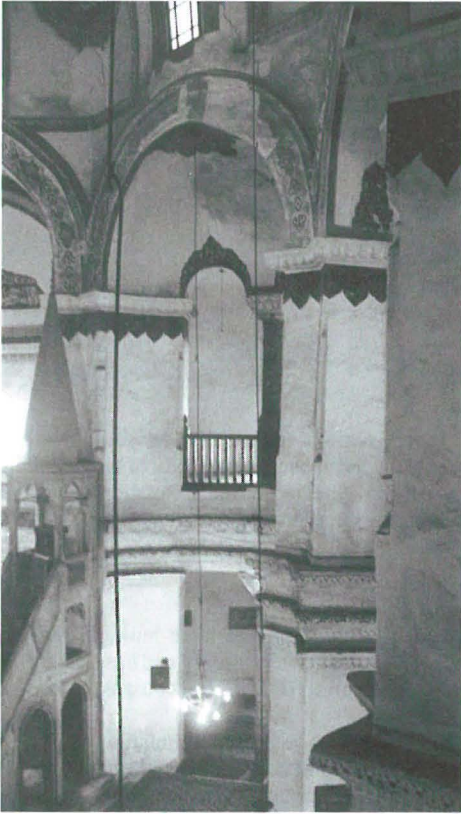
Figure 1. Deformation of piers.

The structural damage shown by the structure of Küçük Ayasofya Mosque (Figs. 1–3) is possibly

Significant horizontal drifts, amounting up to 40 cm, have been also measured at the piers by Alkis et al. (2001). Such movements point to a general deformation of the building towards the South-West direction.
