NOTE ON THE RESTORATION OF FIVE EGYPTIAN MOSQUES

Monica Hanna

KEYWORDS: Islamic heritage, Restoration, Mosques, Rāšid, Ġirġā, Dumiyāt.

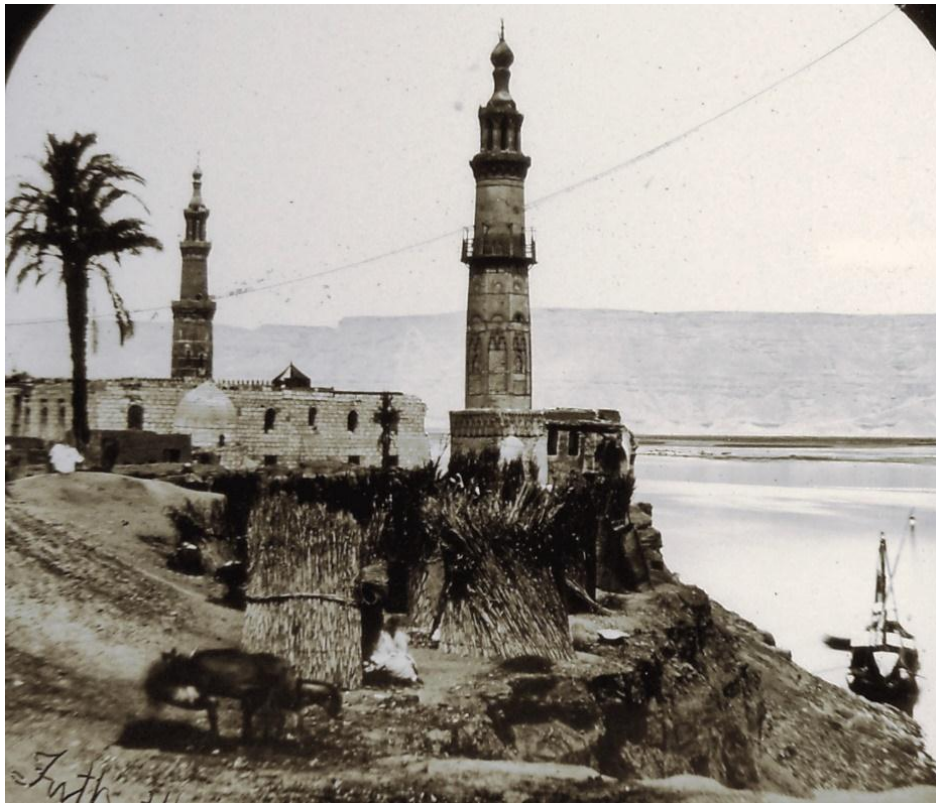
[FIGURE 3]: The mosque of al-Mitwally is in the background to the left
View of Ġirġa by Francis Firth, 1857.

Crenellations and a wooden pointed dome are also clearly visible. A photo by Francis Firth taken in 1857 [FIGURE 3] shows the same limestone building with large windows, crenellations, and the wooden dome still standing intact on the riverbank, which seems to have further approached. The mosque of ‘Aly Bey seems completely gone except for the minaret, which still stood at that time. Another photo, allegedly from 1865 [FIGURE 4], shows the al-Mitwally mosque now damaged: part of the exterior wall has collapsed and so the section of the two-aisled riwāq towards the Nile. Stone and brick arches, granite columns, and Corinthian capitals are clearly visible; one column reclines towards the eastern side. This is how Amelia Edwards described the building around 1874: «A ruined mosque with pointed arches, roofless cloisters, and a leaning column that must surely have come to the ground by this time, stands just above the landing-place. A hundred years ago, it lay a quarter of a mile from the river; ten years ago it was yet perfect; after a few more inundations it will be swept away»⁹.

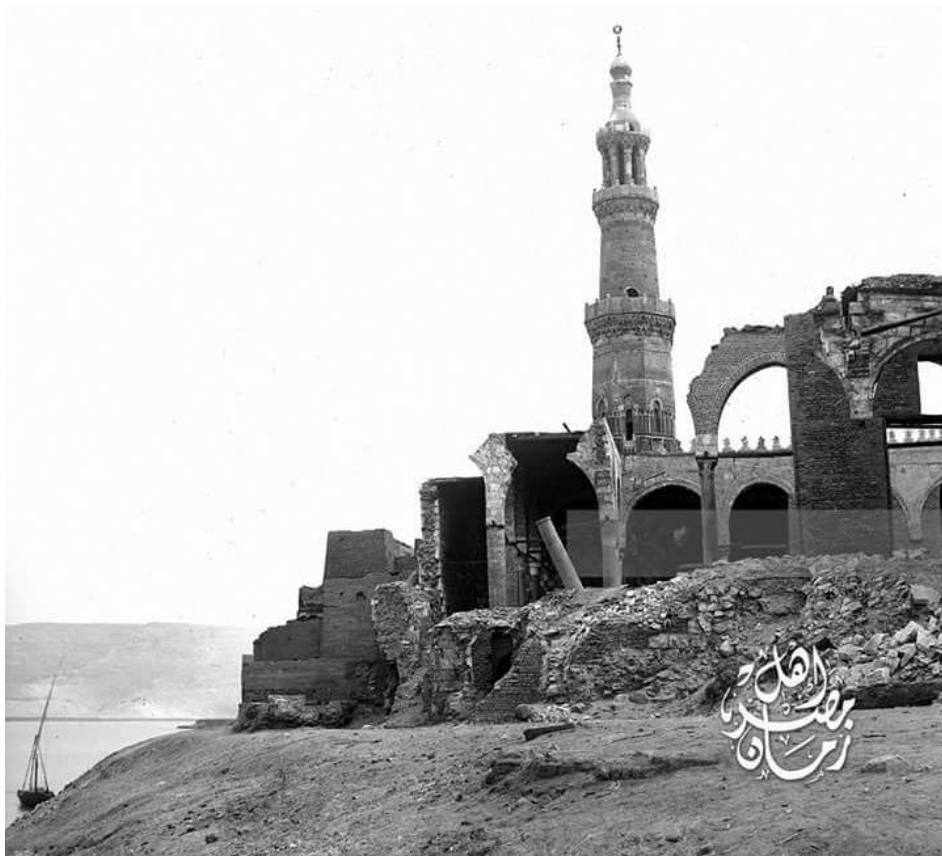
[FIGURE 4]: The ruined mosque of al-Mitwally in a photograph from around 1865

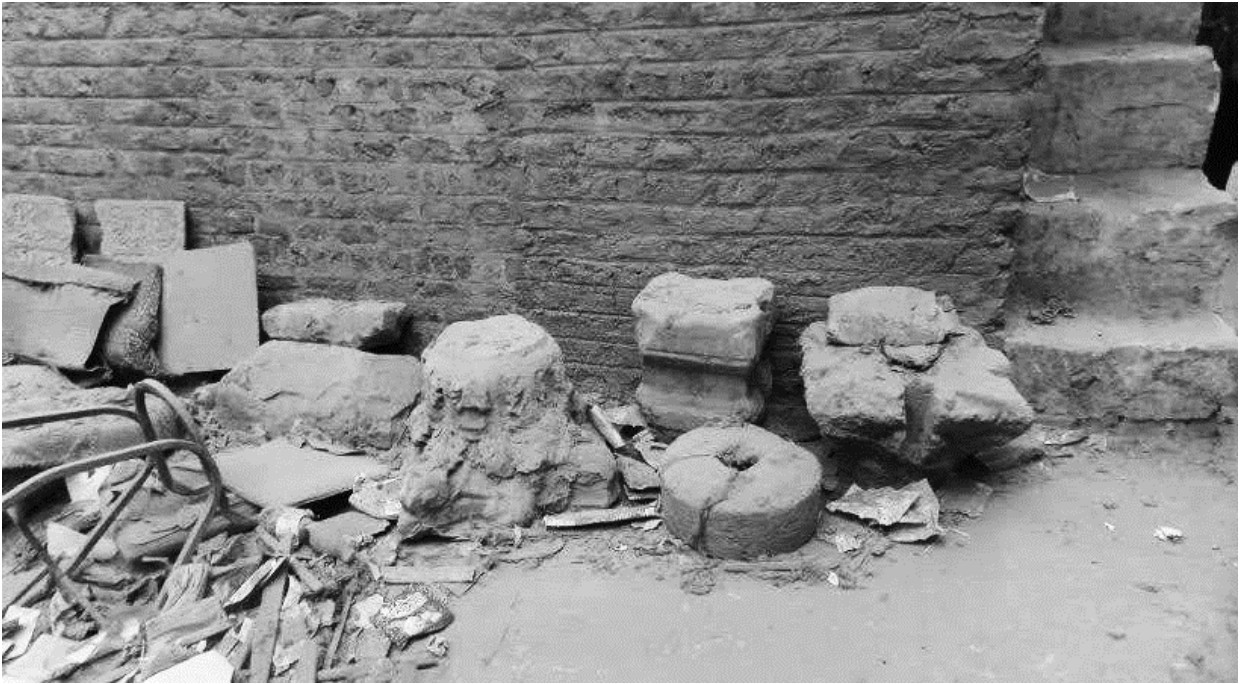
[FIGURE 5]: Graeco-Roman spolia at the base of the minaret of al-Mitwally (©Monica Hanna 2020)

What happens afterwards is less clear. By 1947 the mosque had been completely demolished and the bank of the Nile reclaimed and secured, while the site was used to build a large Islamic revival building. The old minaret was preserved and is now closed in a small irregular courtyard, protected by a metal door. At the base of the minaret there are some stone blocks, including a couple of Corinthian capitals, what looks like a decorated plinth, and a fragment of a column drum, undoubtedly from the original mosque [FIGURE 5]. Three more massive granite columns lay at the southern extremity of the enclosure wall of the Ğirġā Religious Institute, in the public square, until 2019 [FIGURE 6]¹⁰. During a site visit in September 2020, the wall had been rebuilt and the columns were no longer there. Thanks to the courtesy of Mr. Maḥmūd ‘Abd al-Ḥamīd Aḥmad, Inspector of Islamic Archaeology, I was informed that at least one of the columns had been deposited on the ground in front of the mosque of al-Sitt Salma. If this arrangement¹¹ is certainly better than dumping the columns in a landfill, as it appeared after a first investigation, it must be said that it is not ideal as the column is exposed to the elements, the risks of further destruction, and perhaps complete loss. There is no trace of the other two columns that used to belong to the mosque of al-Mitwally. While someone might argue that these columns are not of outstanding architectural importance, I should want to stress that all heritage is relevant and deserves protection. The al-Mitwally columns are an important part of Ğirġā’s heritage as they testify the presence of nearby ancient buildings easily accessible and the practice

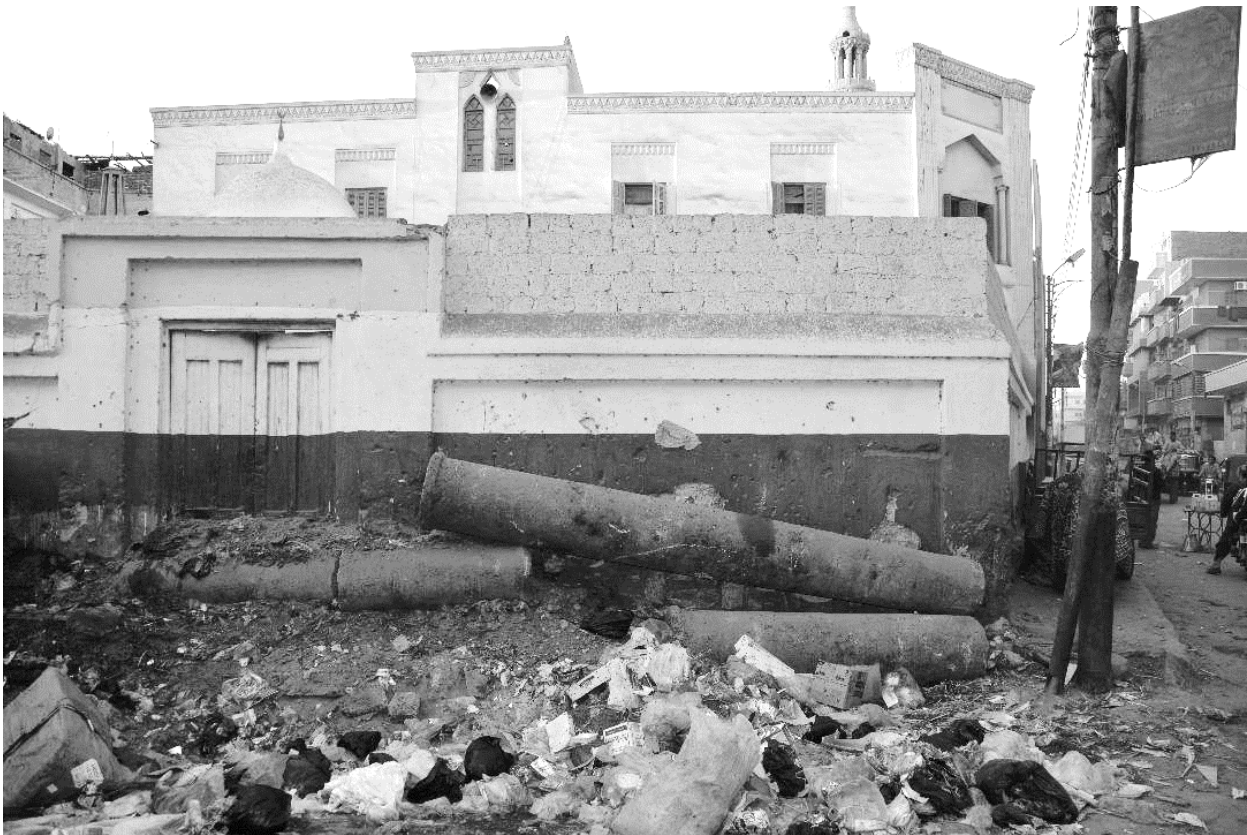
[FIGURE 6]: Three granite columns from the destroyed mosque of al-Mitwally dumped by the Ğirĝā Religious Institute (Photo courtesy Dr. Muḥammad Qināwy)

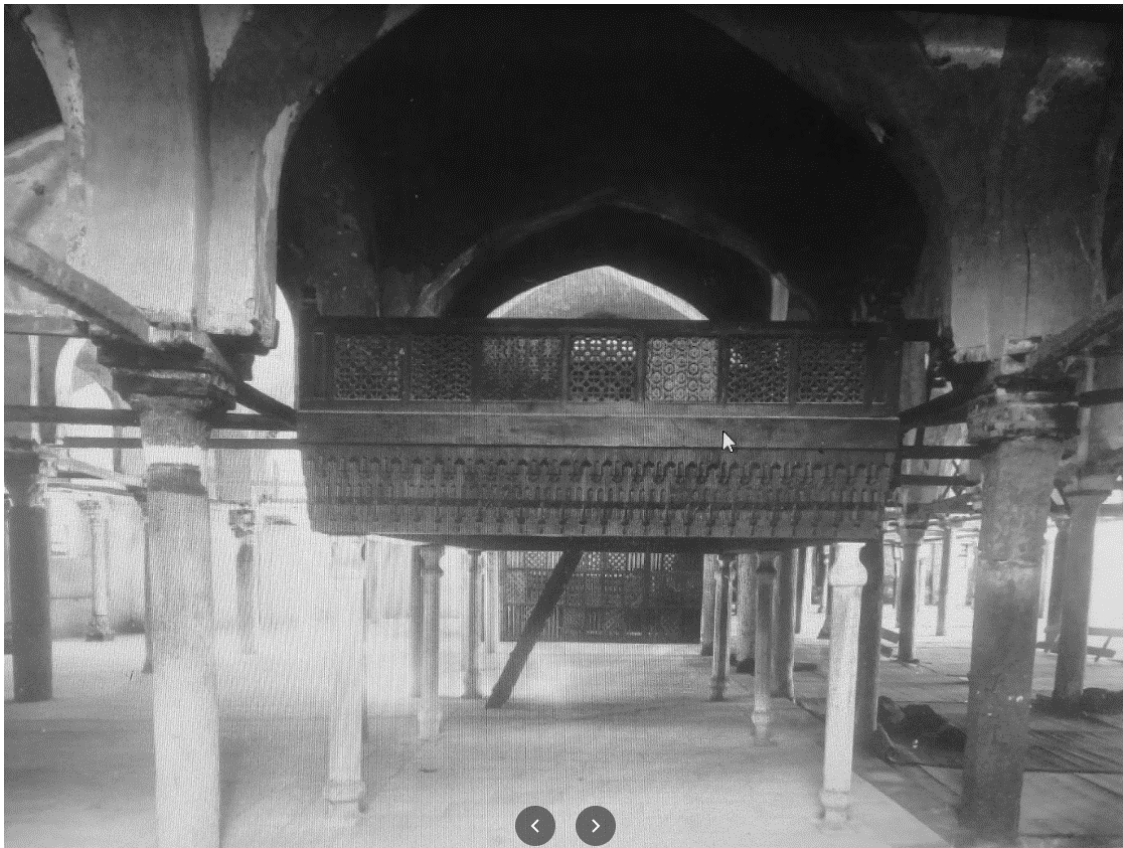
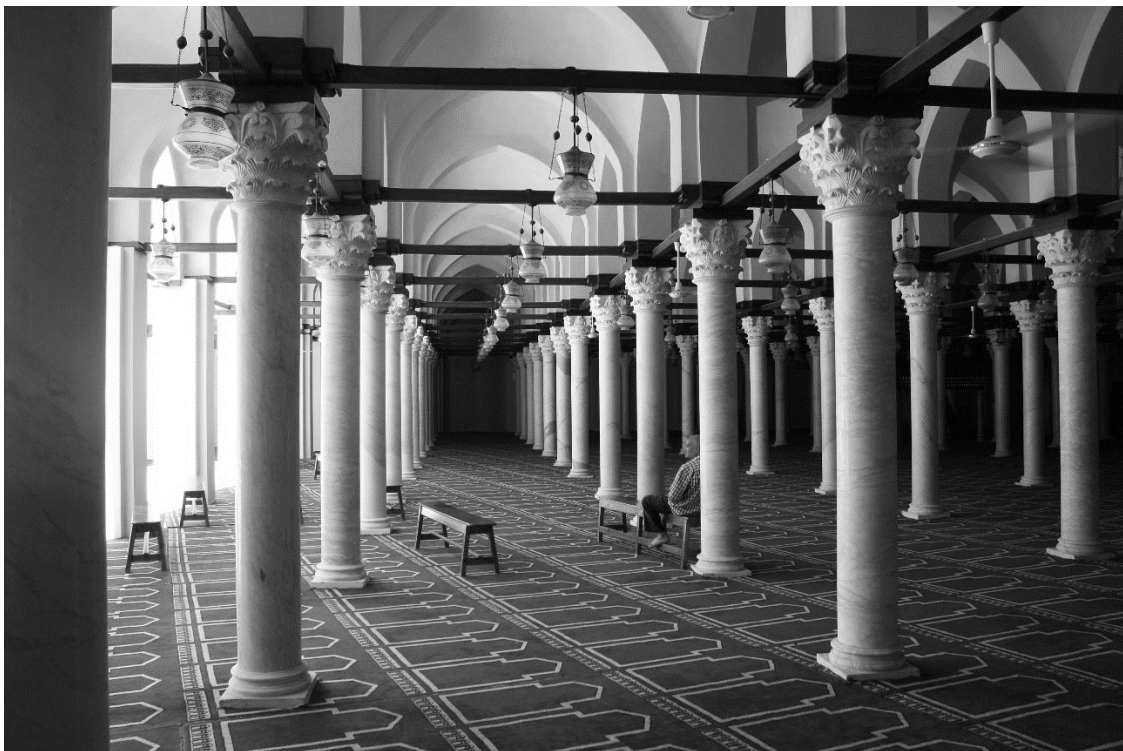
The western mosque was inaugurated in 2018. While the building retained its overall plan, including the position of the ṣaḥn and of the arcades, all the 244 ancient columns have been replaced by an equal number of new, standardized, polished Carrara-marble one with Corinthian capitals. They have no resemblance with the old ones in any possible way [FIGURE 8/A - B]. Further violations of restoration practice include:

[FIGURE 8]: (A) The Zaġhlūl mosque in an undated photograph before restoration (©Google Maps 2017). (B) the Zaġhlūl mosque after restoration (©Monica Hanna 2018)

patching the lower part of the minaret with new stones covering the existing ones that were in a good state of preservation; the elimination of the transition between the square lower part of the tower and the octagonal recessed part on top of it; the faulty restoration of both *mihrābs* without taking into account the original, extremely elaborate, plaster decoration, instead using simple manḡūr bricks.

More than a restoration, this was a case of complete rebuilding, to the point that only few original elements of the historic mosque are still visible: a plaque with a dedicatory inscription by the entrance and part of a *tuluṭ* inscription on a wooden beam of the *dikkaṭ al-muballiḡ*.

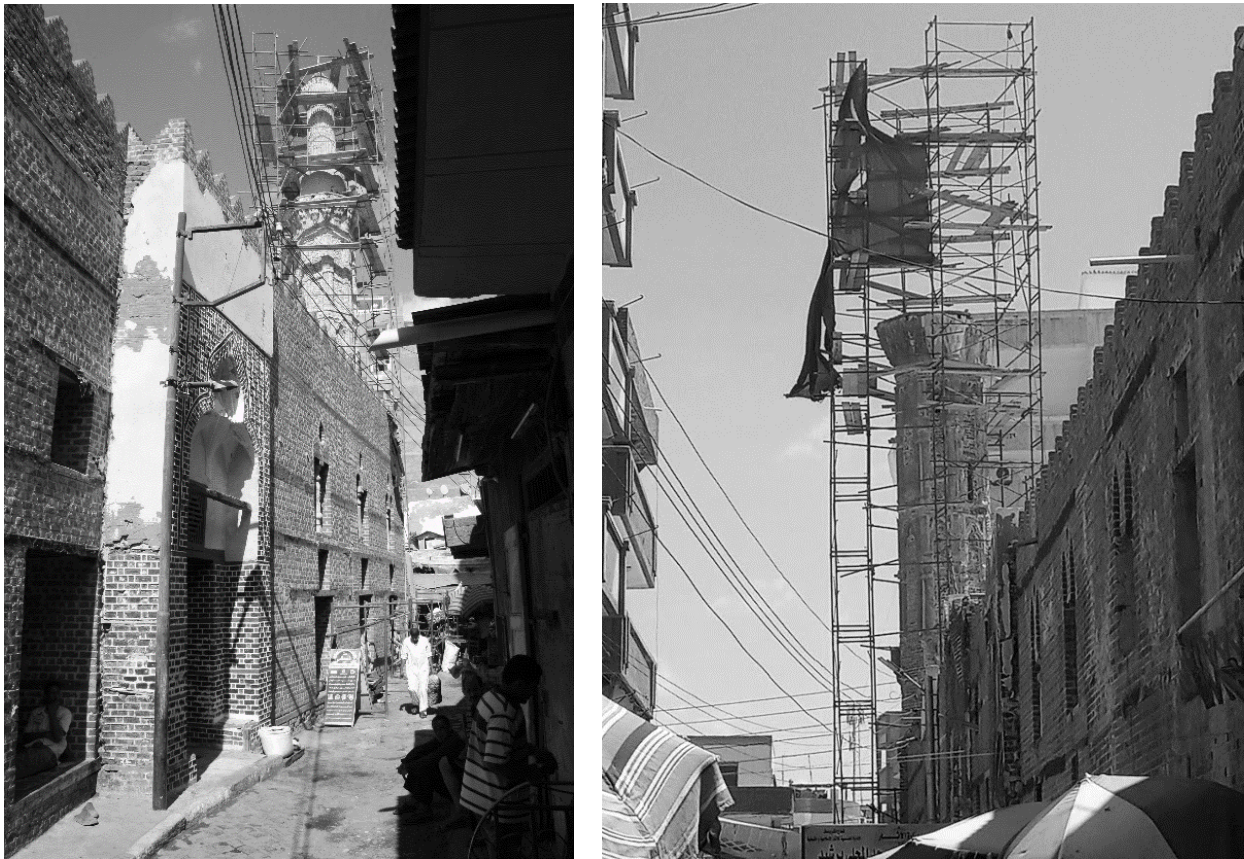
In 1993 al-Ḥuṣary & Abū al-Ḥaṭāb Company replaced four columns, rebuilt all arches and refitted the ceiling with new wooden beams. Otherwise, recent preservation reports describe the mosque as in a good state, only suffering from humidity and salt in the lower part of the walls. Restoration work resumed around 2011 and the mosque has been closed to the public since. By 2018 all plaster in the outer walls had been removed, the bricks cleaned, and at least one of the gates was restored;²³ the minaret was enveloped by scaffoldings. Images from the same year show that the floor of the mosque was flooded with water and in 2020 it was still inaccessible, to the frustration of the local community. While the restoration of this mosque drags to extensive lengths, there are some very negative trends. Plans are for the complete removal of the original columns as in the Zaḡhlūl mosque and their substitution with standardized, brand-new ones with alien materials that belie the original appearance of the building. Most worrisome is the demolition, without apparent reason and documented in July 2019, of the top of the minaret above the *mū’adīn* balcony [FIGURES 10A and 10B].

[FIGURE 10]: The minaret of al-Mahally mosque in 2018 (a) and in July 2019 (b) (©Monica Hanna 2018-2019)

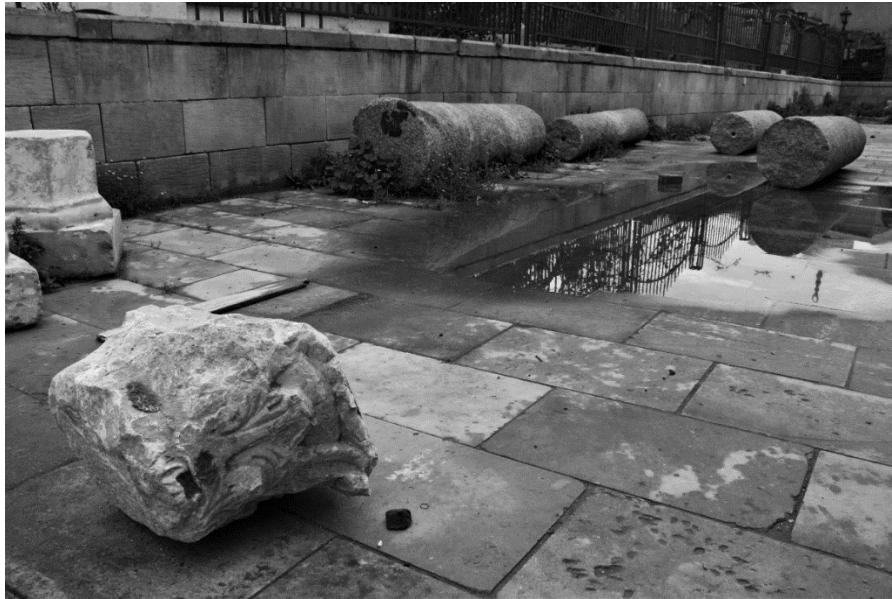
Several restorations took place later in the 20th century: in the second half of the 1980s under the surveillance of the Supreme Council of Antiquities; an intensive restoration done between 2004 and 2010 by The Arab Contractors;²⁶ a last intervention in 2018-2019 under the supervision of the Ministry of Endowments.²⁷ Satellite imagery shows the evolution of the building in the last twenty years [FIGURE 11A, B, and C]. In 2004, most of the building had already collapsed: all of the *ārūqa* around the *ṣaḥn* are down with the exception of the southern one, whose central part is completely on the ground and so are some sectors of the flat roofs to the east and the west. In 2007 there is no mosque: the whole structure, including the perimetral walls, has been demolished. Once again, instead of trying to salvage as much as possible of the old structure, the “restoration” process entailed the demolition of the old structure and the rebuilding of it roughly on the same lines. The new mosque follows more or less the same plan, with a main entrance to the south and a secondary gate to the west; this one roofed by an extensive porch. It nevertheless deviate from the original building in many elements: all ancient columns were removed and substituted by standardized, marble Corinthian columns, while the original mixture of columns and piers was abandoned for an all-column structure; the crenellation of the perimetral walls as well as of the *ṣaḥn* wall is arbitrary as there is no indication from the oldest photographic record of how they looked like; the entrance gate bears no resemblance with the one photographed with Creswell, which had an elaborately plastered trefoil semi-dome with wooden beams engaged in the *maṅḡūr* brick masonry; the biggest loss seems that of the *miḥrāb*, which photos by Creswell show framed by two slim marble columns with Corinthian capitals, a very elaborate plaster niche is crowned by a keel arch squared by an intricated frame of bricks. The new *miḥrāb* is framed by a different kind of columns, crowned by a pointed arch, and decorated by vertical stripes of red, black, and white marble. Of the original columns supporting the arcades, six marble columns were moved, standing with their Corinthian capitals (except for one), in the east area outside the mosque, while four other granite shafts and other marble architectural pieces were left on the ground in the northern fenced area outside the mosque (FIGURE 12). Other than this,

[FIGURE 12]: Roman granite columns and marble capitals at al-'Amry mosque in 2020

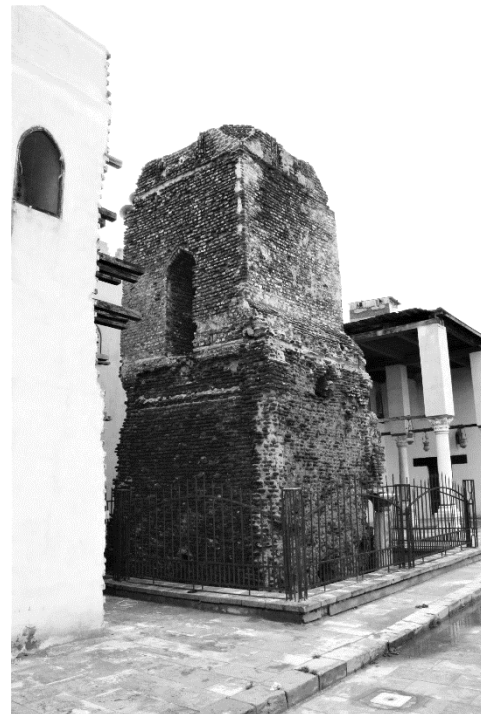
[FIGURE 15]: al-'Amry mosque minaret in 2020
