# Seismic Assessment of the Historical Sütlü Minaret Mosque

historical masonry mosque, time history analysis, finite element analyses, structural assessment

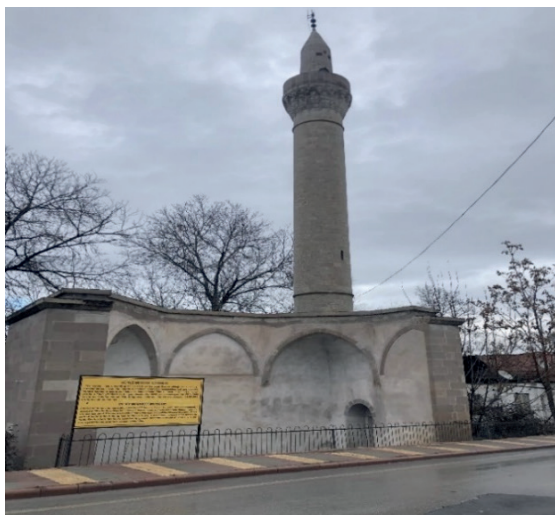
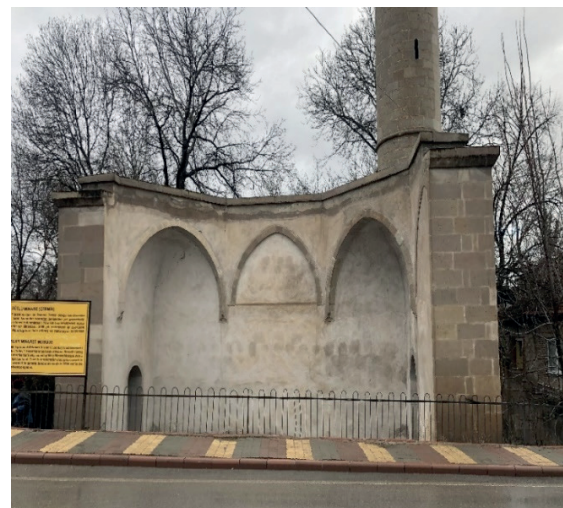
Fig. 2 General view of the historical Sütlü mosque

The Historical Sütlü Minaret Mosque is located outside of the city walls in the Battalgazi District of the City of Malatya and is an Ottoman structure with a single dome (Fig. 2). In terms of the materials, because the mosque was built with stones that maintained their white color and looked clean, the mosque is called "Sütlü" according to its appearance, which means "milky". Elevation views of the mosque are presented in Fig. 3. The mosque is quadruple-fronted. The wall is built with coursed rubble stones approximately 180 cm from the ground. In the initial survey, it was observed that two different types of stones were used in the structure and the walls inside the structure were

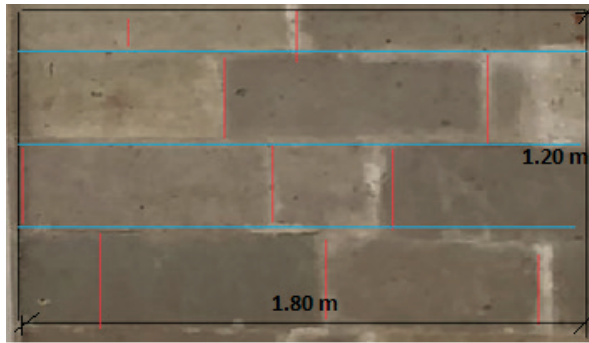
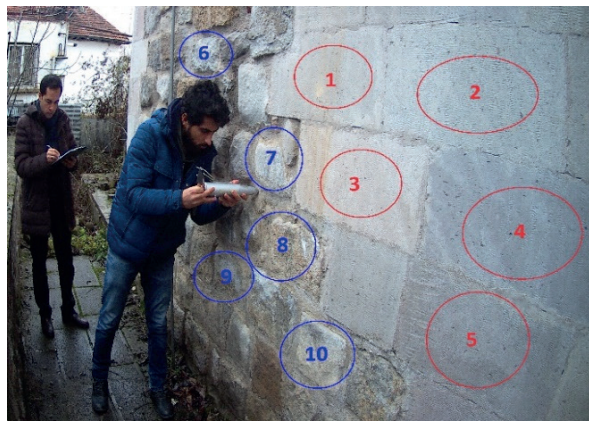
Fig. 4 Surface hardness measurement

in 10 different points. The readings obtained from the restoration stones were presented in red while the readings of the original stones were presented in blue color (Fig. 4). The hardness measurement values were conducted according to ISRM 1978 [23]. According to ASTM D 5873-14 [24], a total of 20 values were read per sample, and the average value of the surface hardness was calculated. The hardness measurement values of the walls of the historical mosque were presented in Table 1 in detail.

In previous studies, various equations were suggested for the determination of compressive strength of masonry walls. In this study, Eqs. (5)–(6) were considered [41–42]. The dimensions in the Eq. (6) can be seen in Fig. 4(b).

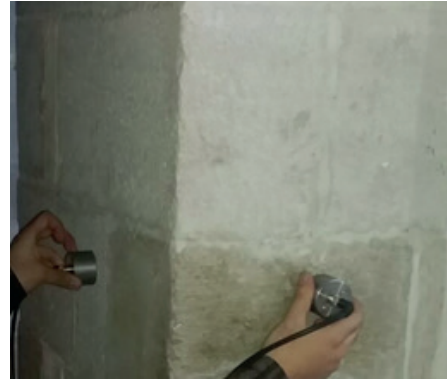
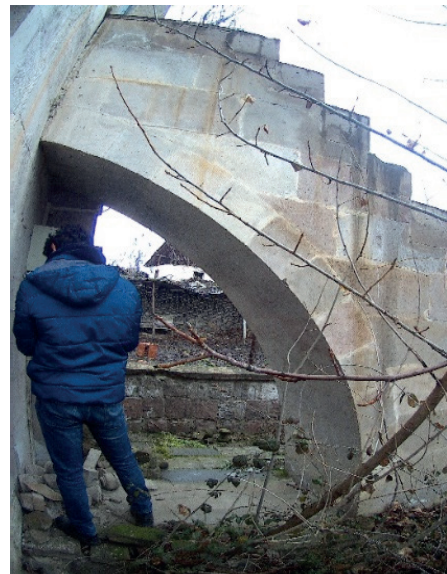
Fig. 5 Ultrasound test application

In the determination of elasticity modulus, ultrasound tests are used frequently [25, 26]. In this study, ultrasound methods, were used for masonry building elements, and the dynamic elasticity modulus was determined according to ISRM 1978 [27] (Table 2). The propagation velocity of

compression ( $V_p$ ) and shear ( $V_s$ ) pulses was applied according to the ASTM D 2845-05 [28]. Ultrasound velocity measurement tests were conducted on different points of the structure (Fig. 5). The Poisson ratio ( $\nu$ ) and the specific weight ( $\rho$ ) of the stone were determined in the laboratory test. Also, the propagation velocity of compression ( $V_p$ ) and shear ( $V_s$ ) pulses was obtained. The Elastic modulus attained from the compression (destructive) test is called the static elastic modulus ( $E_{st}$ ). The dynamic elasticity modulus ( $E_{dyn}$ ) is calculated using the ultrasonic (non-destructive) test method [29]. This is because destructive test methods are not appropriate for historical structures. Furthermore, in cases where it is not possible determine the characteristics of the stone using destructive tests, the

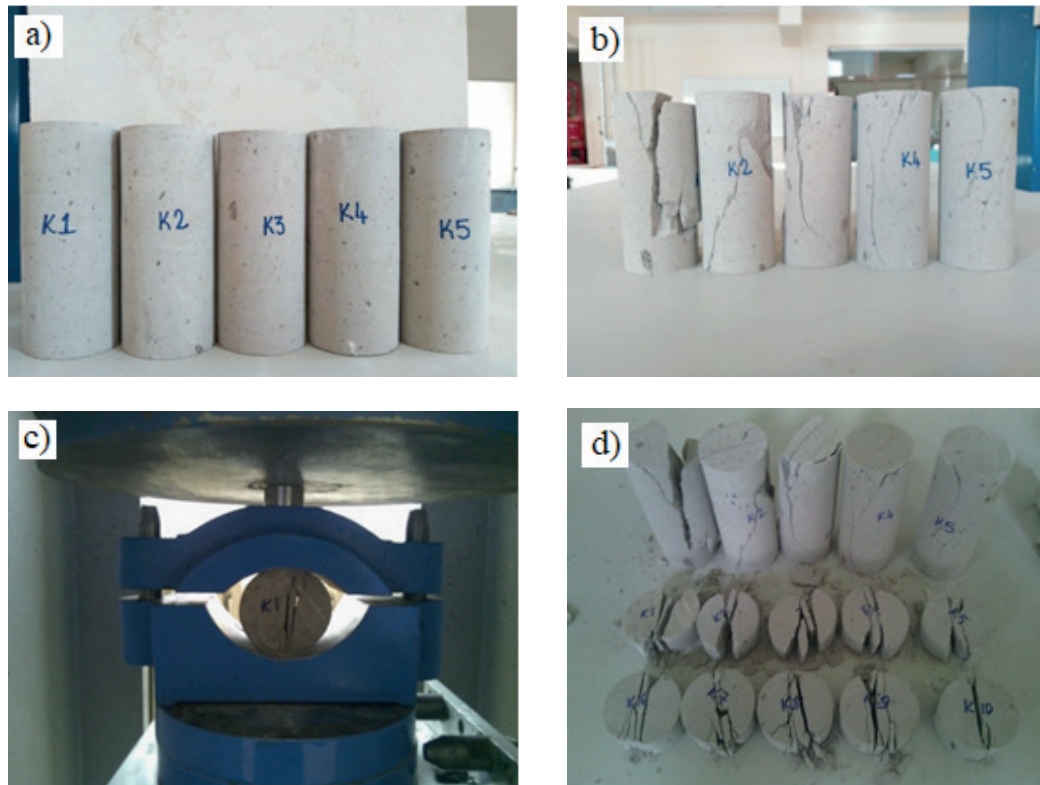
Fig. 6 Experimental tests a) Restoration stone, b) Crack formation following compressive load, c) Brazilian tensile test, d) Crack formation following the tensile test

To determine the mechanical characteristics of the stones used in the mosque, tensile and compression tests were conducted. For this purpose, the uniaxial compressive strength tests of the stones were conducted according to ISRM 1978 [32]. Test samples were prepared as cylinders with a height-to-diameter ratio of 2.0–2.5 for the uniaxial compression test according to ISRM. Samples were prepared as 54 mm diameters and 2–2.5 length/diameter ratios (Fig. 6). The compressive strength value of the specimen was calculated by using Eq. (3).

In this equation,  $\sigma$  is the compressive strength (MPa),  $P_k$  is the ultimate load (N) and  $A$  is area of the sample ( $\text{mm}^2$ ). Additionally, the tensile strength values of the test samples were obtained by using the Brazilian test (indirect test) (Fig. 6) [33]. This test is a well-known indirect method in engineering. The indirect tensile strength values of the specimens were calculated by using Eq. (4).

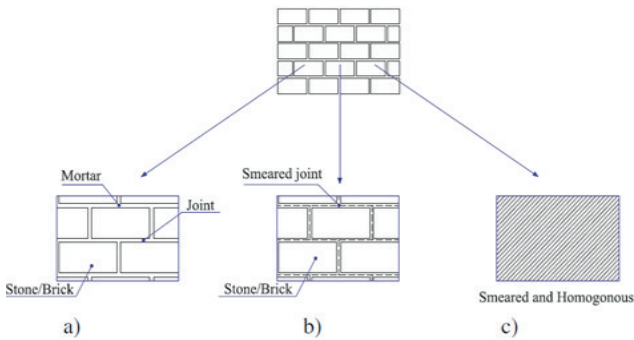
Fig. 7 Modeling techniques for masonry structures, a) detailed micro-model, b) simplified micro-model, and c) macro model [36]

These modeling strategies are given in Fig. 7. Because of its low computational effort, macro-modelling technique is the most common technique for analysis of large-scale models and commonly used in the literature [37–40]. In the macro modelling strategy, stone or brick and mortar material is considered as a homogenized domain. In other words, masonry building elements and the mechanical characteristics of these materials are considered as a whole via the homogenization process and turned into a composite material with a single characteristic.

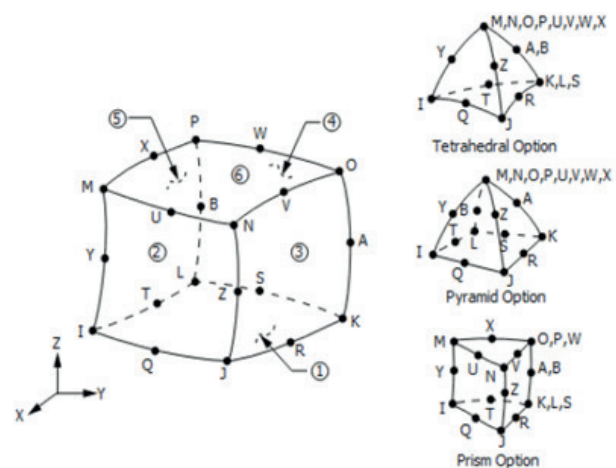
Fig. 8 The geometry of the SOLID186 element [45]

SOLID186 element is described by 20 nodes having three degrees of freedom per node and translations in the nodal x, y, and z directions. The geometry of the SOLID186 element was presented in Fig. 8.

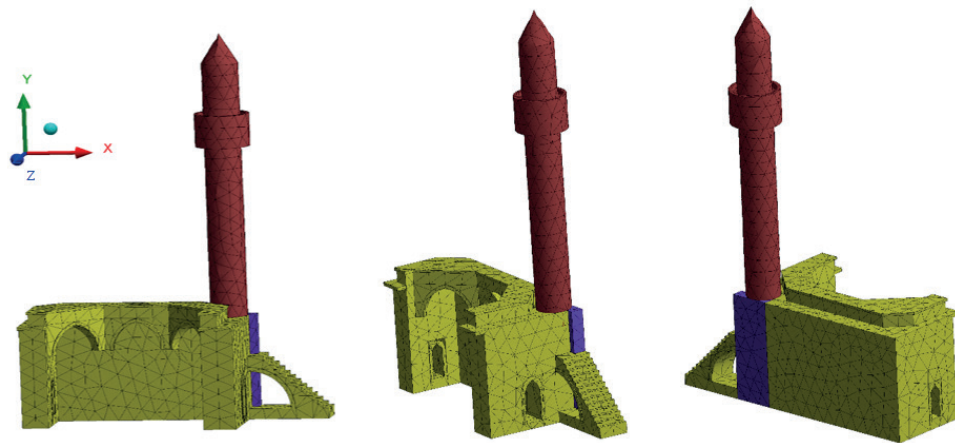
Fig. 9 Finite element model of the Sütlü Minaret Mosque for different angles

The three-dimensional model of the mosque, which was created in the ANSYS software, was presented in Fig. 9. In the finite element model of the mosque, all degrees of freedom were accepted as fixed at foundation level.

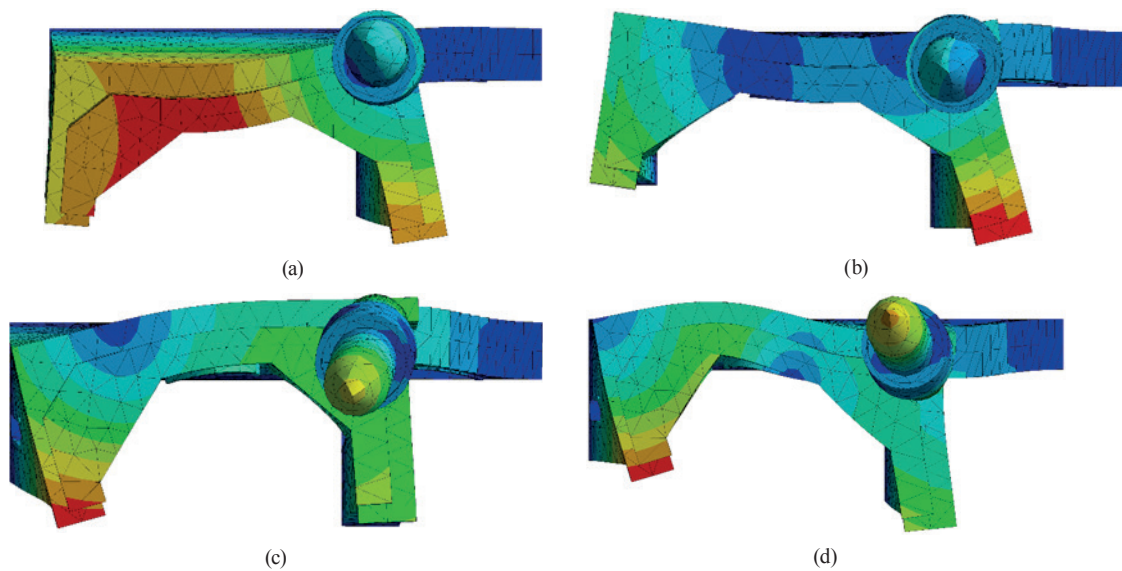
Fig. 10 First four mode shapes and frequencies of the mosque a) First mode ( $f_1 = 1.8364$  Hz), b) Second mode ( $f_2 = 1.9716$  Hz), c) Third mode ( $f_3 = 11.944$ Hz), d) Fourth mode ( $f_4 = 12.724$  Hz)

Dynamic characteristics of the mosque were evaluated with modal analysis. In the analysis, 5% damping ratio was used [1, 4, 5]. The analytically identified first four mode shapes of the mosque were given in Fig. 10. Furthermore, the frequency data of the first 20 modes were presented in Table 5.

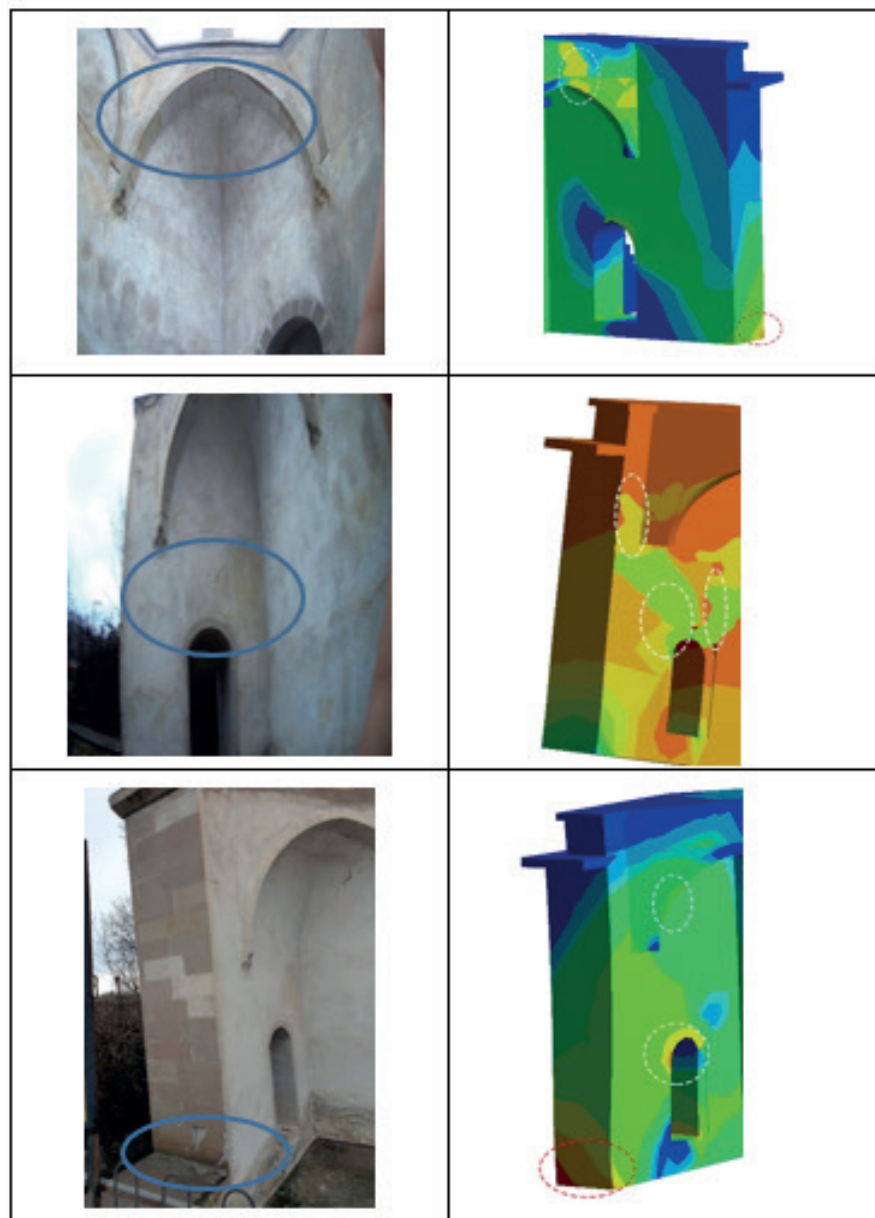
**Fig. 15** The damages that occurred during the Elazığ earthquake on January 24, 2020 ( $M_w = 6.8$ )

that cracks were formed on the upper parts of the openings (doors), on the parts starting from the inner sections of the arches and continuing toward the upper sections of the mosque, and on the parts where the mosque was connected to the ground. As a result of the numerical analyses, it was obtained that the stress concentrations occurred in the parts of the mosque which were cracked by the earthquake. When the compressive and tensile strengths of the materials obtained in the study were compared to the stresses obtained from the numerical analyses, it was observed that the tensile stress that occurred in the three dimensional model exceeded the tensile strength of the material only in the restored section in the bottom part of the mosque. The

observed cracked regions in the mosque and the numerical analysis results after the 24 January, 2020 Elazığ earthquake were given and compared in Fig. 15.
