Analysis of the structural behavior of a historical mosque damaged due to an earthquake: Sofular mosque example

Burçin Şenol ŞEKER* and Merve ÖZKAYNAK

Department of Architecture, Faculty of Architecture, Amasya University, Amasya, Turkey

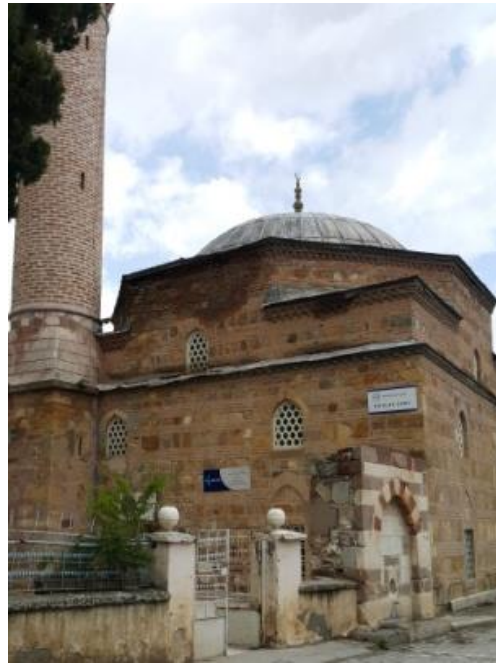
Located in Sofular Neighborhood, the exact date of construction for this complex including a mosque, a shrine and a water fountain is not clear; however, it is accepted that it was built in the 15th or early 16th century by Abdullah Pasha. The mosque has a square-plan structure with a narthex to the north. On the northern edge of western front of the main building, a minaret is situated adjoint to the main outer wall. On the north-west edge, only the lower part of the cylindrical brick minaret is preserved as in its original form. On the main outer walls, a block with an octagonal plan is situated. The main outer walls of the triptych mosque are made with cut stone material and an alternating pattern was employed by laying three or four rows of brick between each row of stone. The narthex located in the northern part was made in the form of a triple-arched portico. This arch system was built by using two different stones of red and white color together. Three little domes are placed on the portico. The columns in this part all have a capital part and they are connected with wooden stretchers from the support points. The main entrance was built out of marble (Figure 1).

Figure 1. Sofular mosque General View.

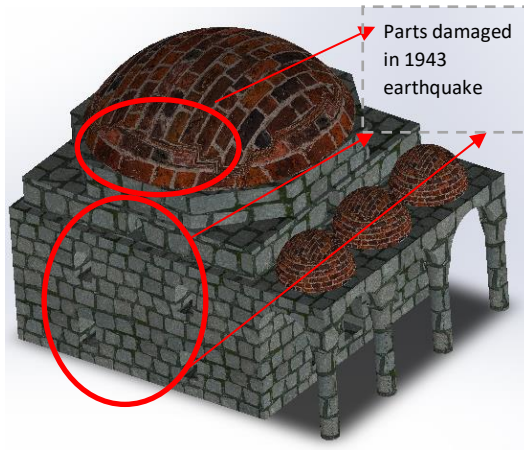
The columns at the outer walls, the cincture systems and the narthex are all made of sandstone material; the main and the little domes are built out of bricks. There are five windows located on the outer walls on each of the three walls except for the front entrance door. These windows are located at the lower and upper part of the main outer walls in pairs. The remaining window, however, is located on the octagonal block above the main outer wall. This window is also found on the northern front. Small support cinctures are paved on the windows in order to distribute the load sideways. The windows on the upper part are smaller compared to the ones in the lower part. The main dome is situated on the octagonal block. A squinch is used as a transitional component for dome. According to the accounts of the eye-witnesses which are included in the study of Çerkez (2005), half of the eastern wall and almost half of the main dome of the mosque collapsed in the 1943 earthquake (Figure 2).

Figure 2. Parts Damaged in 1943 Earthquake.

The parts that are found to be at risk as a result of the analysis are the same parts that were damaged during the 1943 earthquake, which proves the accuracy of the model and the assumptions made. It would be beneficial to conduct non-linear analyses on the stressed parts in order to determine further tensile and deformation forms. It is hoped that the results of this study will be useful for further restoration and renovation projects.

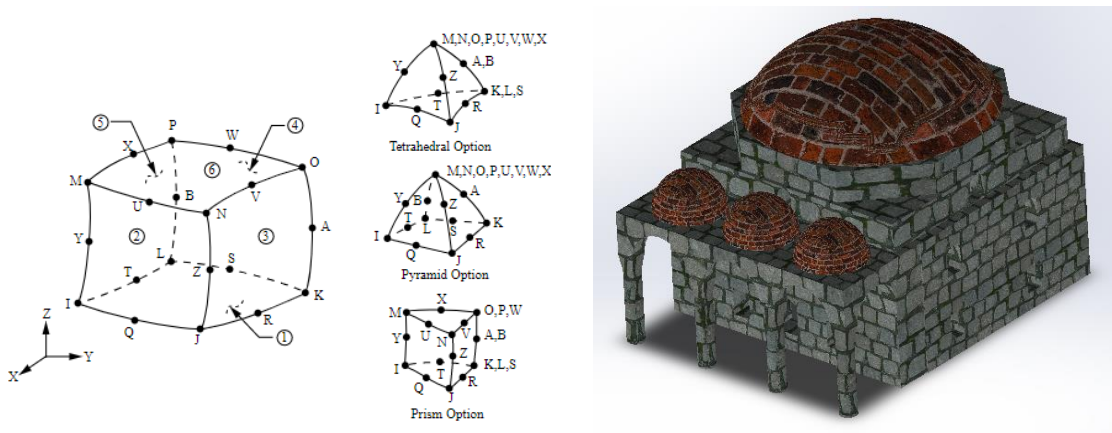
Figure 3. Finite Element and Mosque Model.

The analyses conducted for the mosque studied in this paper are made through ANSYS (2014) software that uses Finite Element Method (FEM). In the scope of this study, the building is considered as a whole with macro-modelling technique, and specific mechanic characteristics for each part are assigned to relevant parts corresponding

to their building material. Within its scope, a 3D model of the mosque was created according to its real dimensions. The geometrical structures of the building, support conditions, and material properties of the relevant parts were assigned to the model. The finite element model consists of 37056 node points and 47204 solid elements in ANSYS Workbench. The Solid 186 elements used for analysis has 20 node points, which each of has three translational freedom. The properties of the Solid 186 (ANSYS (2014)) elements are presented in Fig 3. The minaret was excluded from the analysis in order to examine the deformation and stresses on the main building block. Characteristics of the material to be used in the analysis were identified as a result of the experiments conducted on the materials (Şeker et al., 2014). The main part of the mosque, narthex, and arches were built using cut stones, while the domes were built with bricks. Mechanic and physical features of the materials are shown in Table 1, and the model created for analysis is shown in Figure 3. These analyses conducted on the mosque using the material features are evaluated in two parts as static and dynamic. Because of the size of the mosque model and the high number of nodes, the values obtained from the analyses are presented as a colored propagation in the model.

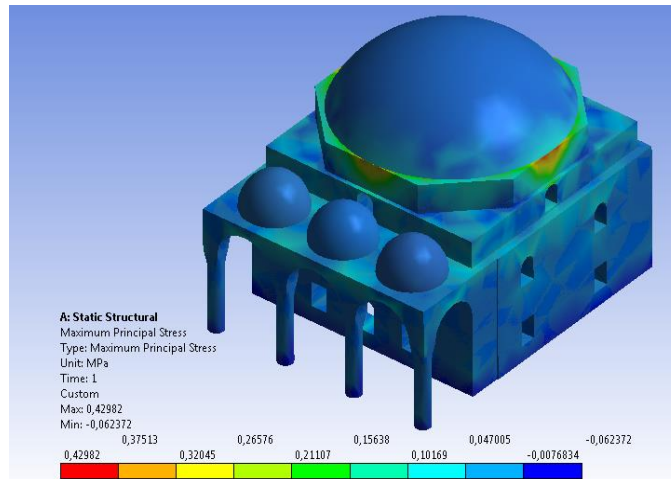
In the first part of the study, structural analyses are made according to the fixed loads on the building. As a result of these loadings, the obtained values for strain and deformation are shown in Figure 4 and Figure 5. It can be from in Figure 1 that the principal tensile stress is found to be concentrating on the dome's support points and the peak point of squinches of dome pulley parts. At these points, the stress values reach 0,43 MPa. The forces occurring at the supports of the dome cause the dome to widen sideways under static loads. So, to prevent this, necessary measures need to be taken for these areas during the construction period. It is known that the dome part is built with bricks. Therefore, the principal tensile stress values shown in Figure 4 are lower than the allowable stress which is 2,69 MPa. However, long term loading may cause the supports to be deformed and widen laterally.

Figure 4. Static Analysis Maximum Principal Stress Values.

Within the scope of this article, historical Sofular mosque has been subjected to static and dynamic loads. The main objective of the analysis was to identify the parts that can be damaged under these loads. Evaluating all of the analysis results, it is seen that the support points of the main dome stand out as the parts in the most danger under static loads; therefore, special measures need to be taken concerning this part. The horizontal thrust force stemming from the slope of the dome causes to become large stress values on these parts. A possible suggestion could be to surround the dome with either wooden or iron stretchers at these parts. When the deformation values are evaluated

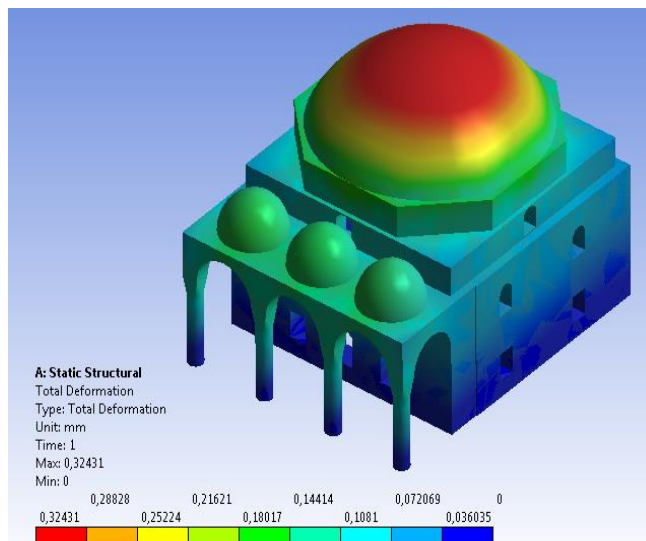
To prevent this from happening, A. Bayraktar (2006) emphasized that these parts need to be strengthened with wooden tension elements in mosque building techniques. It is seen that the deformation values in Figure 5 are concentrated around the main dome’s peak point. Similarly, A. Bayraktar (2006) also suggested giving prestress to the system by driving nails between the dome brick in mosque building technique. Furthermore, the chandelier hung from the peak point helps with the stability of the dome.

Figure 5. Static Analysis Total Deformation Values.

in this analysis, it can be seen that maximum values are concentrated around the peak point of the dome. This reveals the necessity of ensuring the rigidity of the peak point adequately during construction. In addition, modal analysis reveals that stress concentration points are located in the narthex, main dome and upper parts starting from half of the front walls.

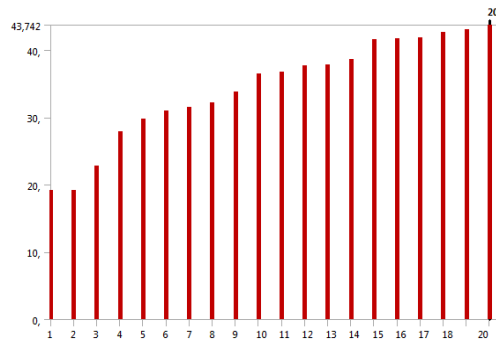
detail. As a result of the modal analysis, Figure 6 shows the mode frequency values while Figure 7 shows that the two mode shapes with the highest mass participation ratio are translations on north-south and east-west directions.

Figure 6. Mode Frequencies.

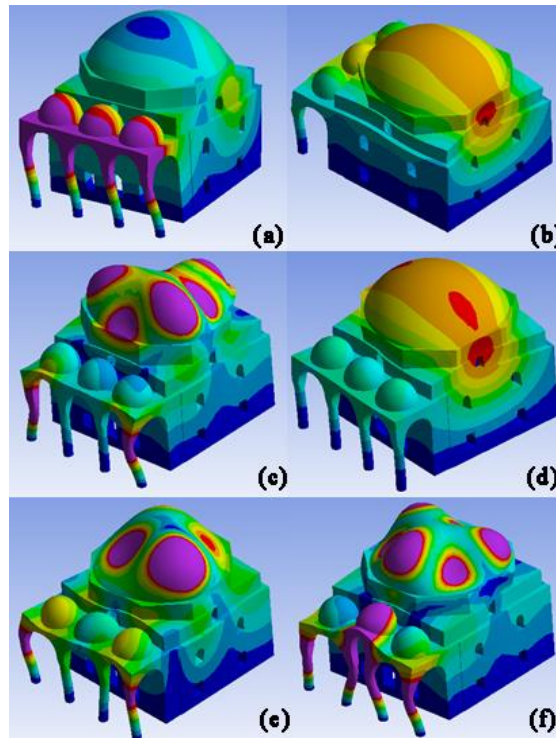
Figure 7. Mode Shapes with The Highest Mass Participation Ratio (A-1. Mode Shape, B-2. Mode Shape, C-4. Mode Shape, D-10. Mode Shape, E-15. Mode Shape, F-20. Mode Shape).

In accordance with these translation shapes, it can be said that the upper part of the mosque above the main outer walls including the dome would be damaged. Moreover, taking other mode shapes into consideration, narthex and main dome participate actively in building's behavior and as a result of stress, the joint points of these parts can undergo deformation. Table 2 shows the active frequency modes, periods, and mass participation ratios. Since the main block is a small-scale building very close to a square plan, the periods remain low. Consequently, this shows that the mosque will resist possible earthquake effects with a rigid structure.

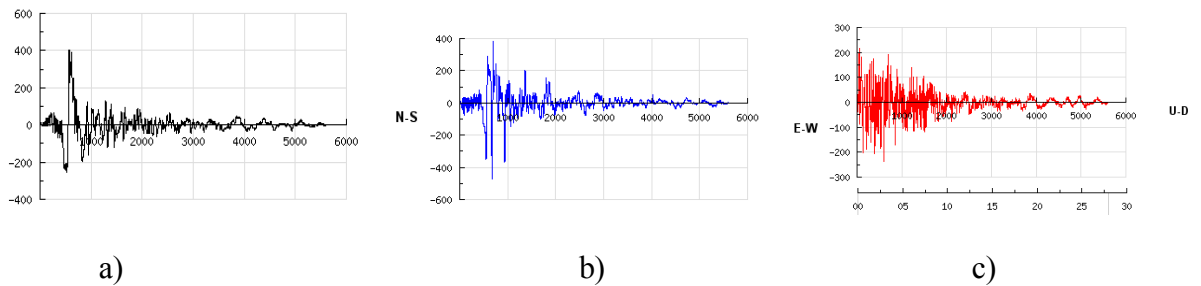
Undoubtedly, earthquakes are the most destructive force acting upon the buildings in our country (M. Karaton (2011), E. Hökekleli (2020) and B.S. Seker (2015)). Therefore, it holds great importance to perform analyses on such buildings with historical and cultural heritage and subsequently to take necessary precautions. Since Merzifon is located on the North Anatolian Fault line which is a first-degree seismic zone, it is expected that an earthquake would cause more damage to such structures. Depending on the intensity, duration, direction and the epicenter of the earthquake, the range and intensity of the damage would vary. In this part of the study, based on the records of Erzincan earthquake in 1992, the analysis of the mosque under earthquake force was performed and possible damage areas were identified. Accelerogram values are given in mm/s^2 . Maximum acceleration value for north-south direction is $4049,71 \text{ mm/s}^2$, and $4709,152 \text{ mm/s}^2$ for east-west direction, and the maximum value for vertical direction is $2385,513 \text{ mm/s}^2$. The directions for the acceleration values are chosen in parallel to the directions of the mosque. In other words, the records for north - south direction of the earthquake is applied to north-south direction of the mosque, the east-west direction record to the east-west direction of the mosque, and the vertical direction record is to the vertical direction of the mosque. The accelerogram records of the earthquake are given in Figure 8 (URL-1, 2020) and the directions of the mosque are shown in Figure 9.

Figure 8. 1992 Erzincan Earthquake. North-South Direction (a), East-West Direction (b), and Up-Down Direction (c). Acceleration Records.

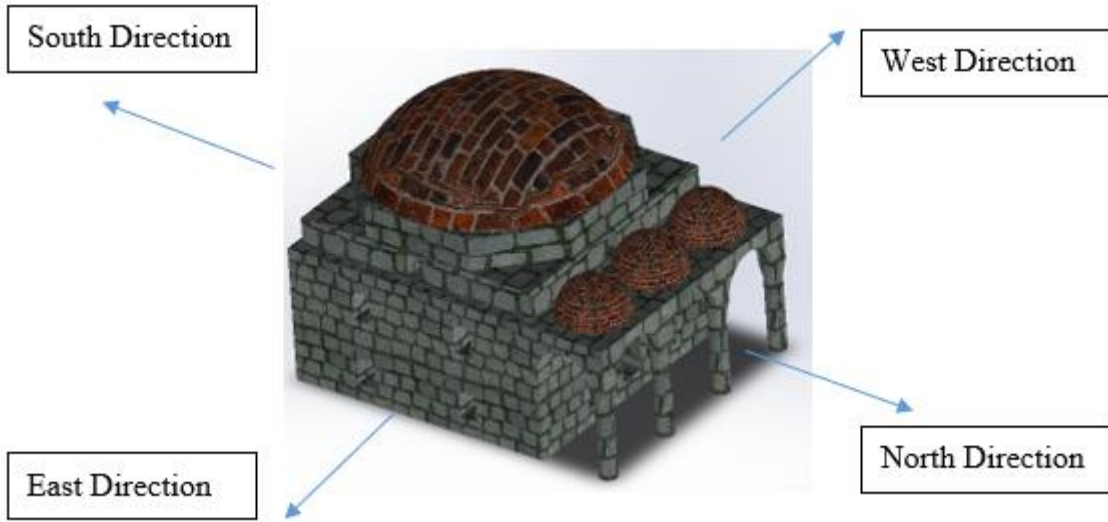
Figure 9. Directions of the Mosque for Time History Analysis.

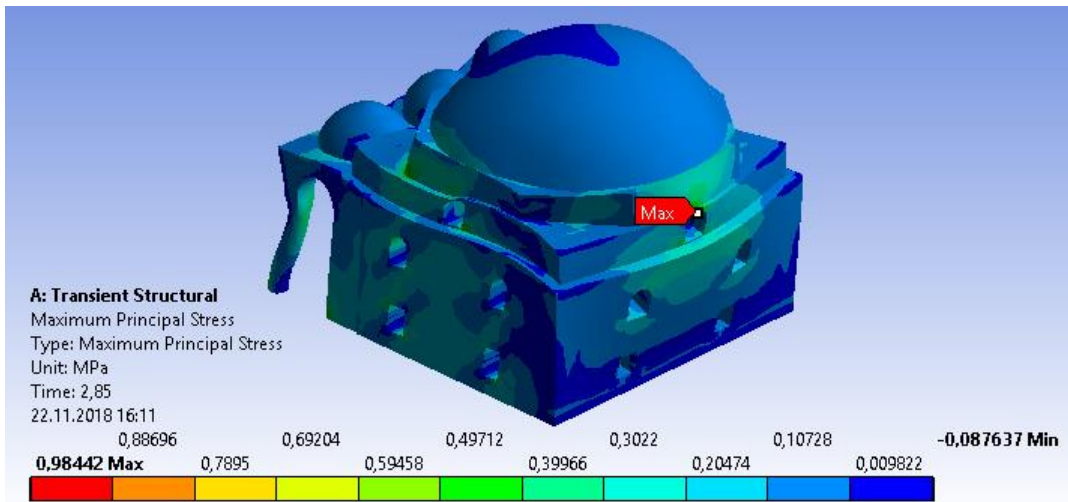
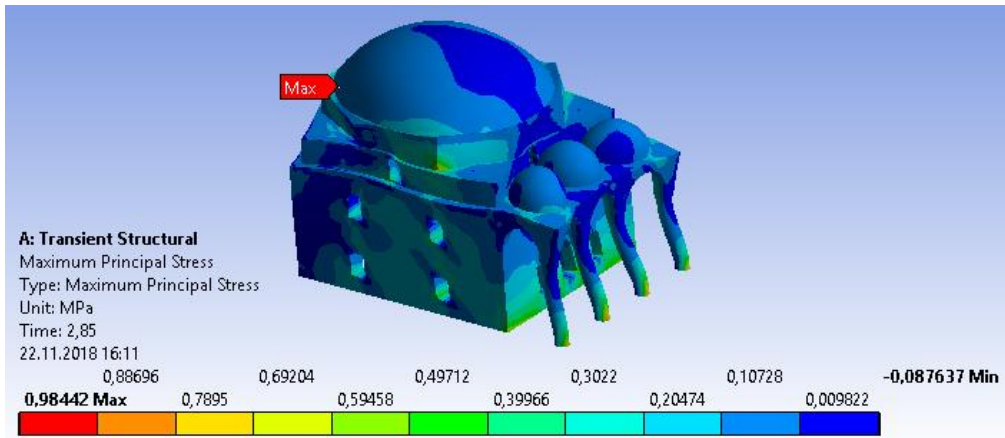
The principal tensile stress distribution obtained from the analysis can be seen in Figure 10. Maximum values concentrate above and below the window on the upper side of the south front wall. In addition, the top windows located in the same part of the eastern and western front walls exhibit large scale deformations around them and large stress values. Similarly, around the support points of narthex columns and below the entrance front, there are areas with considerable stress concentrations. It can be seen that the maximum value is 0.98 MPa and occurs at the upper part of the south wall.

Figure 10. Maximum Principal Stress Distribution.

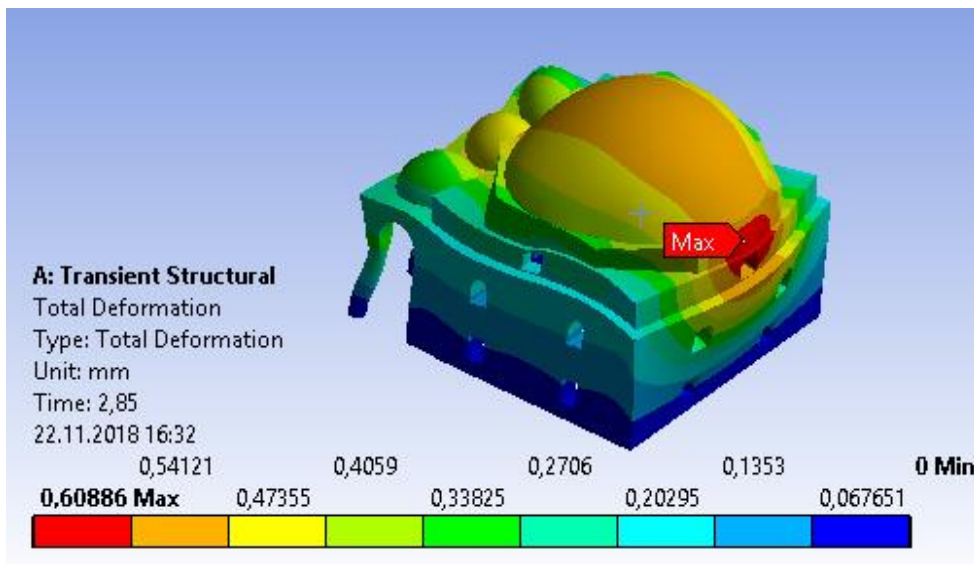
Figure 11 shows the maximum deformations of the analysis. An examination of these distributions reveals that deformation reaches maximum around top window on southern front during an earthquake. Furthermore, the window at the same height on western and eastern fronts show out of plane deformations. Maximum value is 0,68 mm.

Figure 11. Total Deformation Distribution.

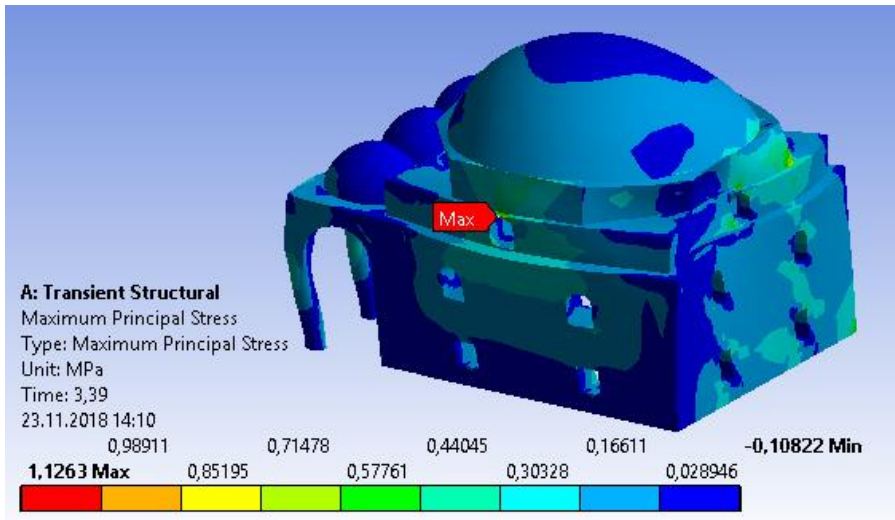
Maximum tensile stress distribution for east-west direction acceleration records analysis can be seen in Figure 12. Examining the figure, we can see that maximum values occur at the upper window on the western front wall which is 0,64 MPa. An earthquake in this direction can lead to fractures due to stress concentration at lower parts of the western and eastern front walls. Maximum value is 1,1263 MPa.

Figure 12. Maximum Principal Stress Distribution.

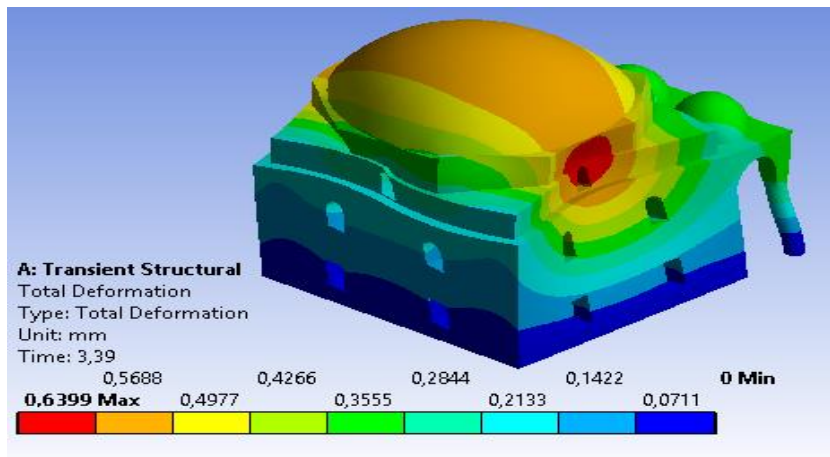
Maximum deformation values for east-west direction acceleration records are shown in Figure 13. The figure reveals that there is active out of plane behavior from lower windows of the eastern front wall upwards and towards the lower part of the wall. In case of such a deformation, it is predicted that starting from approximately half of the eastern front wall upwards and half of the area between the support points of the dome and its peak point have a chance of collapsing. The maximum value is 0,64 mm.

Figure 13. Total Deformation Distribution.

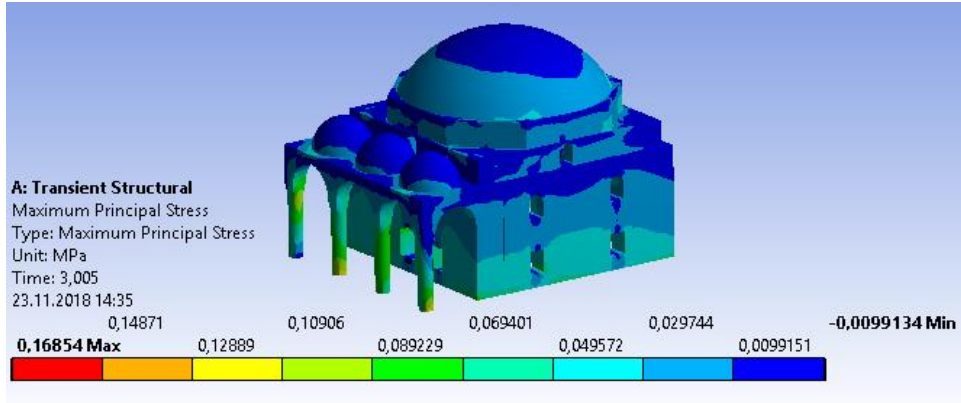
Figure 14 demonstrates the maximum tensile stress distribution for vertical direction acceleration. This figure clearly shows that the maximum values increase starting from bottom parts of the narthex columns towards joist hangers. In an earthquake in this direction, fractures can occur in columns due to stress concentration in these areas. The maximum value is calculated as 0,168 MPa.

Figure 14. Maximum Principle Stress Distribution.

Lastly, according to the results of the vertical directional time history analysis, support points of the narthex columns are seen to have the highest values for tensile stresses. Also, main dome has been identified as the riskiest part of the buildings in terms of the deformations. It has to be noted that modal analysis has been quite helpful in determining the dynamic behaviour of the building and identifying the part that experienced deformation and excess stresses.

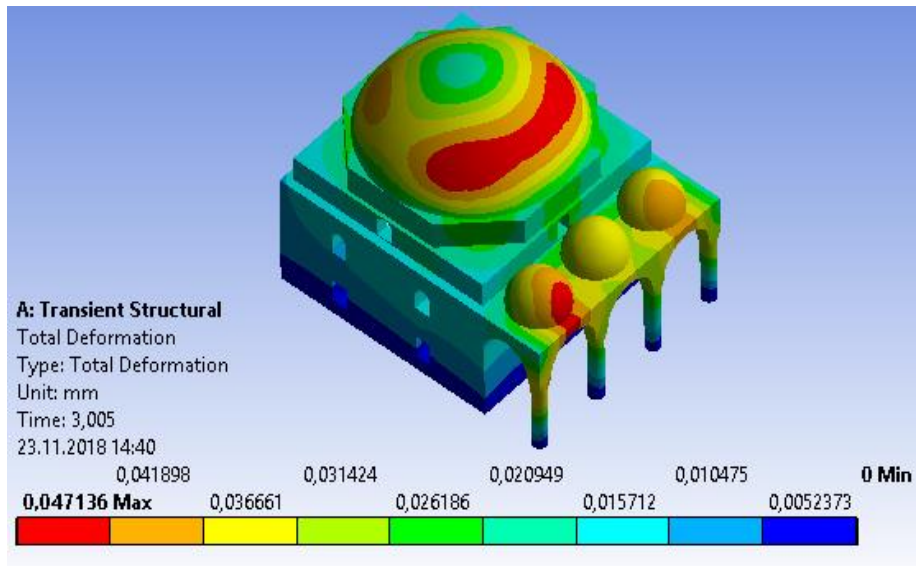
The deformation values for vertical direction acceleration analysis can be seen in Figure 15. This figure shows that main dome and smaller domes in the narthex have large deformation values. The maximum value is given as 0,047 mm. Deformation values obtained from these analyses are within the limits determined in the regulation (TYDRYK, 2017).

Figure 15. Total Deformation Distribution.
