USERS' PERCEPTION AND POST-CONSERVATION EVALUATION OF KAMPUNG TELUK MEMALI MOSQUE IN IPOH, PERAK, MALAYSIA

AZIM A. AZIZ & M. HAZIQ ZULKIFLI
ATSA Architects, Kuala Lumpur, Malaysia

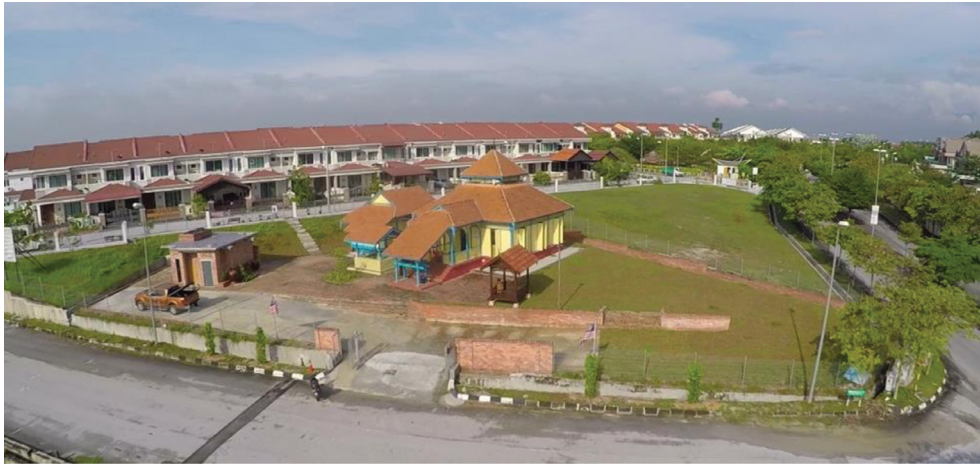
After efforts of more than 3 years, the historic timber mosque of Kampung Teluk Memali has finally come to fruition. The mosque has now been serving the local Muslim community of around 100 people as a local *surau* (small mosque) in Taman Seri Bougainvillea, Bandar Seri Botani in the city of Ipoh, Perak. The mosque's unique feature of the Perak traditional architecture now stands out harmoniously in the urban township area, with the original building elements are seamlessly intact, without any juxtaposed additions (Fig. 1).

Figure 1: Aerial view of Kampung Teluk Memali Mosque in Ipoh, Perak, Malaysia.

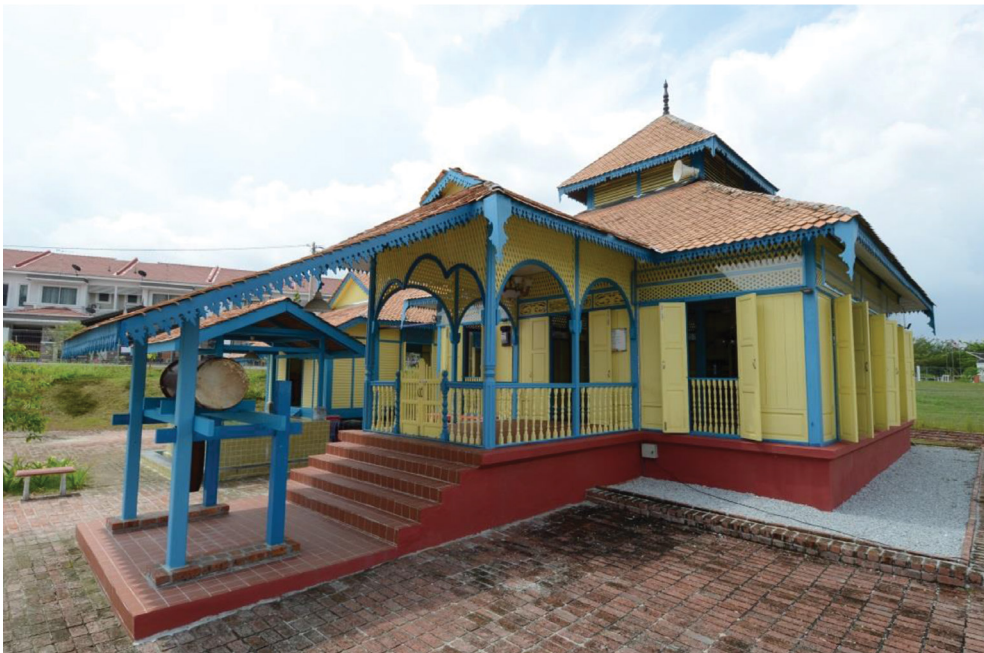
In this regard, the majority of the end-users believed the mosque is still in good condition, in this post-conservation stage. This is reckoned as the mosque has been used for a year, as it is still in an infancy stage. Besides that, a proper conservation procedure was established and done in the rebuilding of the mosque to ensure that the mosque can be re-used and repurposed as an Islamic place of worship for the next 100 years (Fig. 2).

Figure 2: Conditions of mosque building after the completion of conservation works.

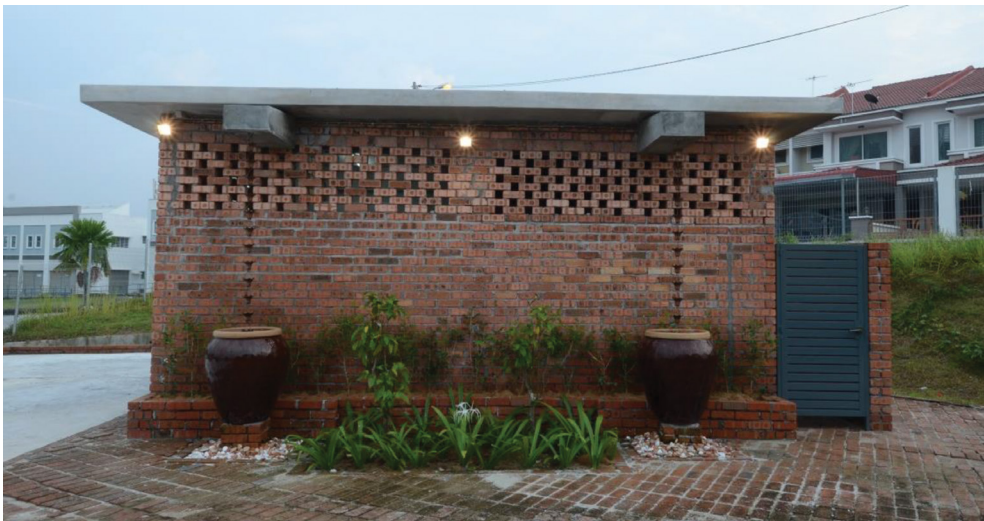
The end-users concern on the toilet can be understood from its lack of maintenance, as well as some issue during and after the construction. The toilet building is a new addition to the mosque as a modern facility for ablution and washing purposes (Fig. 4). Unfortunately, it had not been executed properly by the appointed contractor as they were issues on workmanship and leaking at certain parts. Even though it had been rectified, some minor issues were surfaced from time to time, such as water accumulation, clogging and leaking pipes, etc.

Figure 4: The new toilet building.

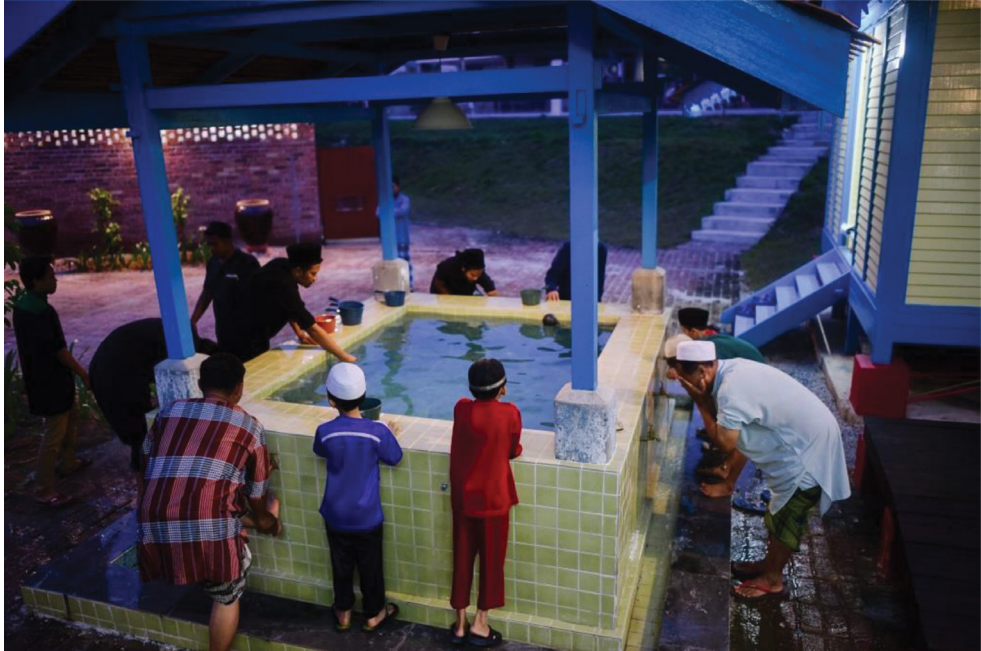
Ablution and storage space comes in the second place with 20% respondents picked it up. Comfortability for the ablution area can be translated as probably bigger space or more water tap for ablution. It can also be in terms of the space of ablution point or walkway from

Figure 8: Ablution water trough.

ablution to the prayer hall (Fig. 8). While for the storage space, as there is currently a medium size storage space in the toilet building, the respondents felt that the space size could be further expanded to accommodate their cooking utensils and other stuff.
