# AGA KHAN HISTORIC CITIES PROGRAMME

## THE CONSERVATION OF THE ALTINBUGHA AL-MARIDANI MOSQUE, CAIRO

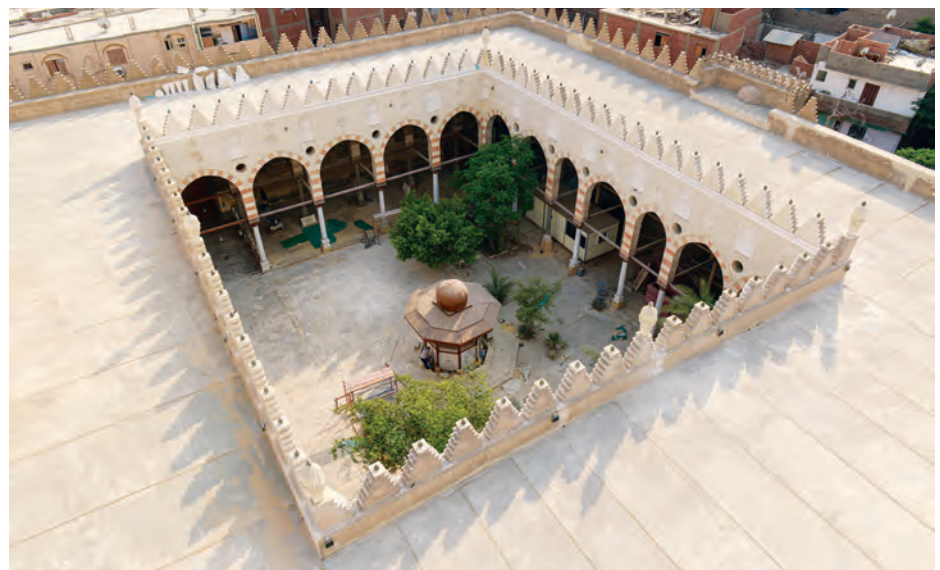
*Right:* The complete rehabilitation of the Maridani mosque's roof was necessary to secure from water infiltration the external envelope of the monument (Adrien Buchet / AKTC, 2021).

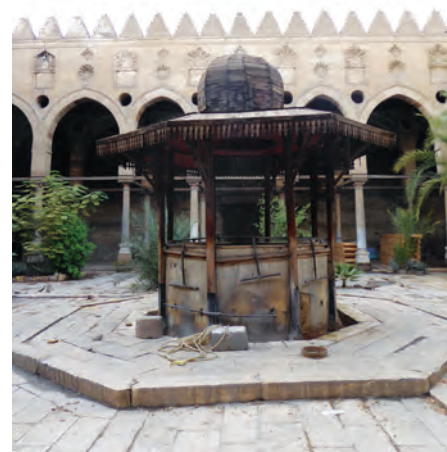
*Above & Below: The Ottoman ablution pavilion, relocated by the Comité to al-Maridani from the Sultan Hassan Mosque, before and after restoration (Christophe Bouleau, 2017 and Adrien Buchet, 2021).*

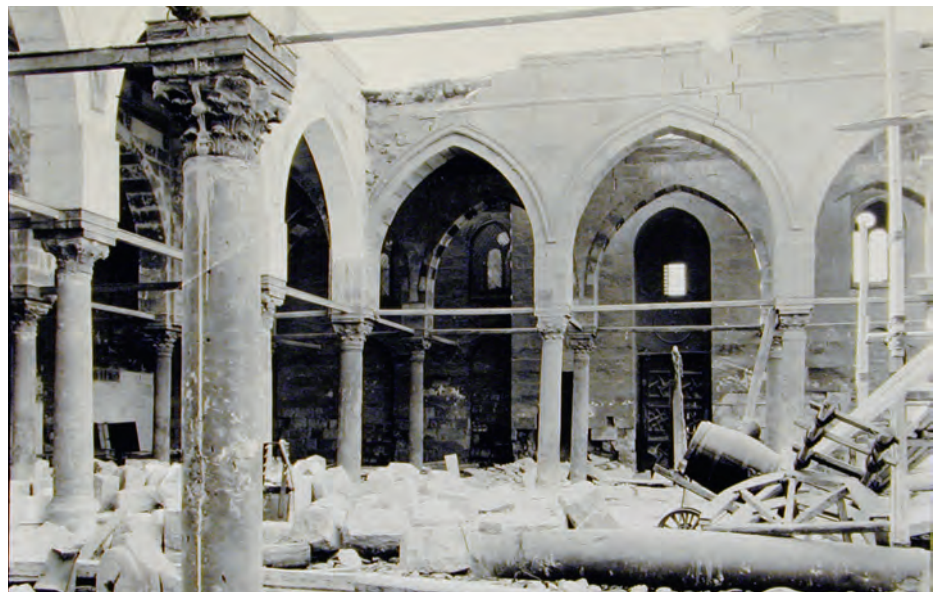
*Right: The Maridani Mosque's courtyard arches under reconstruction by the "Comité" (Bulletins of the Comité de Conservàtion de l'Art Arabe, 1896).*

important works in 1897, including restoration and partial reconstruction of the collapsed arcades and the reinstatement of twelve stucco windows in their original location.

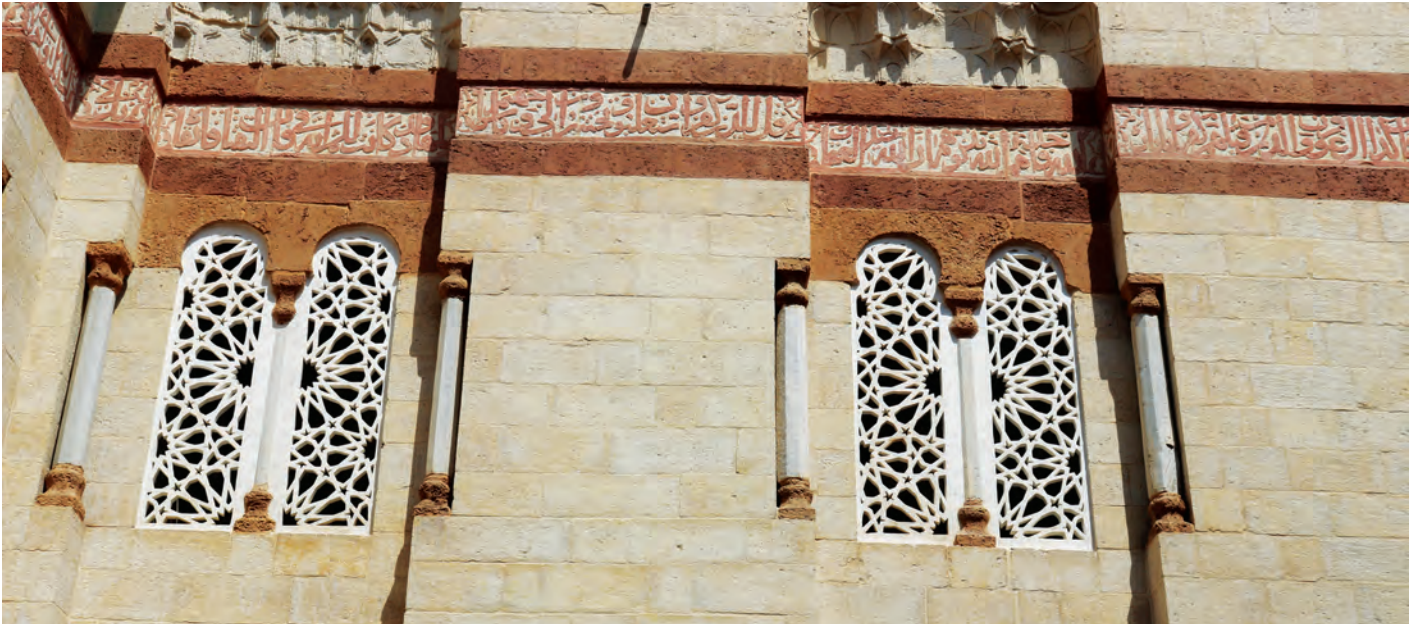
Above: View of the upper part of the mosque's east elevation with chiselled gypsum plaster openings and upper inscription band (AKTC Conservation Team, 2020).

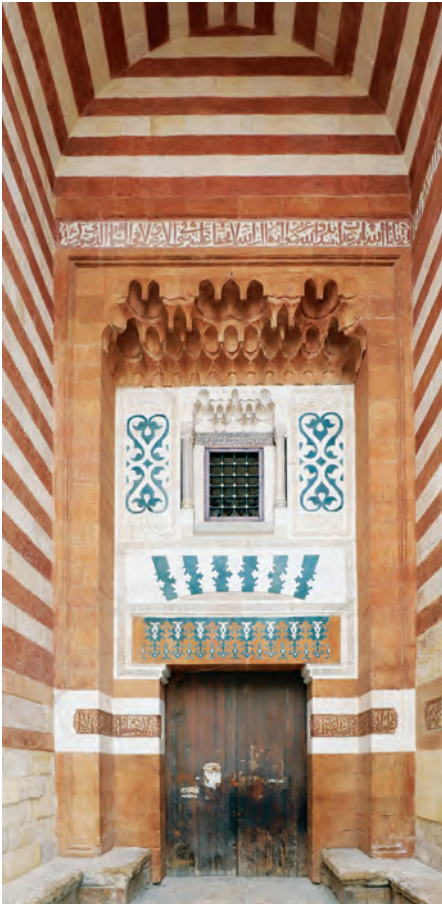
Below: The northeast monumental portal is the main access to the mosque near the Zuweyla Gate (AKTC Conservation Team, 2020).

- **The northeast portal** is the mosque's main entrance. It is regarded as one of the finest Bahri Mamluk portals, a lavish testament to the generosity of Sultan al-Nasir Muhammad towards Altinbugha al-Maridani. The rectangular portal is located at the back of a plain vaulted bay flanked by two stone benches and is crowned by a stalactite hood. Here high-quality craftsmanship can be observed in the decorative details, such as the elaborate stone carvings and intricate marble inlays. Above the plain wooden door is an inlaid lintel with alternating-colored stones, crowned by a tympanum and an arch with joggled voussoirs of interlocked stones, a typical treatment found in many Mamluk facades. Above it is a window grille of fine metalwork placed between two small columns and two marble panels displaying floral decorations in black and white marble. Both sides of the metal grille are of great historic importance, as they include inscriptions bearing the titles of al-Maridani and Sultan al-Nasir Muhammad. In addition, two blazons with the stemmed cup of the cup-bearer are carved on either side of the metal grille. These are the only surviving heraldic emblems in the mosque.

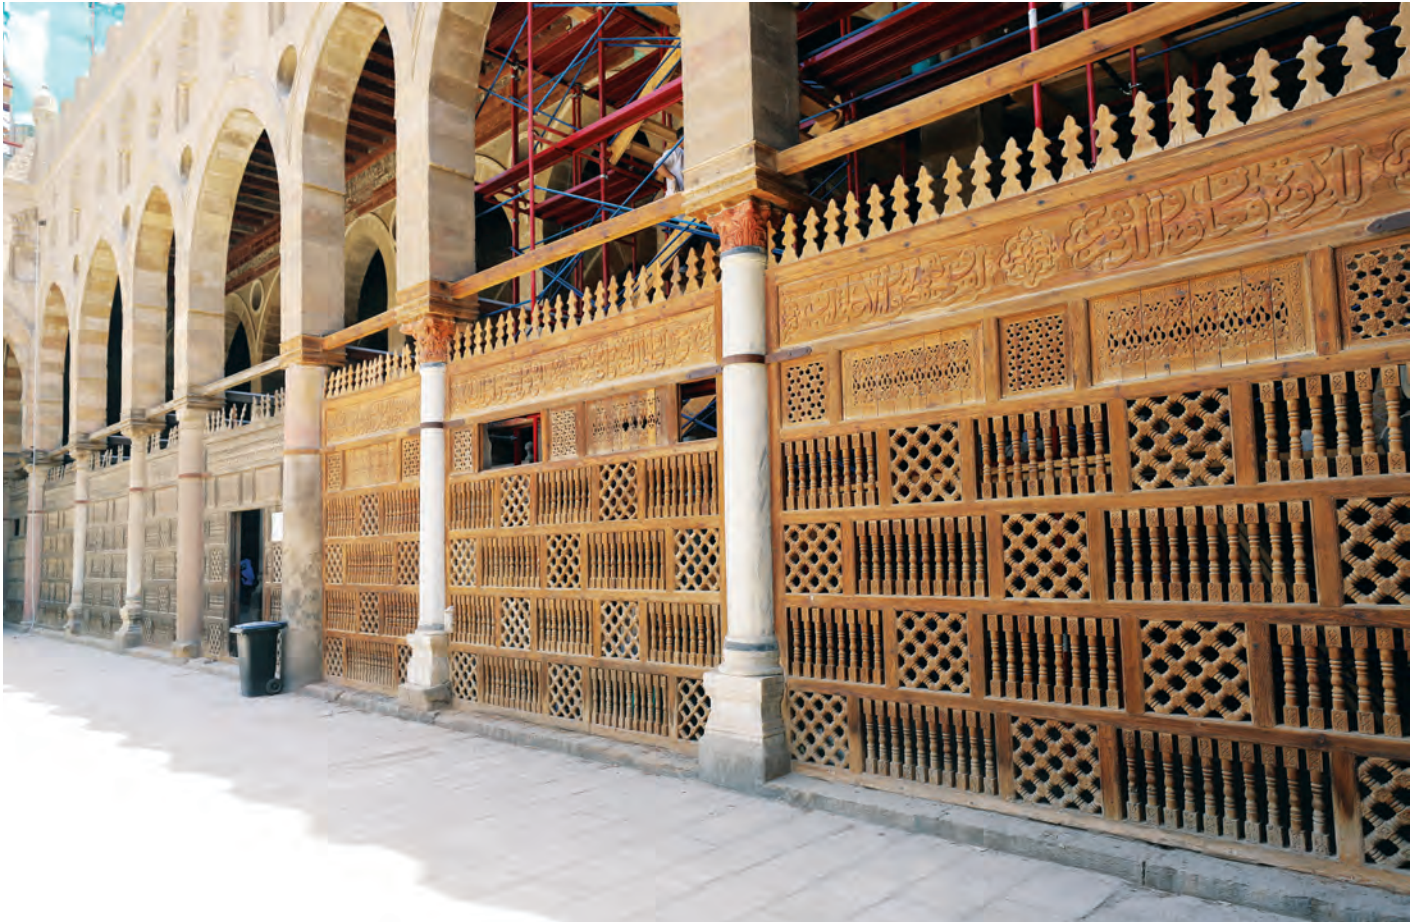
Above: The *mashrabiya* screen, here under restoration, separates the prayer hall from the inner courtyard (AKTC Conservation Team, 2020).

- **The Mashrabiya Screen:** among the special decorations found in the *qibla*, the *mashrabiya* screen deserves special mention. The elaborate screen in al-Maridani is one of the few surviving wooden screens in the mosques of Cairo. Together with the wooden screen of the Fatimid Mosque of al-Salih Tala'i and that of Sultan Qalawun's mausoleum, it represents a unique feature entirely made of timber, a valuable and expensive material in Egypt. This particular screen is an early example of wooden latticework craftsmanship in Cairo. It is made of oval shapes of turned wood joined together by ribbed connections delicately carved on either side. The upper part of the screen, on both sides, presents Quranic inscriptions: the one towards the courtyard displays the Surah al-Mu'minun (Qur'an 23:1-14), while the inner one, towards the arched hall, displays the Surah An-Najm (Qur'an 53:1-23). The screen was restored by the Comité in 1899 with some of its original elements still in place. The *mashrabiya* separates the prayer hall from the interior court and filters a pleasant light towards the *qibla*. Unique and of top quality, it is considered the highlight of the courtyard facade along the side of the *qibla*.

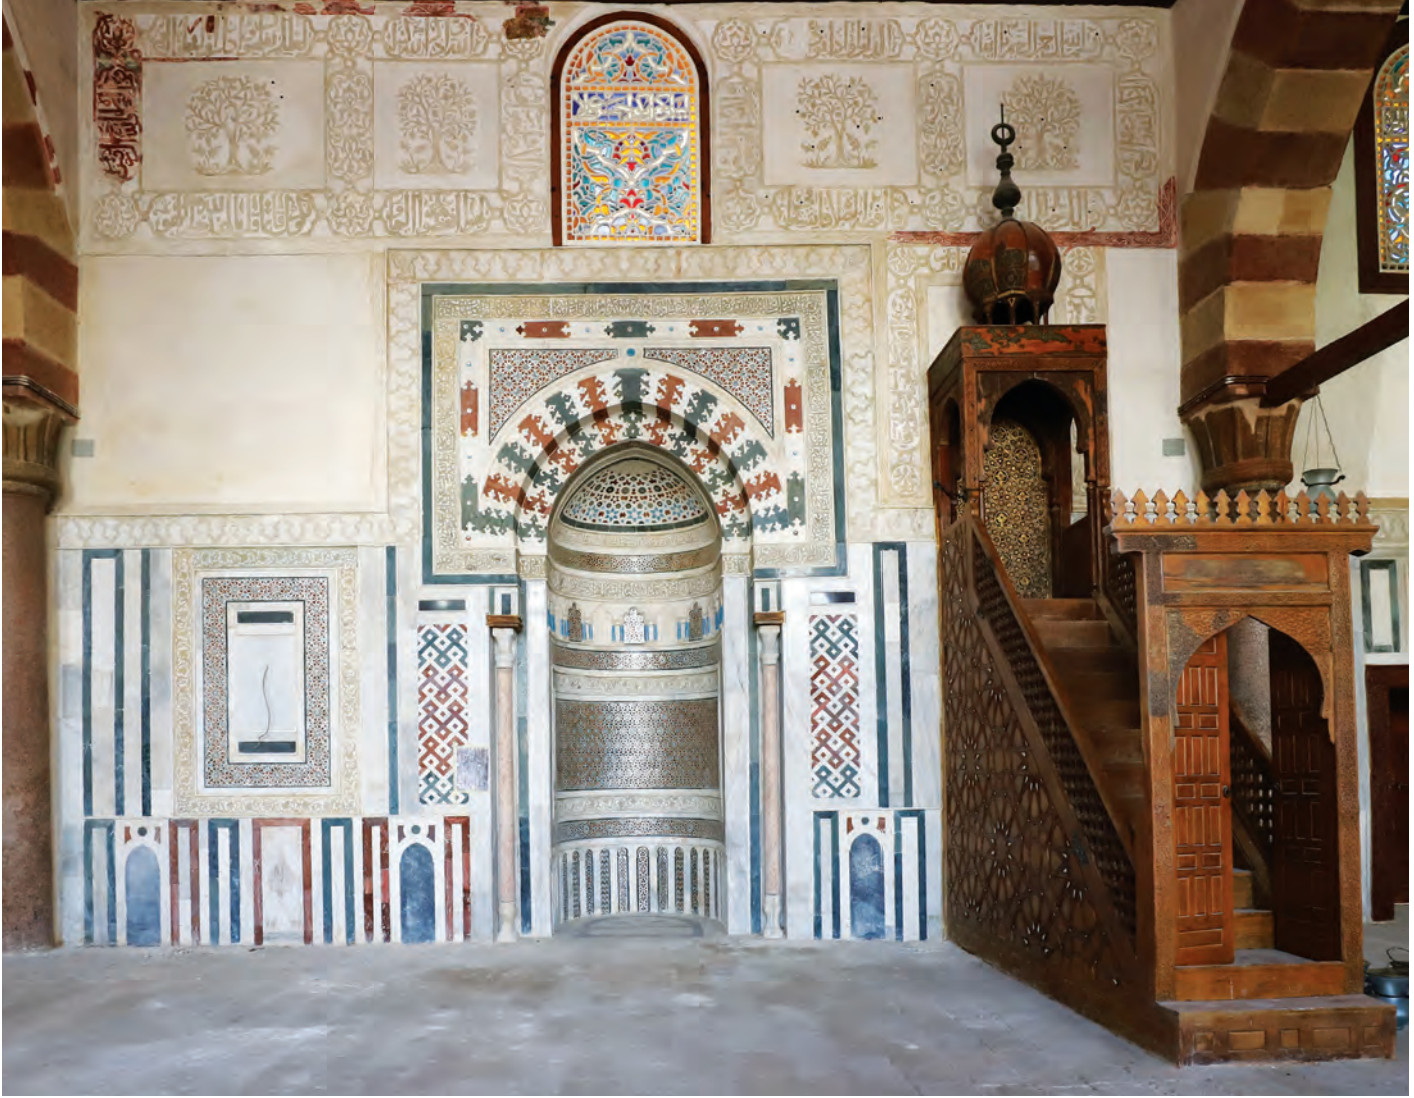
Above: The *mihrab* marble mosaics, *qibla* marble panels and *minbar* wooden panels after restoration (AKTC Conservation Team, 2021).

- **The Mihrab:** the marble decoration of the mihrab in the Maridani mosque is an example of the Bahri Mamluk tradition of panelling walls with polychrome marble decorations. In this case, the decorative theme is inspired by the one in the mausoleum of Sultan Qalawun at Bayn al-Qasrayn. The interior walls of the *qibla* are panelled with marble and mother of pearl inlays

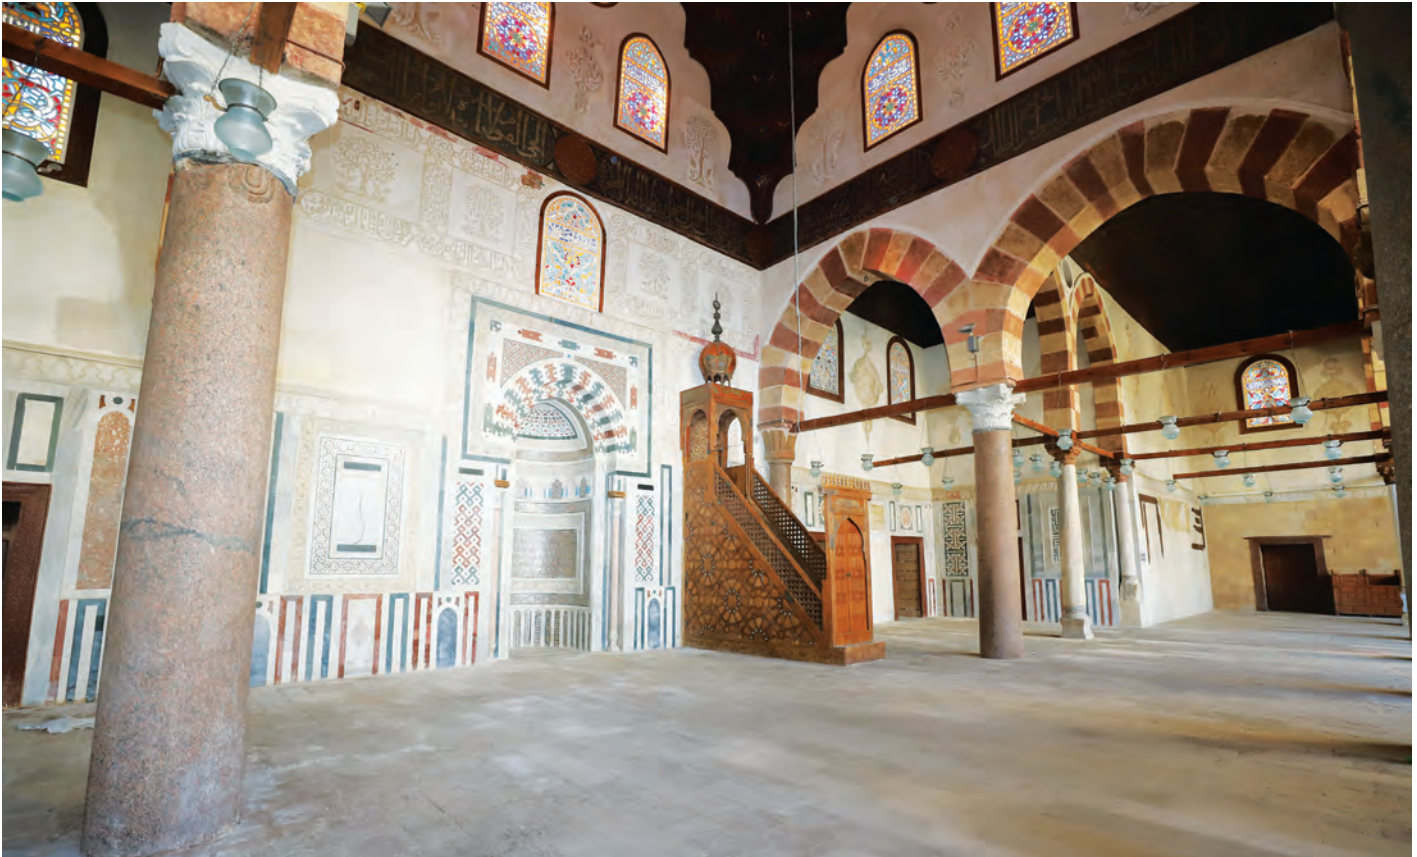
Above: The *mirhab* marble mosaics, *qibla* marble panels and *minbar* wooden panels before restoration (AKTC Conservation Team, 2021).

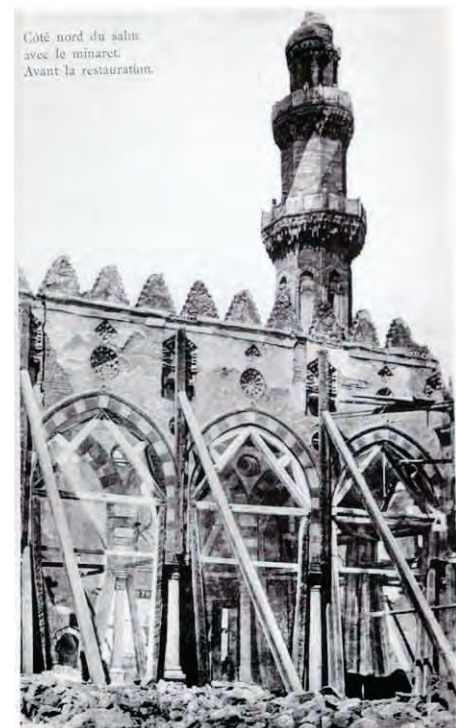
Above: Unstable conditions on the north side of mosque's interior courtyard prior to the restoration works undertaken by the "Comité" (*Bulletins of the Comité de Conservation de l'Art Arabe, circa 1884*).

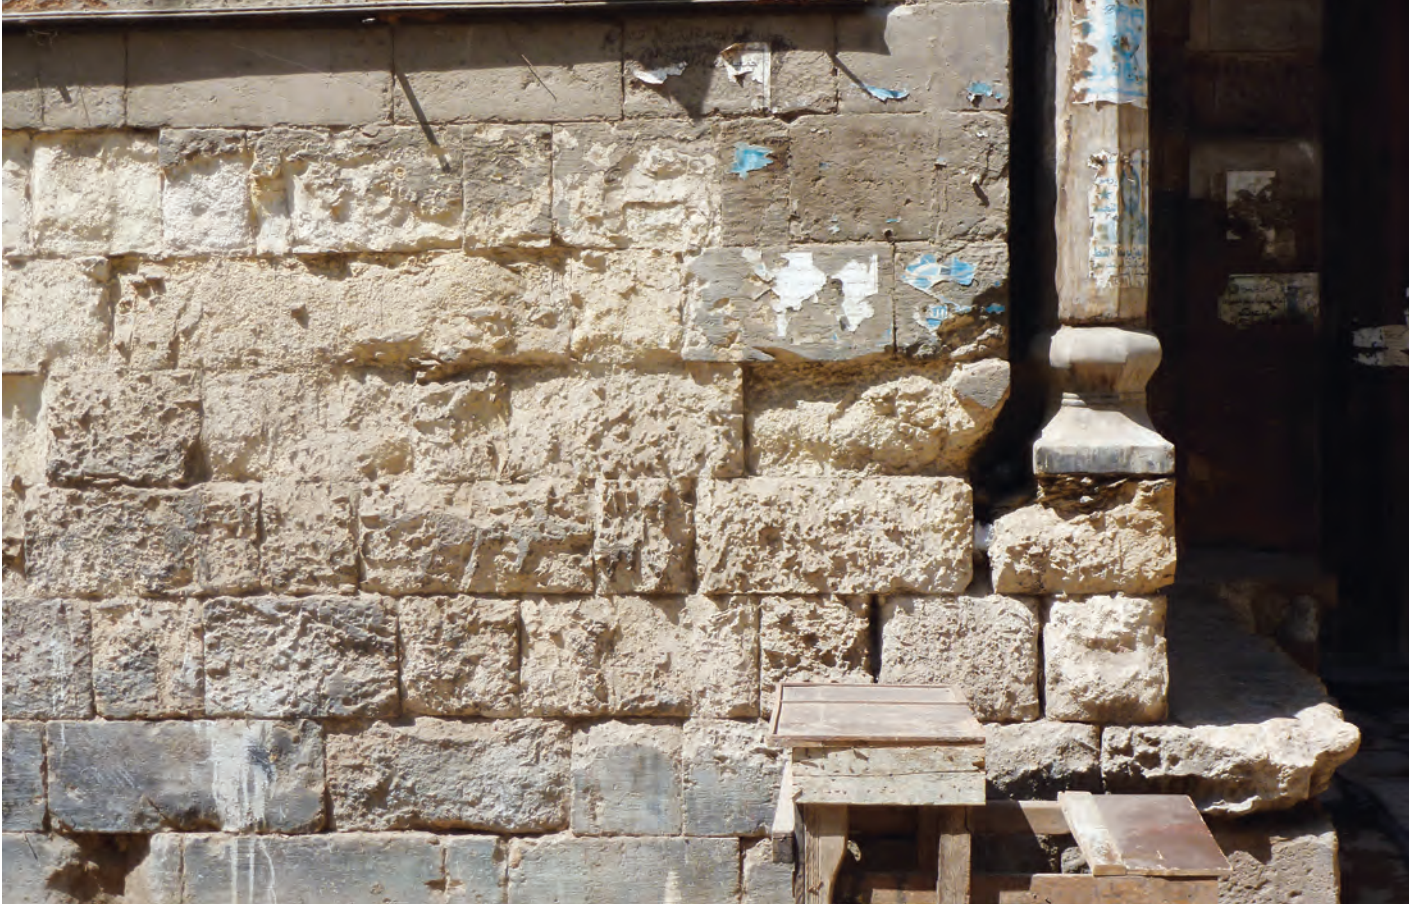
*Above: The effects of raising damp on the lower sections of the exterior facades (Christophe Bouleau / AKTC, 2016).*

been brought about by extrinsic causes. These, in turn, are the result of a combination of environmental threats and man-made actions. As already noted, environmental threats include rising damp due to leakages in the public infrastructure. Because of scarcely maintained underground networks, permanent leakages from sewer and water pipes create pockets of humidity in the soil which then transmigrate through capillary suction into the foundations and lower sections of bearing walls up to a height of three metres. Moisture carries with it soluble salts into the buildings whose masonry units deteriorate rapidly. The result is efflorescence, which manifests itself in a whitish haze. Dressed stone loses its facing and marble panels may detach and even warp and bow. The presence of efflorescence also indicates salt accumulations under the surface of the masonry, the so-called sub-florescence, which is potentially even more damaging as it undermines the very core of the stone.

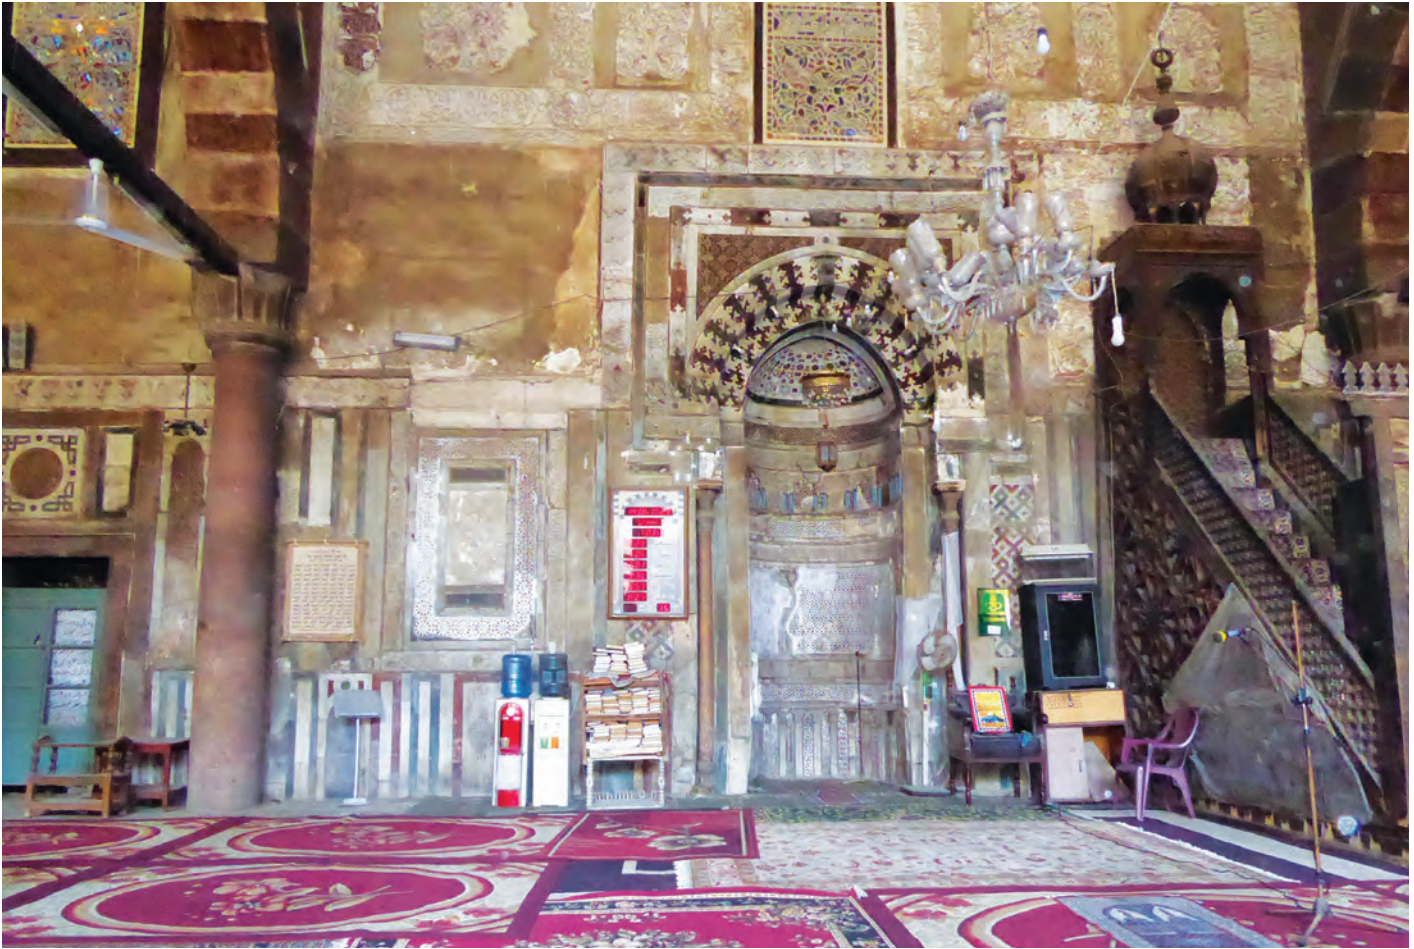
*Above:* The introduction of modern furniture, fittings and lighting are totally inappropriate to the monument's quality and its setting (Christophe Bouleau / AKTC, 2016).

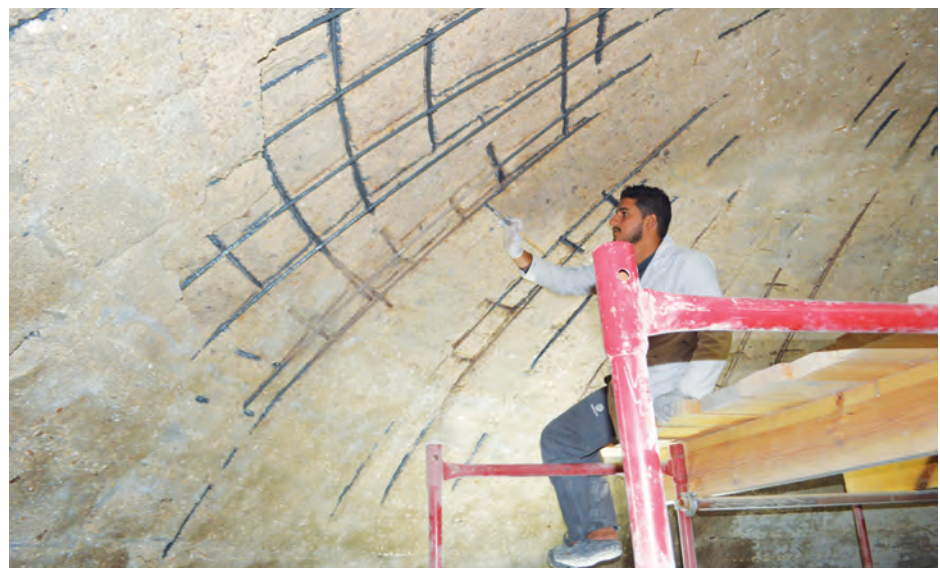
*Right:* Treatment of corroded reinforcement bars in the intrados of the dome. Restoration by the "Comité de conservation de l'Art Arabe" at the beginning of the last century introduced an innovative reinforced concrete technology, the Hennebique system, which proved highly detrimental and incompatible with the techniques and materials employed in the original construction (AKTC Conservation Team, 2020).

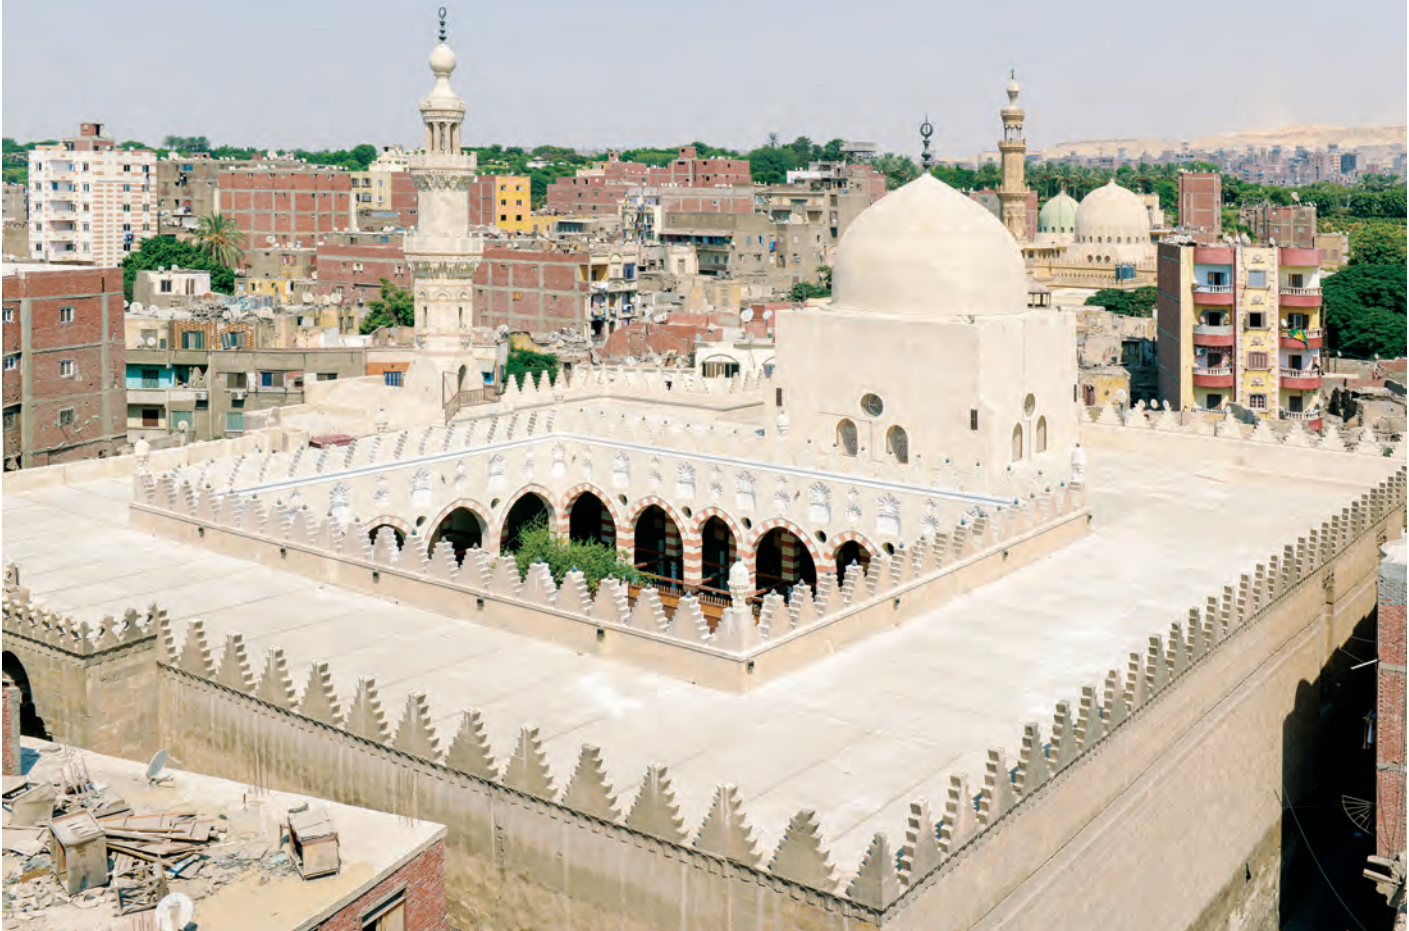
Above: General view of the flat roof of the mosque after rehabilitation (Adrien Buchet / AKTC, 2021).

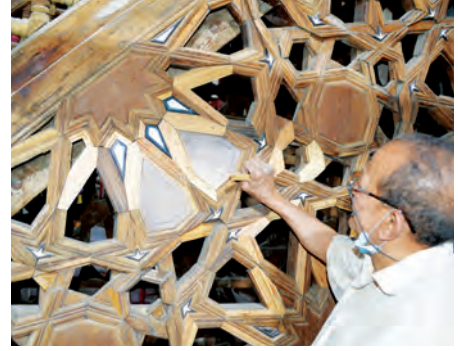
Above: Replacing lost wooden elements and decorative inlays to reconstitute the complex geometric design of the prayer hall's *minbar* (AKTC Conservation Team, 2020).

- The *minbar* was the second important woodwork restoration carried out within the framework of Maridani project. The minbar's very survival in the mosque, in its current, reasonably complete state despite the recent disappearance of some of its inlay work, is by itself extraordinary. It was only in 1901 that it could be reassembled, after its panels had been stolen and exported to Europe at the end of the nineteenth century. The importance of the minbar as a part of a mosque's required interior furnishing cannot be underestimated. An essential component of the *qibla* wall, it functions as a pulpit from where prayers are led. It is also an element of high aesthetic and inspirational value, embellished with Koranic verses and geometrical and floral patterns. Each panel of the Maridani *minbar* was painstakingly reintegrated to the highest standard by employing some of the best local specialists in woodcarving, inlay, interlocking and finishing work, all done by hand without the use of any fixing materials.

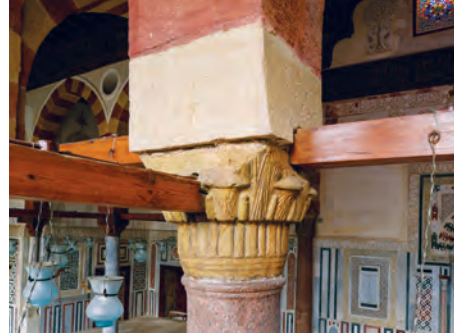
Below: Restored capital of one of the re-purposed Pharaonic architectural elements in the prayer hall (Adrien Buchet / AKTC, 2021).

- Great care and attention were devoted to the treatment of the re-purposed Pharaonic architectural elements in the prayer hall, presented as a gift by Sultan al-Nasir Muhammad to his son-in-law. Eight capitals and fourteen out of the eighty columns supporting the ceiling and dome of the hall were carved in antiquity from Aswan granite and stand today, fully preserved, to support the arches and dome of the mosque.

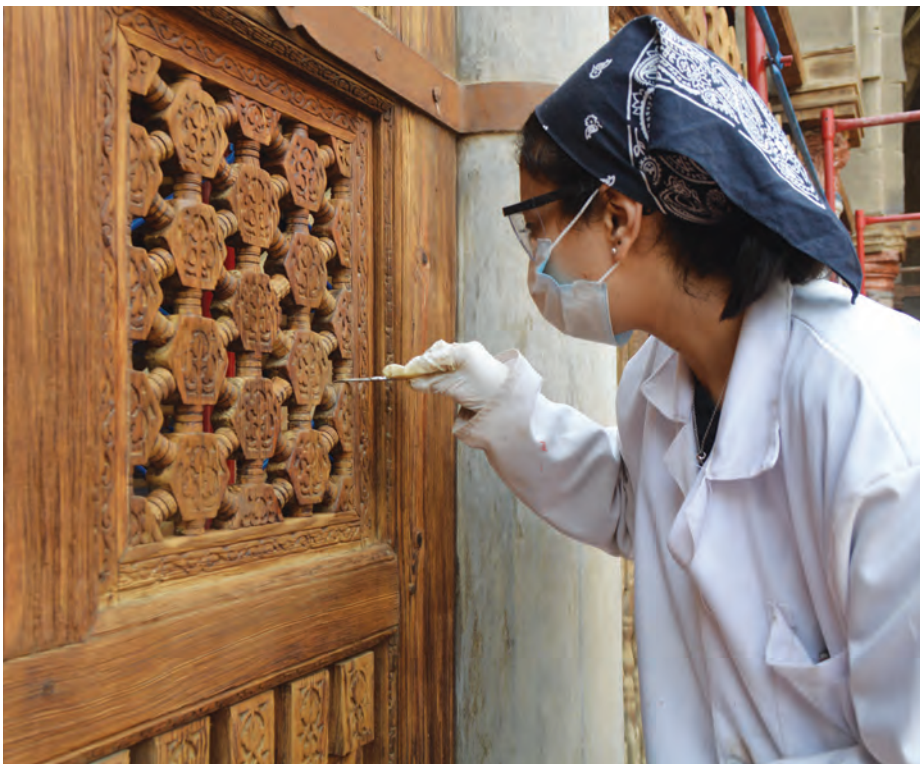
Left: Cleaning and treating the carved latticework of the courtyard's wooden panelling (AKTC Conservation Team, 2020).

carved wooden latticework (*mashrabiya*). The panelling was in relatively good condition but required partial replacements and the application of a traditional wax finish known for its protective effectiveness and the quality of its aesthetic results.

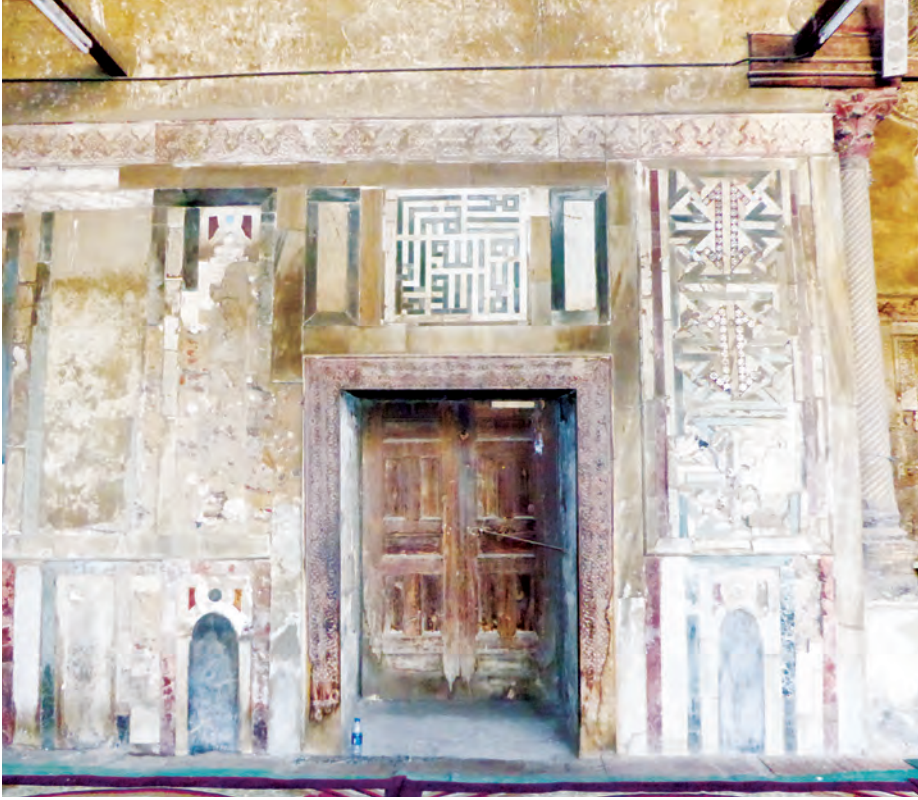
Above: The advanced state of deterioration and significant losses of the marble mosaics in the north section of the *qibla* wall prior to conservation (Christophe Bouleau / AKTC, 2016).

- The highly significant polychrome inlaid marble panels on the *qibla* wall and inner niche of the *mihrab* are from the Bahri Mamluk period and were the subject of a special restoration effort. They were found in an advanced state of deterioration and suffering material loss due to capillary rising damp and the effects of rusting metal. Each panel had to be dismantled and, after insulating the wall against the rising damp and treatment of the reinforced metal bars, reassembled in its location following the reintegration of each panel's marble inlays.

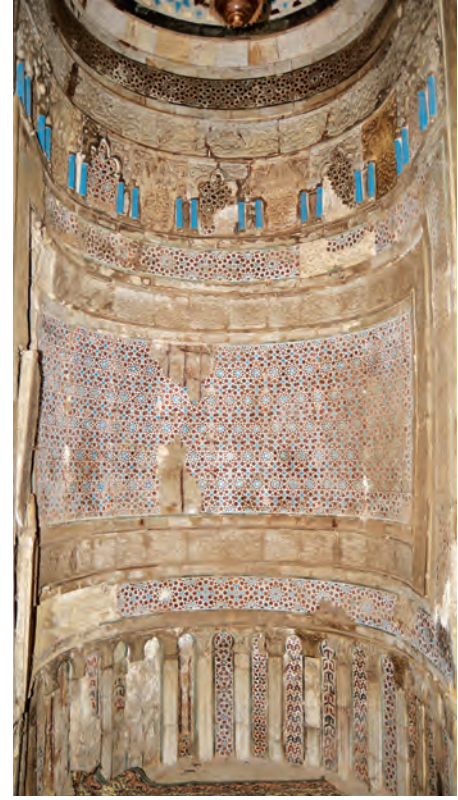
Above Right: Front view of the *mihrab* before conservation. Detached marble panels and mother of pearl mosaics as a result of the corroded reinforcement bars installed during the restoration works carried out by the "Comité de conservation de l'Art Arabe" (Christophe Bouleau / AKTC, 2016).

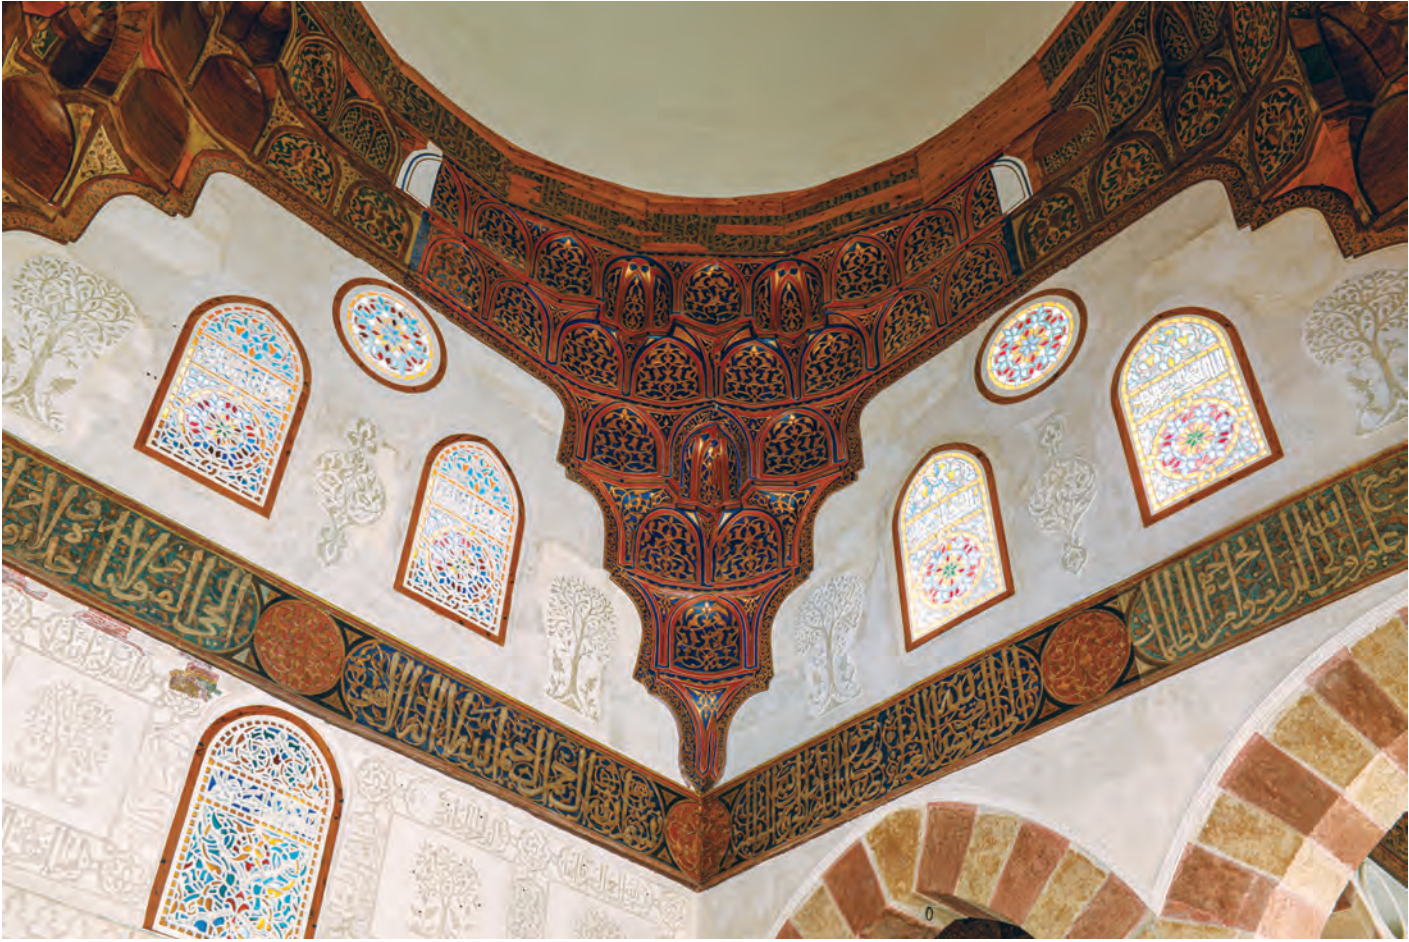
Above: Restored stalactite squinches at the corners of the prayer hall’s dome above the *mihrab* (Adrien Buchet / AKTC, 2021).

- The dome of the mosque, above the *mihrab* and *minbar*, was carefully assessed for damage, prior to carrying out the necessary repairs and cleaning. The areas where plasterwork had cracked or fallen off were carefully reintegrated with matching plaster. Attention was also paid to the ornamental vaulting (*muqarnas*). These decorative wooden ‘stalactites’ are mounted in the transitional spaces at each of the corners between the upright walls and the circle of the dome. Despite their advanced state of disrepair, they still showed traces of painting and gilding. These were stabilised and the traces of the surviving painted decoration carefully restored.

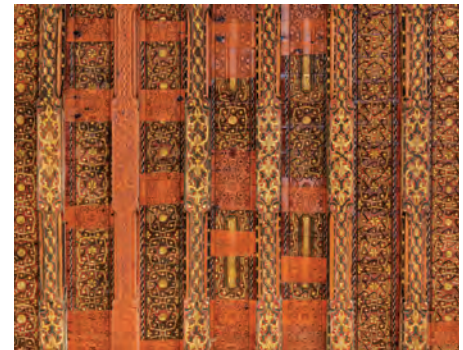
Below: View of the painted and gilded wooden ceiling above the prayer hall after restoration (Adrien Buchet / AKTC, 2021).

- The painted and gilded wooden ceiling, covering the largest part of the prayer hall, was meticulously cleaned. The ceiling sections where the painted colours had been reintegrated by the “Comité” were stabilised, while new wood re-integrations were left unpainted.

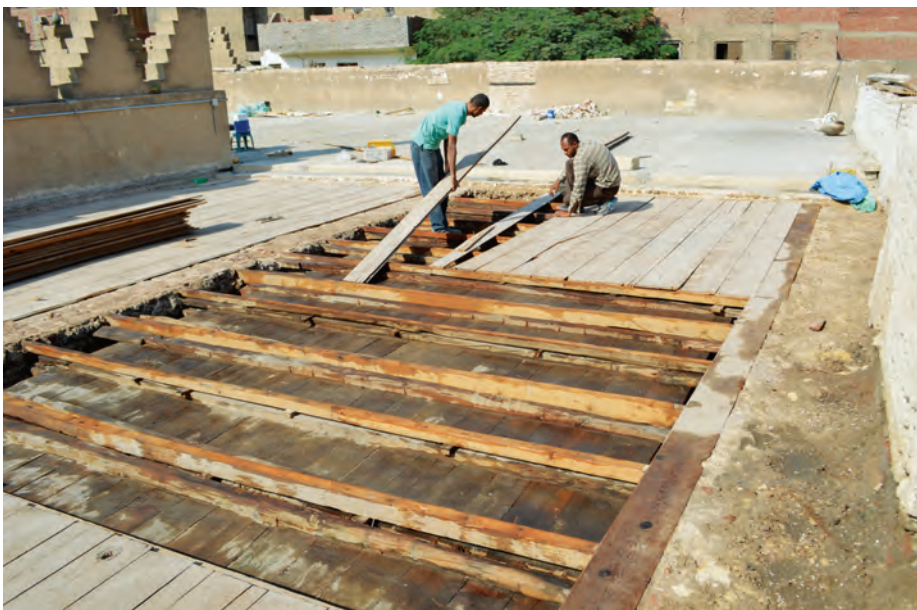
*Left: Exposed structural timber and boards on the roof of the Maridani mosque during repairs (AKTC Conservation Team, 2020).*

- Dismantling of the cracked and deteriorated screed and insulation cover surfaces to the level of the flat boards above the structural timber.
- Replacement of any deteriorated boards affected by wood rot.
- Introduction of a thin polyethylene membrane above the boards covered by a smooth mix of lime and sand mortar 5 to 7cm thick.
- Installation of a water-proof membrane made of torch-applied bitumen sheets.
- Application of the mortar screed in between expansion joints every 8 to 10 metres to avoid cracking during shrinkage and movement from thermal expansion and contraction cycles.
- Laying of the final layer of mortar screed to suitable falls in order to drain rainwater to the projecting spouts positioned along the edge of the roof.

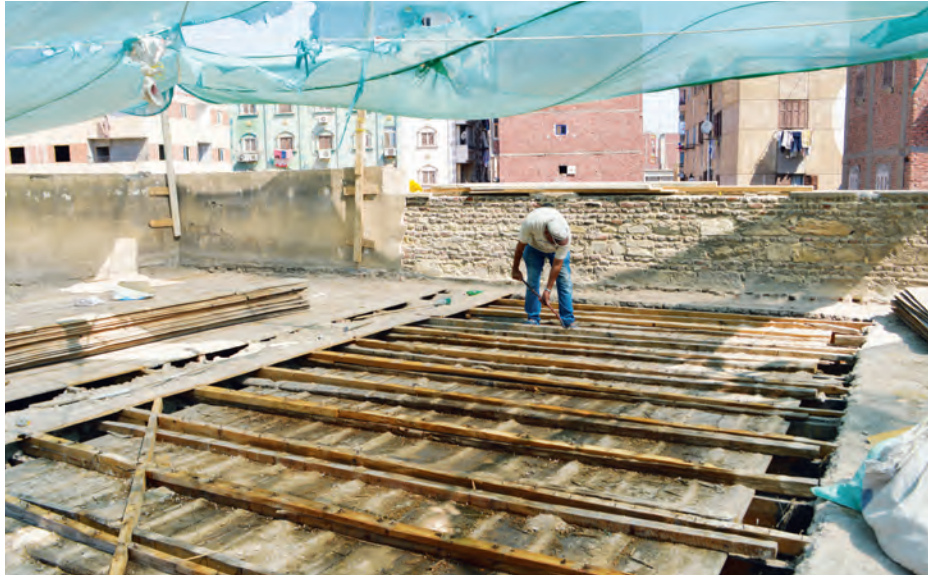
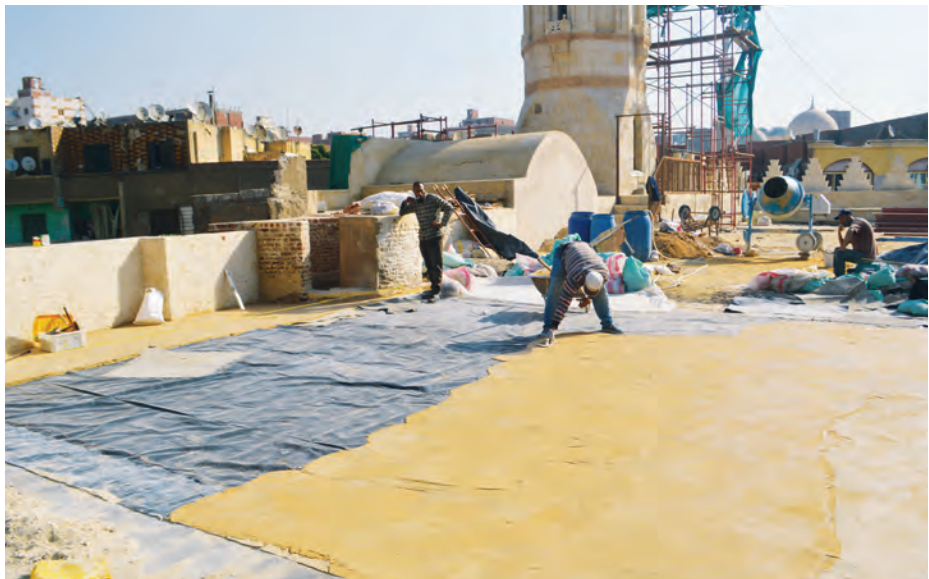
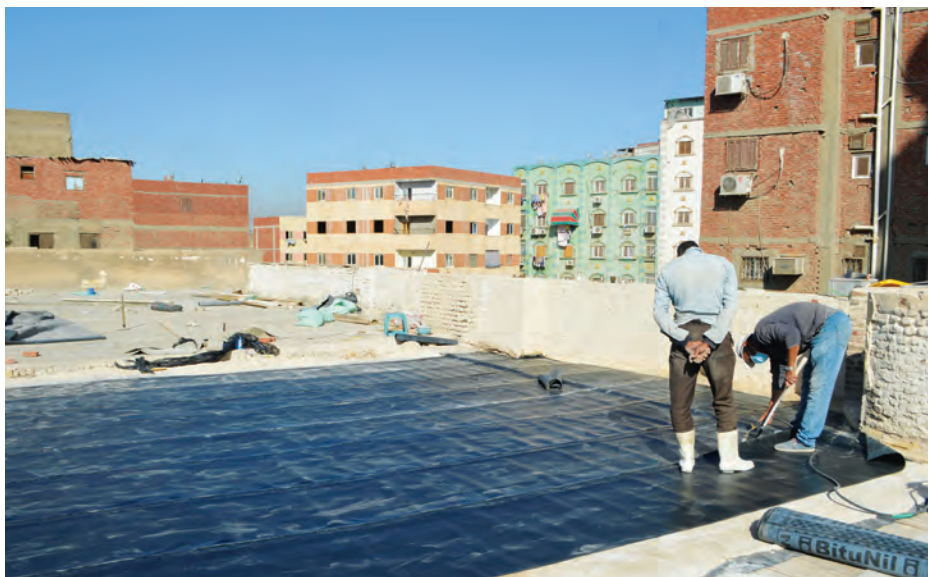
*Above: Checking the boards for wood rot following the removal of the deteriorating screed and faulty insulation cover (AKTC Conservation Team, 2020).*

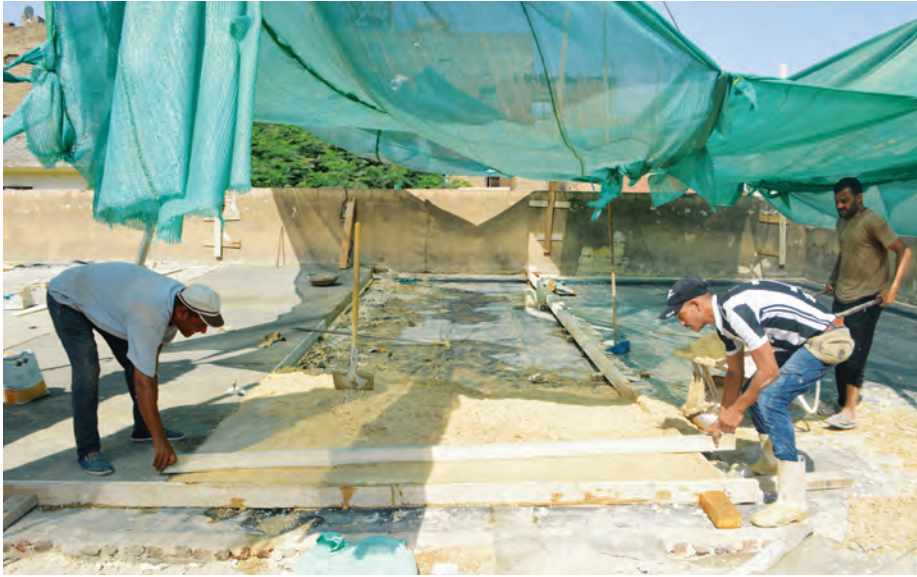
*Above: Application of the first mortar screed in between expansion joints (AKTC Conservation Team, 2020).*

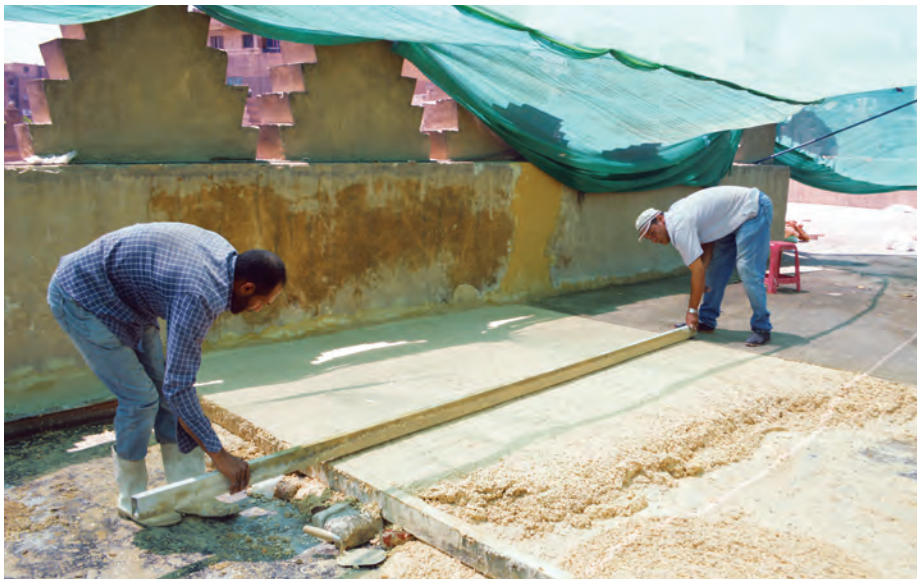
*Middle: Laying of the final layer of mortar screed to suitable falls to drain rainwater off the roof (AKTC Conservation Team, 2020).*

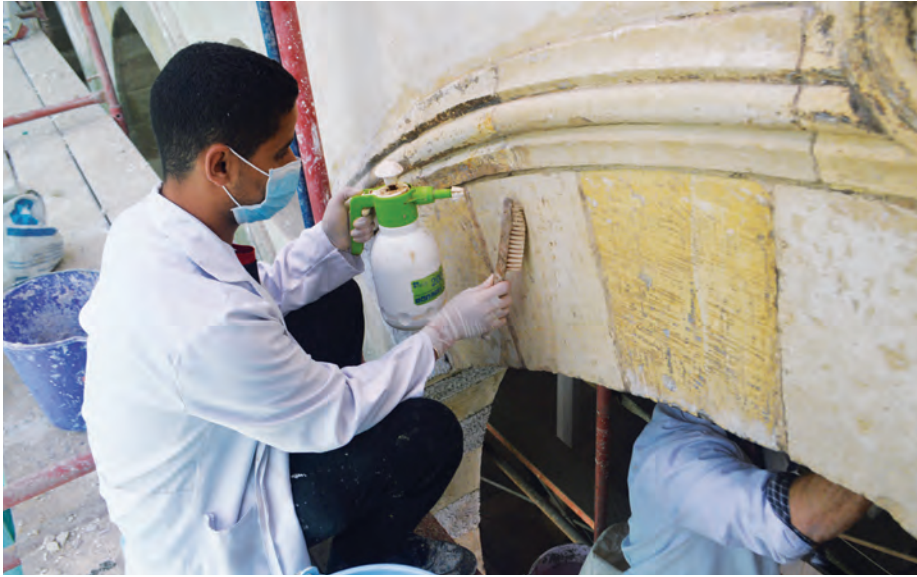
*Above:* Manual brush cleaning of the arch's voussoirs on the upper section of the external walls (AKTC Conservation Team, 2020).

- *Stone cleaning and desalination of exterior wall surfaces and muqarnas:* cleaning exterior surfaces saw the application of a variety of techniques adapted case by case to the level and nature of dirt to be removed. In the lower portion of the facades, subject to high salt content and stone damage, stone cleaning was carried out using a dry method of micro sand blasting. Where the stone presented a high degree of disaggregation or flaking, cleaning took place at very low pressure, to remove loose stone particles and accumulated salts from the surface. In the middle and upper portions of the walls, including the delicate *muqarnas*, paper pulp poultices were employed extensively. Prior to their application, the poultices were soaked in five percent ammonium bicarbonate. This is known as the Mora poulticing method from the name of the conservators who first applied it.
