# AGA KHAN HISTORIC CITIES PROGRAMME

## THE CONSERVATION OF THE ALTINBUGHA AL-MARIDANI MOSQUE, CAIRO

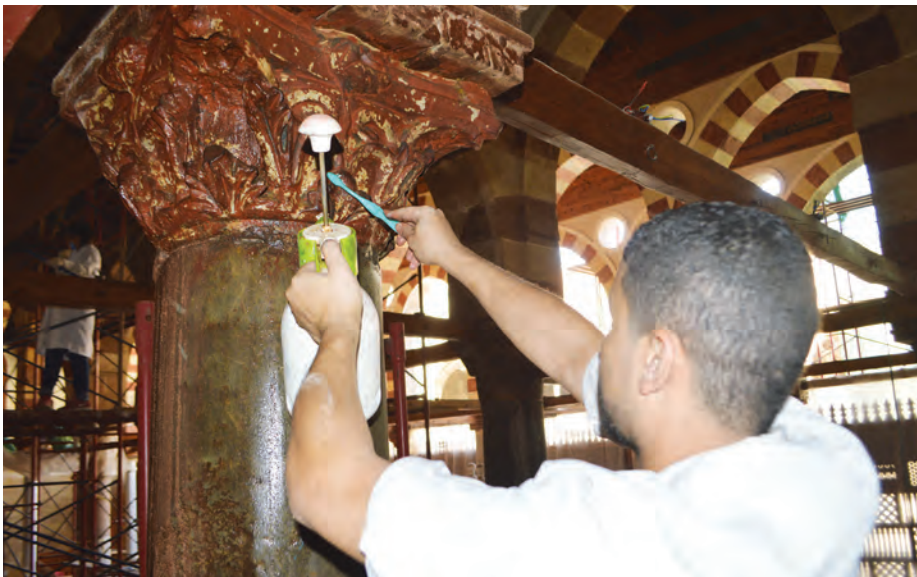
*Middle:* Cleaning by hand with a cotton swab one of the ancient capitals in the prayer hall (AKTC Conservation Team, 2020).

- *Stone cleaning and desalination of exterior wall surfaces and muqarnas:* cleaning exterior surfaces saw the application of a variety of techniques adapted case by case to the level and nature of dirt to be removed. In the lower portion of the facades, subject to high salt content and stone damage, stone cleaning was carried out using a dry method of micro sand blasting. Where the stone presented a high degree of disaggregation or flaking, cleaning took place at very low pressure, to remove loose stone particles and accumulated salts from the surface. In the middle and upper portions of the walls, including the delicate *muqarnas*, paper pulp poultices were employed extensively. Prior to their application, the poultices were soaked in five percent ammonium bicarbonate. This is known as the Mora poulticing method from the name of the conservators who first applied it.

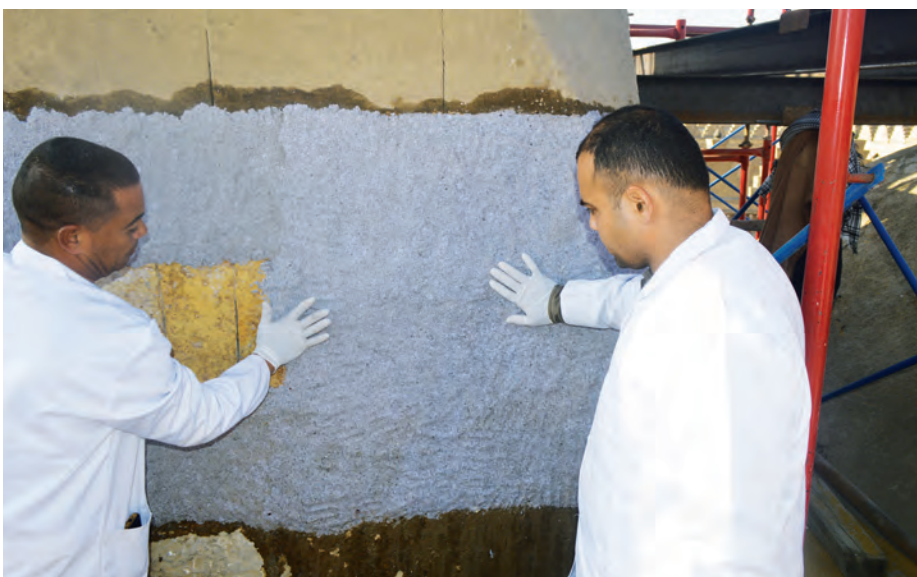
*Below:* Application of a paper pulp poultice to remove salts from the base of the minaret (AKTC Conservation Team, 2019).

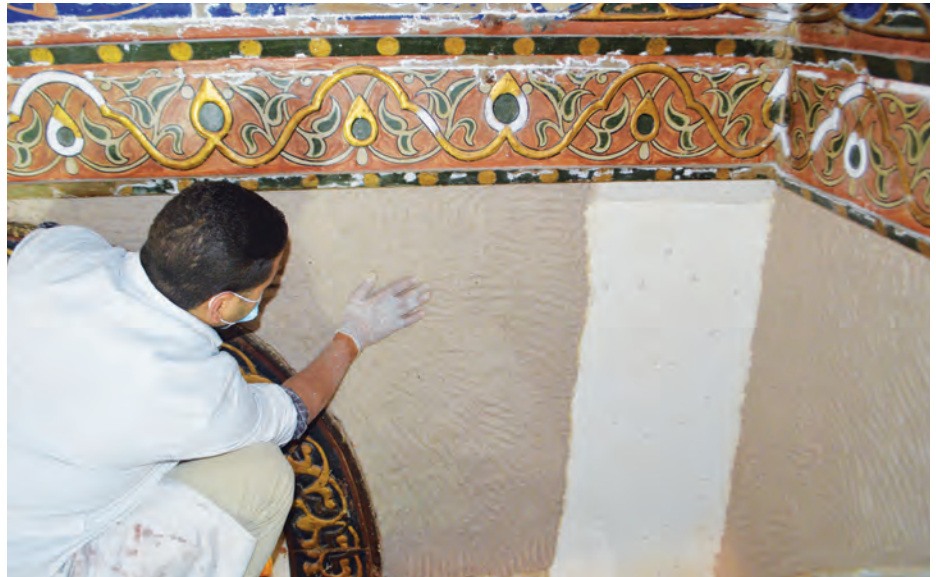
*Above: Applying clay poultices soaked in ammonium carbonate below the cornice of the prayer hall (AKTC Conservation Team, 2019).*

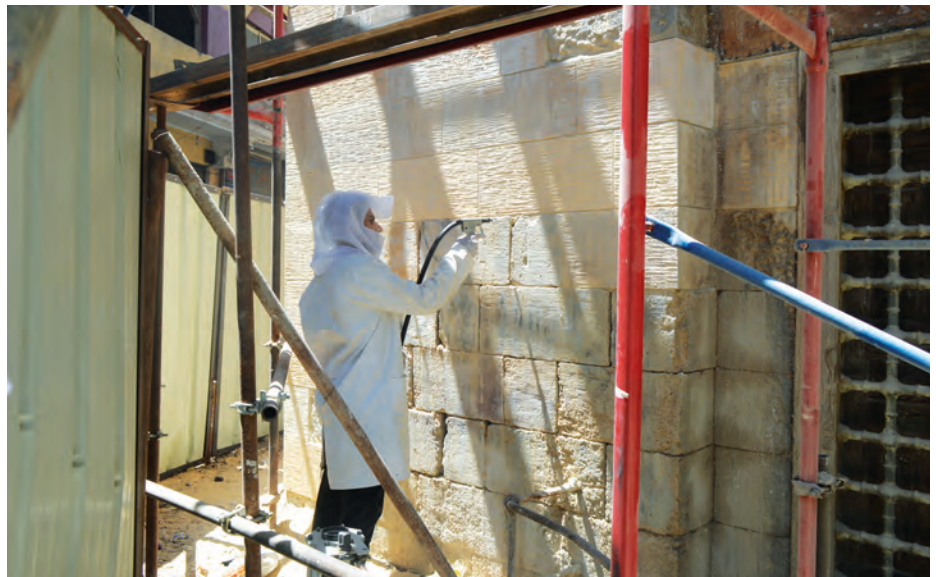
*Middle: Micro sand blasting applied to the base of the exterior walls (AKTC Conservation Team, 2019).*

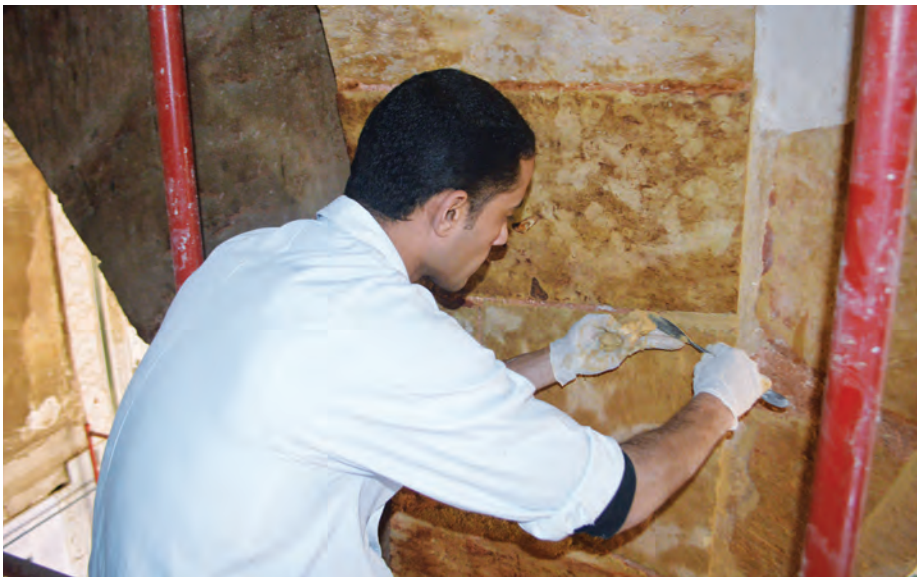
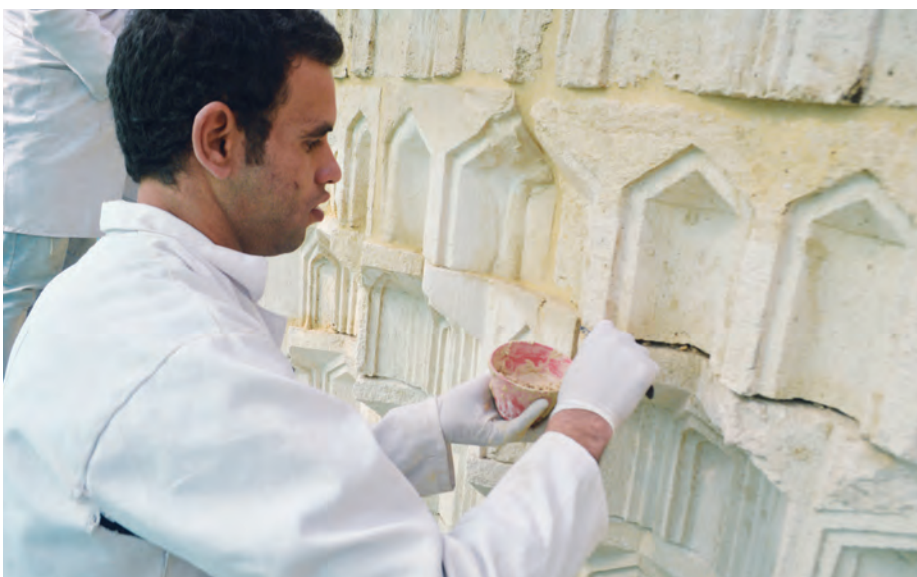
*Above:* Repointing with a mix of lime-based mortar with the aid of a spatula to achieve a consistent finish nearly flush with the masonry (AKTC Conservation Team, 2020).

The process of repointing consisted of packing the mortar manually into the joints using metal spatulas to achieve a consistent finish, nearly flush with the masonry units. Under extreme heat conditions, the repointed areas were covered with water-soaked burlap to reduce the speed of drying, thereby decreasing the risk of shrinking and cracking.

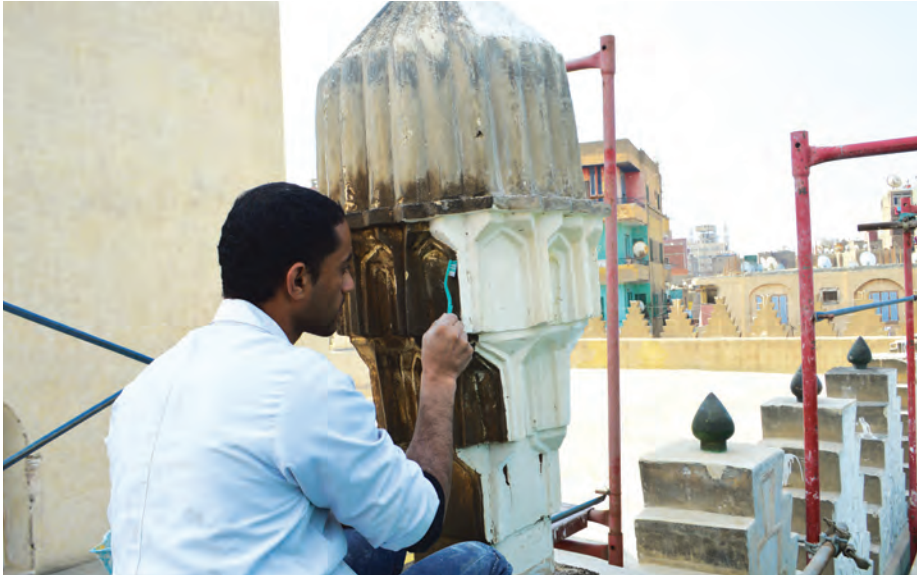
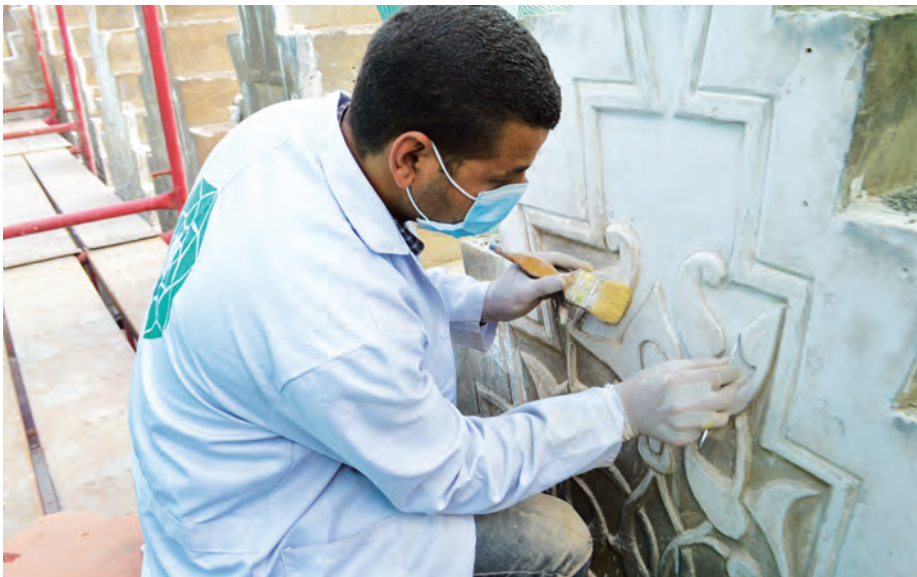
*Above:* Cleaning by hand the ornamental plaster *muqarnas* in one of the finials located at the corner of the mosque (AKTC Conservation Team, 2021).

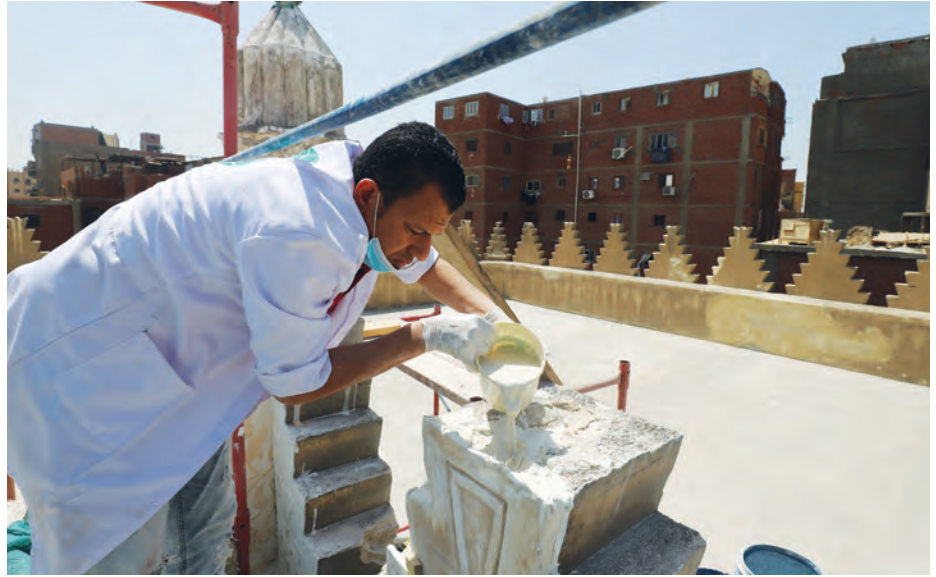
*Above: Grouting the voids behind the plaster decorations in one of the crenelations (AKTC Conservation Team, 2021).*

- *Plaster re-attachment and compensation:* these treatments were generally limited to the upper portion of peripheral walls in the prayer hall and above the interior arches where cracking, detachment and loss of the original plaster had occurred. Plaster re-attachment was carried out by eliminating with a soft brush or hand blower any fragments or debris from behind the detached plaster. All visible losses on the plaster surface were then sealed and compensated with a mix of lime putty and sand to match the colour of the original plaster. Eventually, adhesion of the detached plaster to the masonry behind was achieved through the injection of lime-based hydraulic grout behind the plaster fragments to be re-attached. In the case of large areas of detached plaster, small holes were drilled into the plaster prior to injecting the grout. Once the void had been filled and no hollow sound could be detected when tapping on the plaster surface, the edge of the re-attached plaster was sealed with matching mortar.

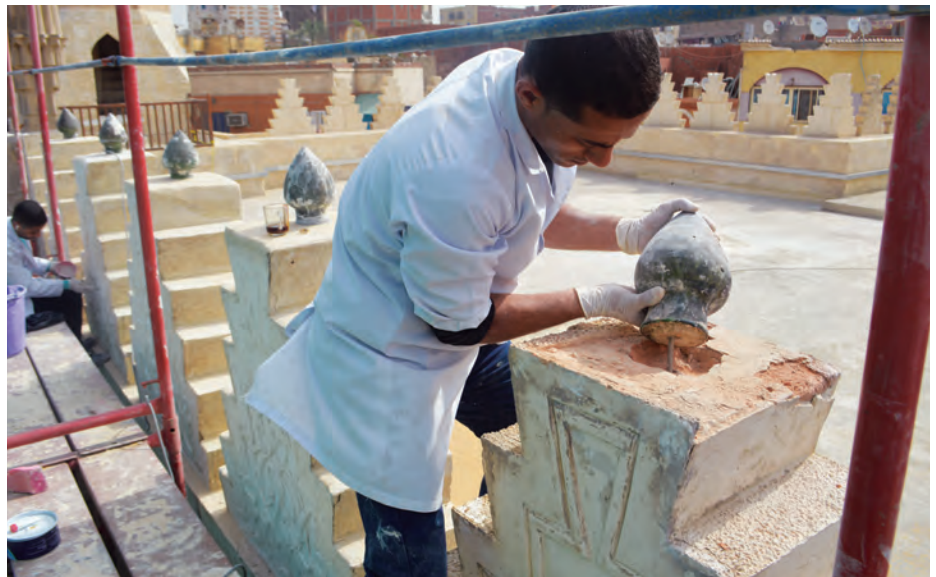
*Middle: Re-attaching the bulb finial on top of a crenelation (AKTC Conservation Team, 2021).*

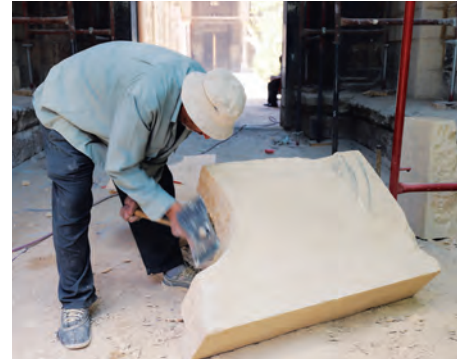
*Above:* The final stage of stone cutting and finishing was done on site with the use of traditional tools (Christophe Bouleau / AKTC, 2019).

Replacement was carried out in small 'window-like' sections, from the bottom up, to avoid the removal of mortar and masonry units along horizontal bands in order to minimise the risk of collapse. The stones to be replaced were carefully extracted from the masonry wall to avoid damaging the adjacent stones. The removal of sound header pieces embedded in the core was avoided to prevent the weakening of the wall core. Replacement blocks came from the quarry unfinished and had to be shaped and finished on site by professional stone cutters. They ensured that new stone units met the required size and specifications to fit into position and match the quality of the original limestone blocks.

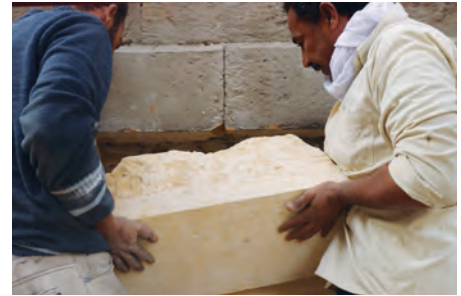
*Below:* Setting the individual blocks in place after the application of bedding mortar mixed with stone fragments to ensure a tight fit with the adjacent stones (AKTC Conservation Team, 2020).

Load bearing replacement stones were placed using wooden wedges to guarantee evenly distributed joints and facilitate the binding of the new stones to the older ones. The blocks were set in a mortar mix of lime putty, sand and brick dust. A slurry back-up of mortar and rubble served to fill voids between the new stone and the existing rubble core. Joints were tooled to imitate in form and colour those observable in the original stonework. After replacement, the new stones were bush-hammered to blend with the texture of the original blocks to improve the visual uniformity of the exterior wall surfaces.

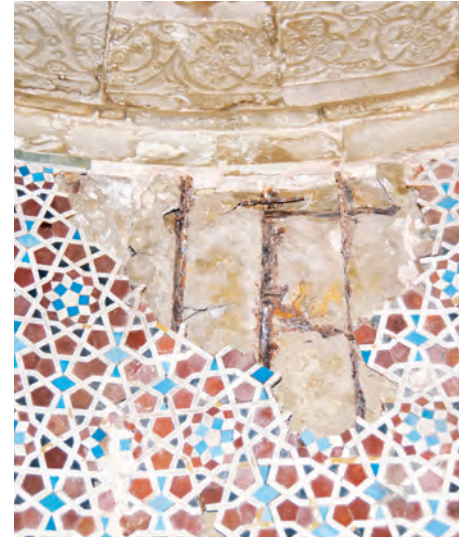
Above: Extent of loss of mosaics and oxidation of the grid of reinforcing rebars observed in the niche of the *mihrab* (AKTC Conservation Team, 2020).

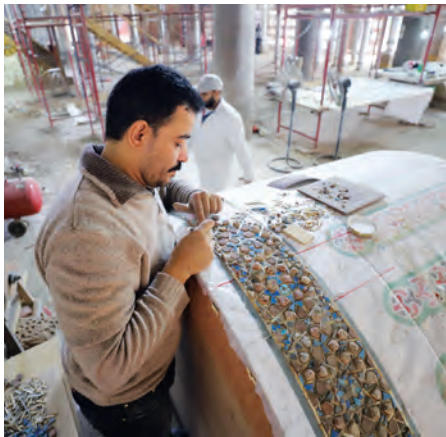
Below: Specialized artisan working on the formwork replicating the curvature of the mihrab to reassemble the marble and mother of pearl mosaic prior to installation (AKTC Conservation Team, 2021).

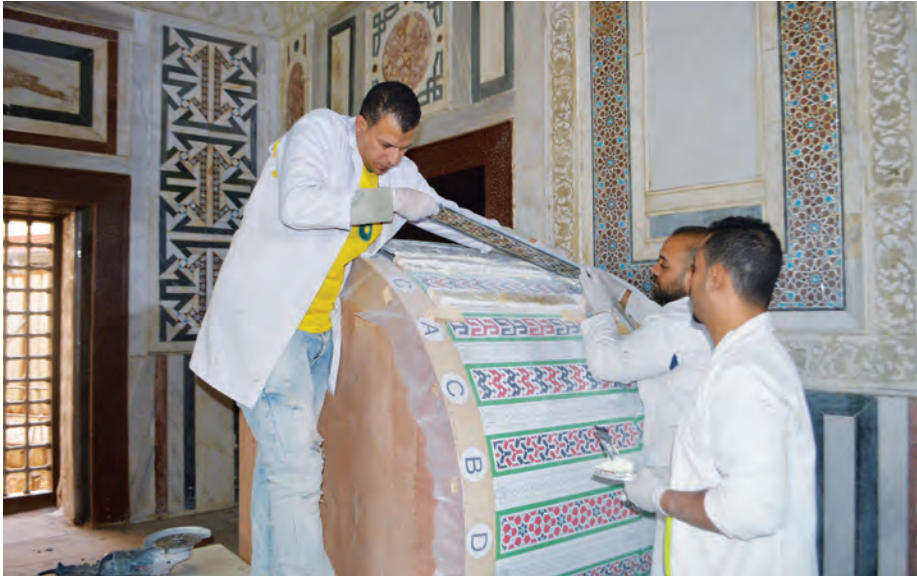
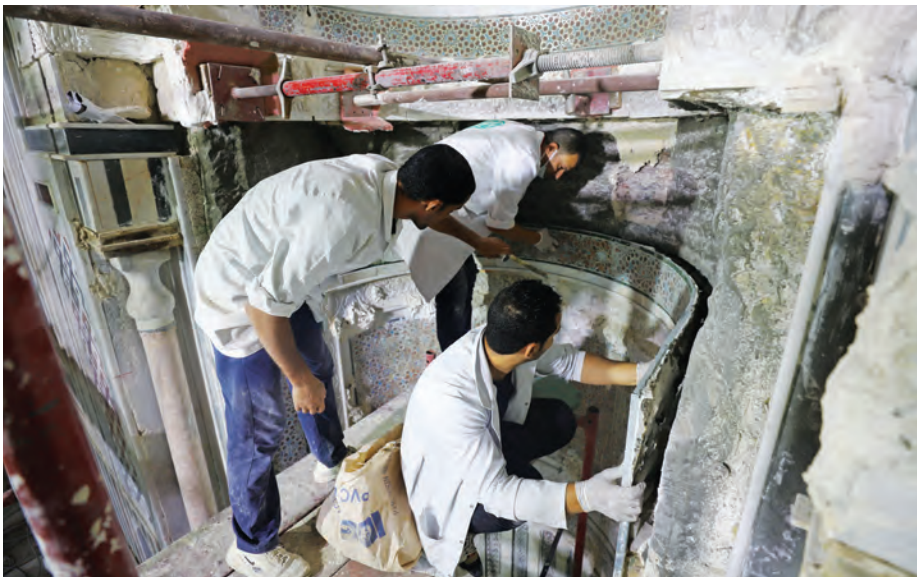
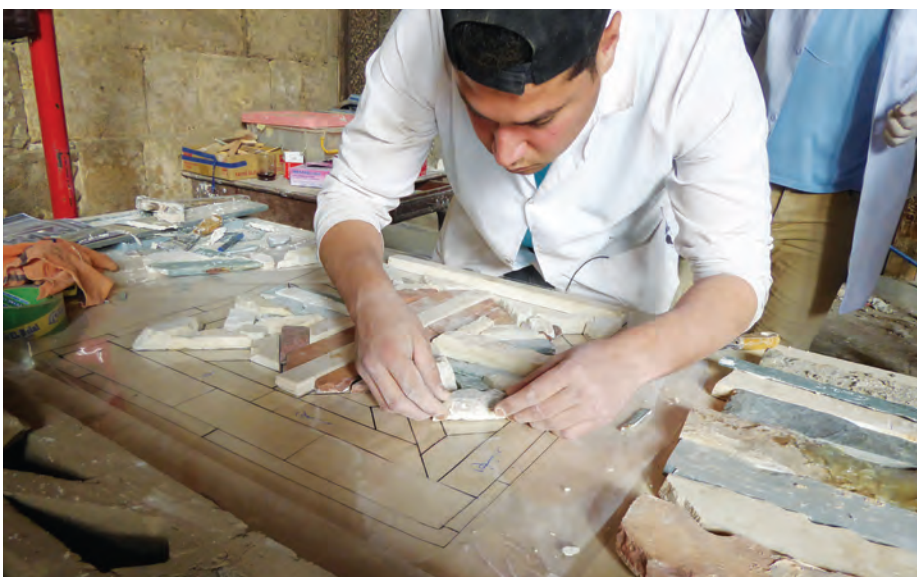
Above: Conservators detaching one of the re-assembled panels prior to re-installation (AKTC Conservation Team, 2020).

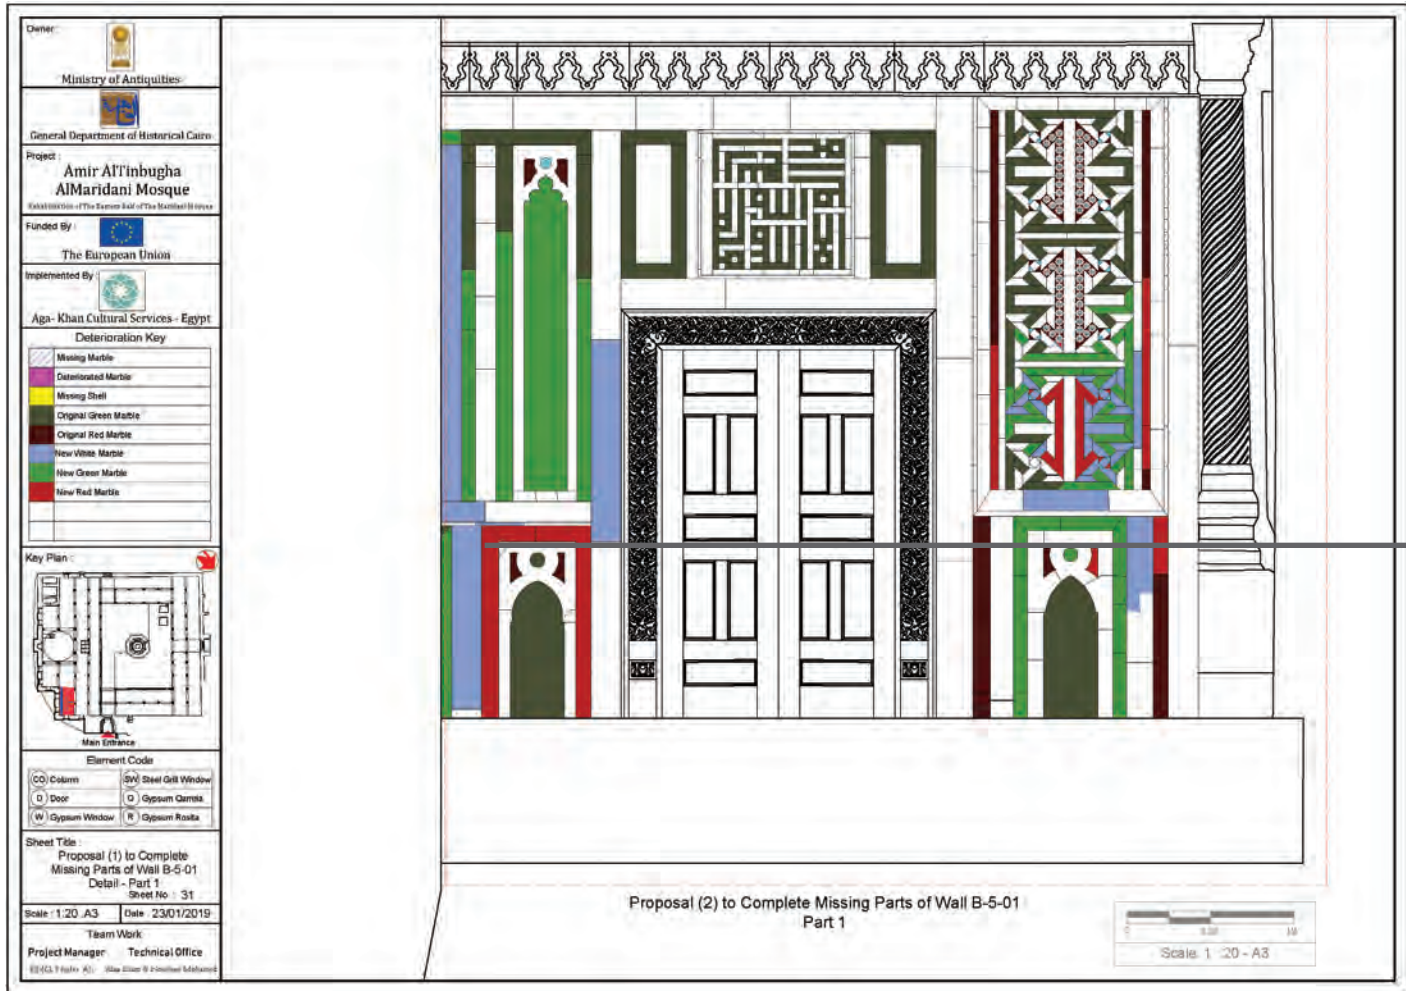
Above: Identification of the original and replacement marble mosaic components in the southeast corner of the qibla wall (AKTC Conservation Team, 2021).

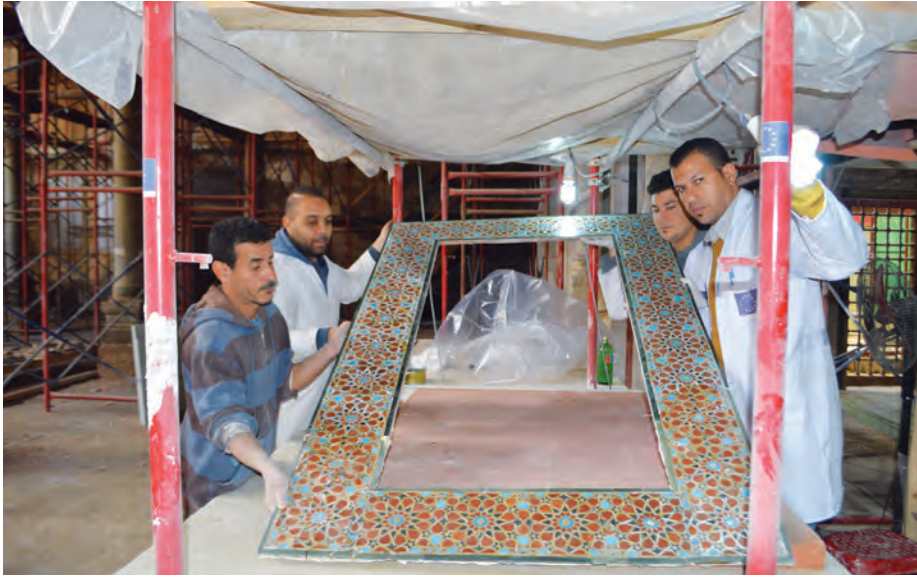
Above: Restored mosaic frame prior to installation on the *qibla* wall (AKTC Conservation Team, 2020).

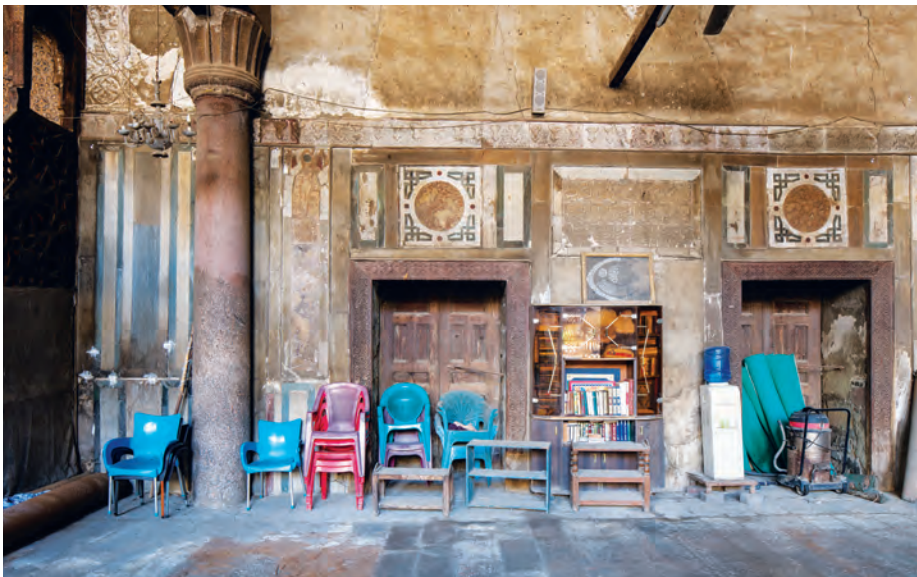
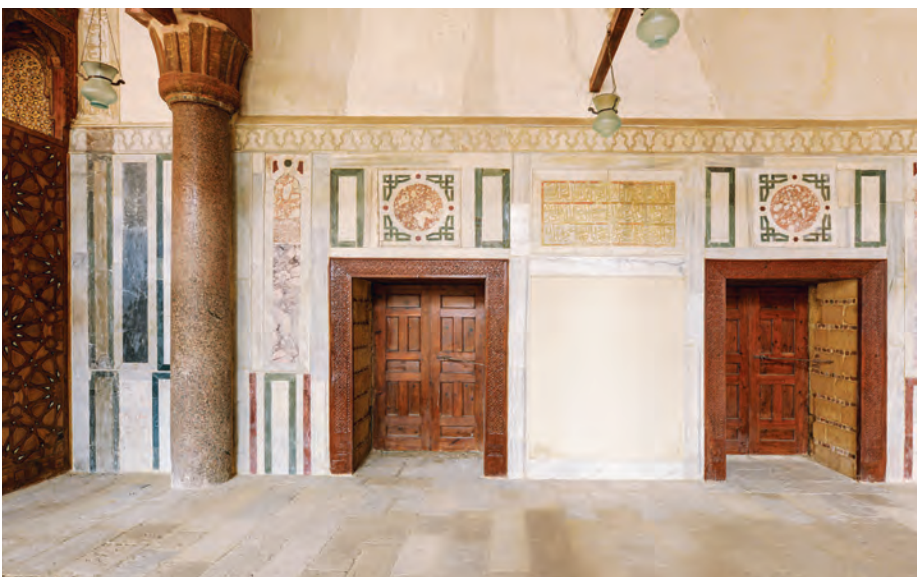
Middle & Below: The south eastern portion of the *qibla* wall before and after the completion of works (Christian Richters and Adrien Buchet / AKTC, 2017 and 2021).

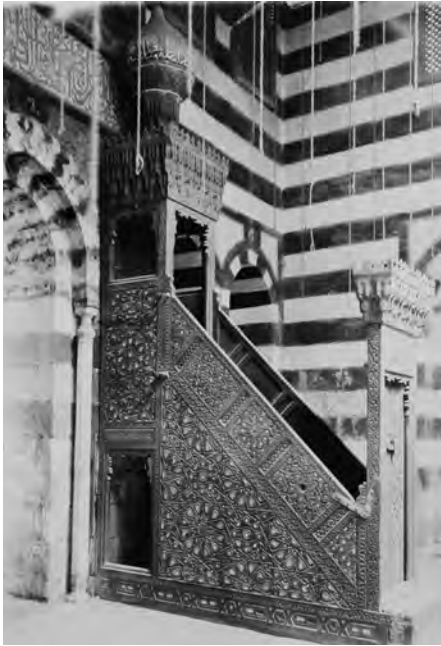
Above: The Maridani *minbar* before restoration by the “Comité” with the small door leading to the interior of the structure and the baldaquin with *mukarnas* and a bulb-form pinnacle (*Bulletin of the Comité de Conservation de l’Art Arabe*, 1896).

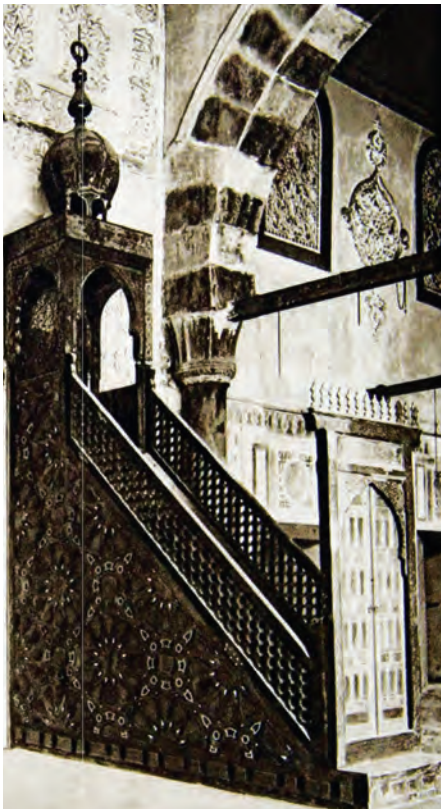
Below: The Maridani *minbar* in its simplified form after restoration by the “Comité” (*Bulletin of the Comité de Conservation de l’Art Arabe*, 1905).

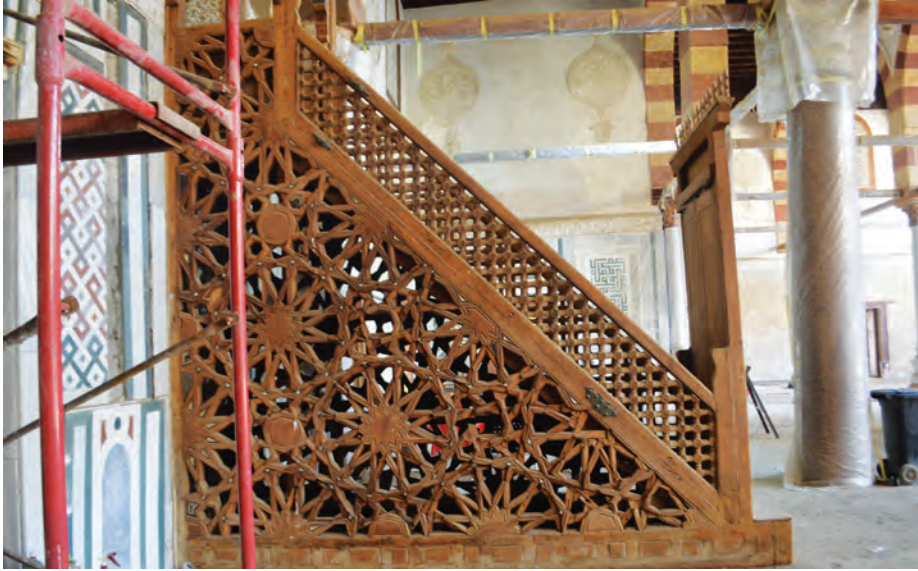
Left: The skeleton of the *minbar* in 2008 following the theft of its inlaid panels (Christophe Bouleau / AKTC, 2018).

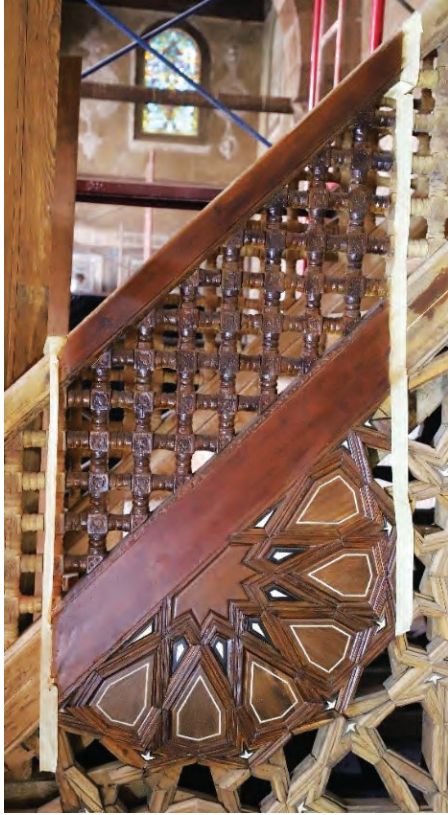
Right: Proposal for the repair and re-integration of the *minbar*'s inlaid panels (AKTC Conservation Team, 2019).

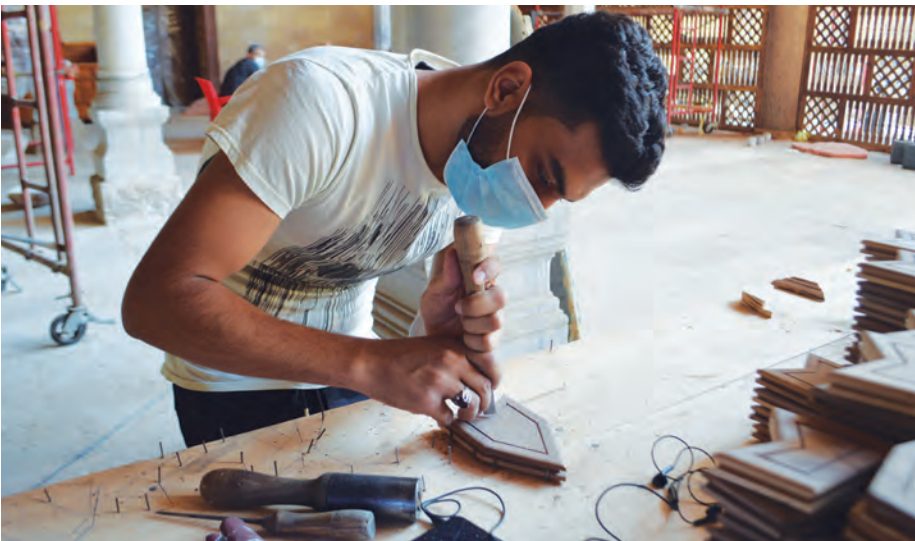
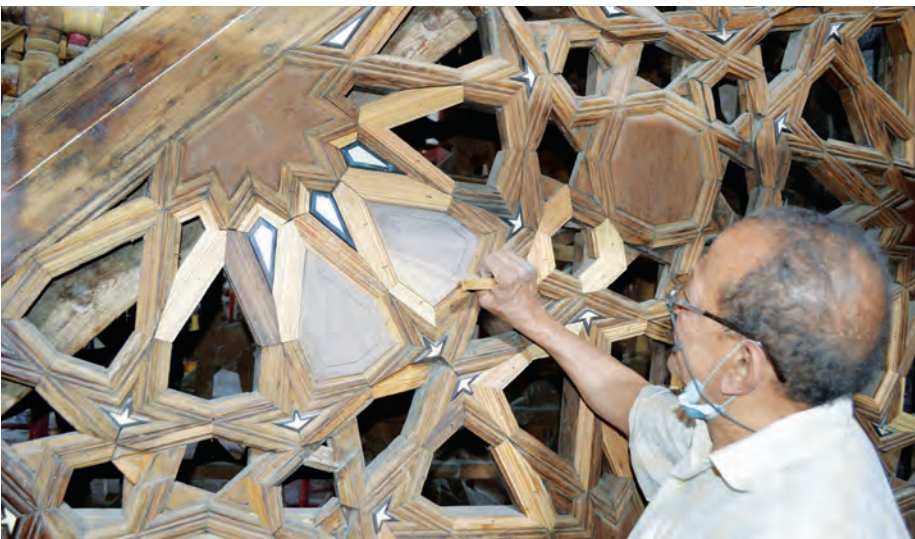
*Above: Manufacturing the individual inlaid pieces to be mounted on the panels (AKTC Conservation Team, 2020).*

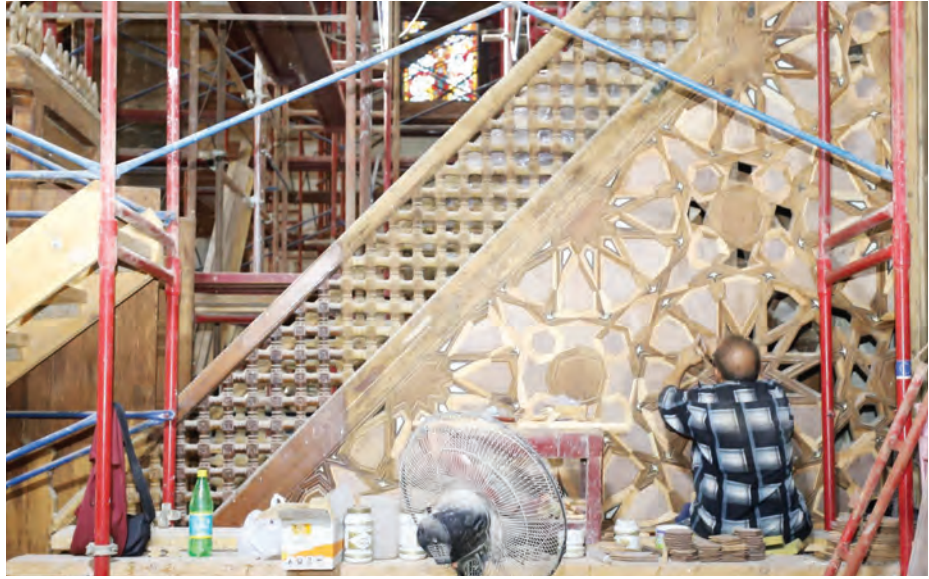
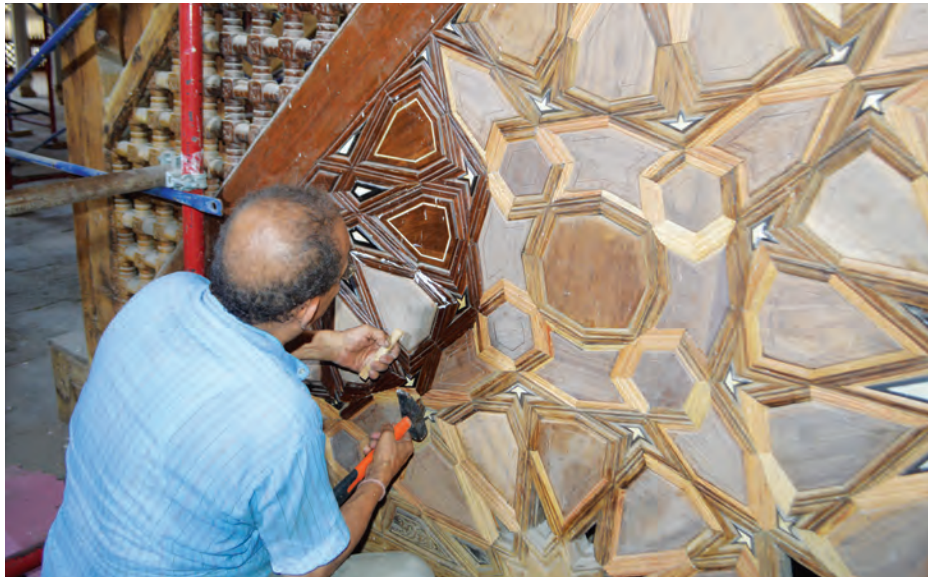
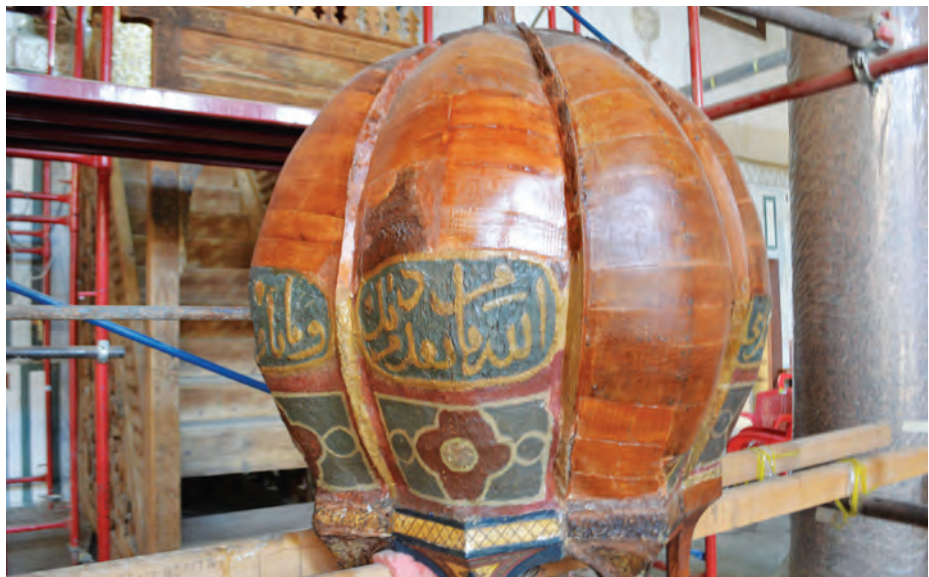
*Above: Advanced stage in the repair and installation of the inlaid infill elements on the west side of the minbar (AKTC Conservation Team, 2020).*

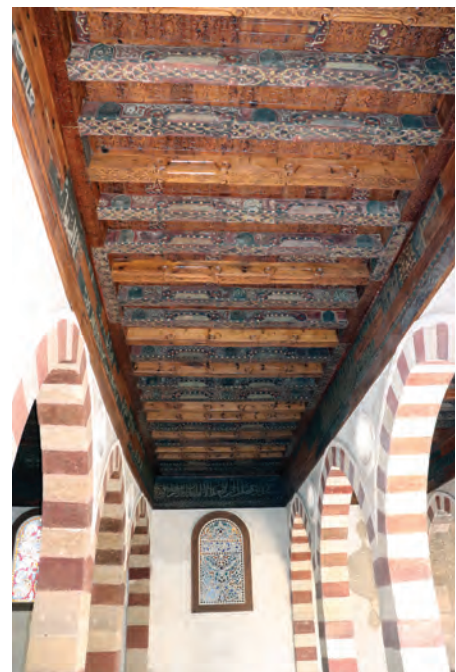
Above: View of the decorated ceiling of the prayer hall showing the combination of painted and plain coffers, the latter having been left intentionally undecorated by the Comité (AKTC Conservation Team, 2020).

When the project started in 2018, the existing conditions in the decorated sections of the ceiling had worsened considerably. However, it became apparent that the painted decoration dated from the fourteenth century, with only limited alterations as a result of the conservation work carried out by the Comité. In particular, the painted ceilings along the qibla wall retained most of their original decoration, including those on the upper section of the upright wall that presented richly decorated koranic inscriptions.

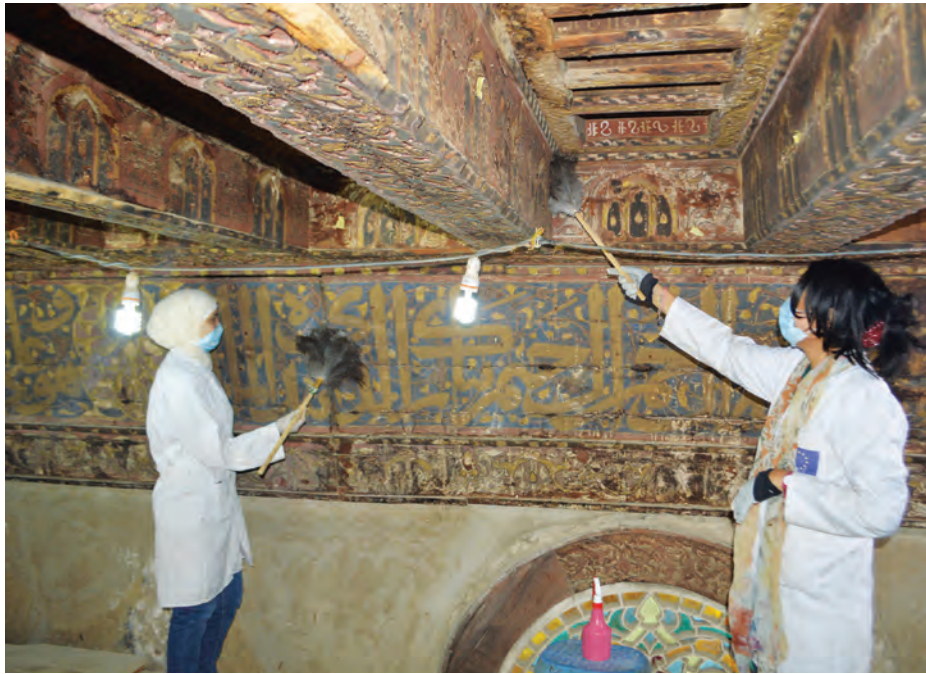
Right: Manual cleaning of the inscription and decorated ceiling to remove dust and accumulated dirt (AKTC Conservation Team, 2020).

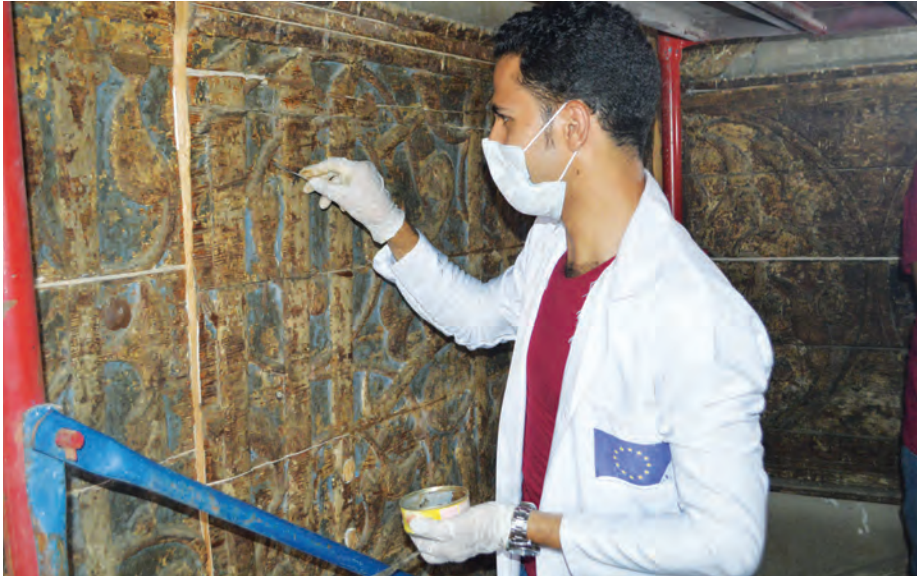
*Above: Manual cleaning with the use of a small scalpel to remove black crust (AKTC Conservation Team, 2020).*

- Manual tracing of the painted decorations and inscriptions for the preparation of base drawings.
- Mechanical cleaning with soft brushes and scalpels in the case of persistent crusts.

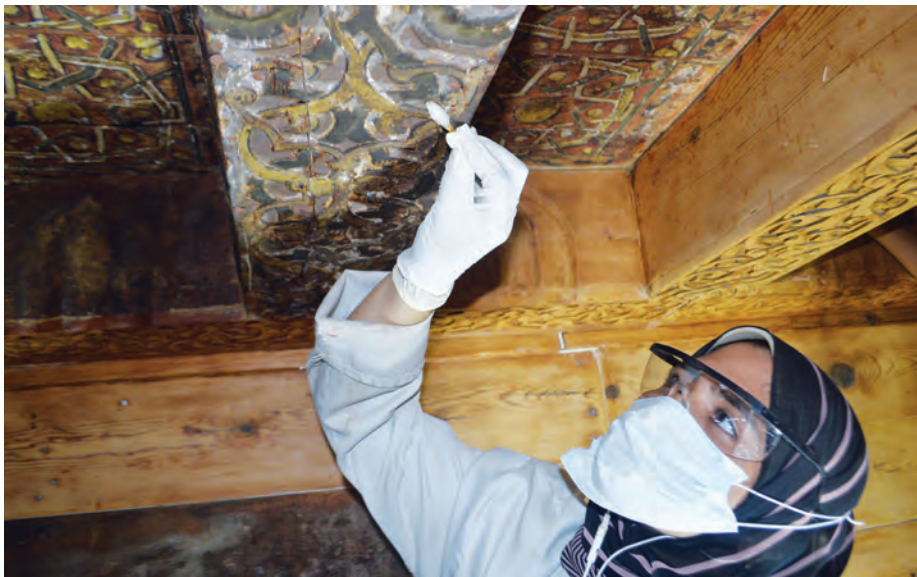
*Middle: Application of organic solvent with a cotton swab to remove persistent dirt and grease from the painted surfaces (AKTC Conservation Team, 2020).*

- Chemical cleaning with organic solvents with the use of cotton swabs.
- Carpentry repairs to re-integrate missing parts of the wood coffers.
- Filing of joints between the planks with soft wood fillers shaped *in situ* by the conservators, including gaps along the band of koranic inscriptions. Minor gaps were filled with wood dust mixed with Paraloid B72, an acrylic resin with adhesive and consolidating properties.

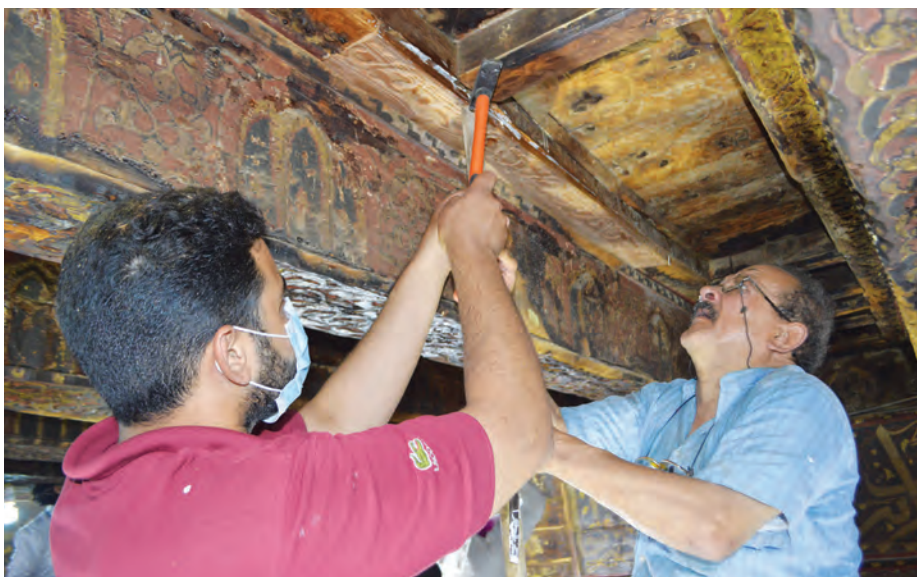
*Below: Stabilising loose wood boards in the recessed panels between structural beams (AKTC Conservation Team, 2020).*

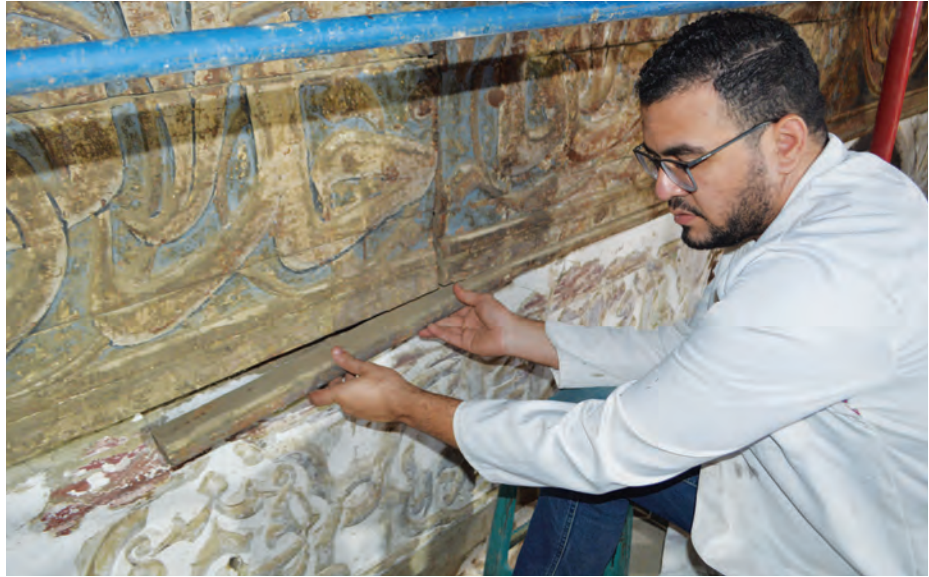
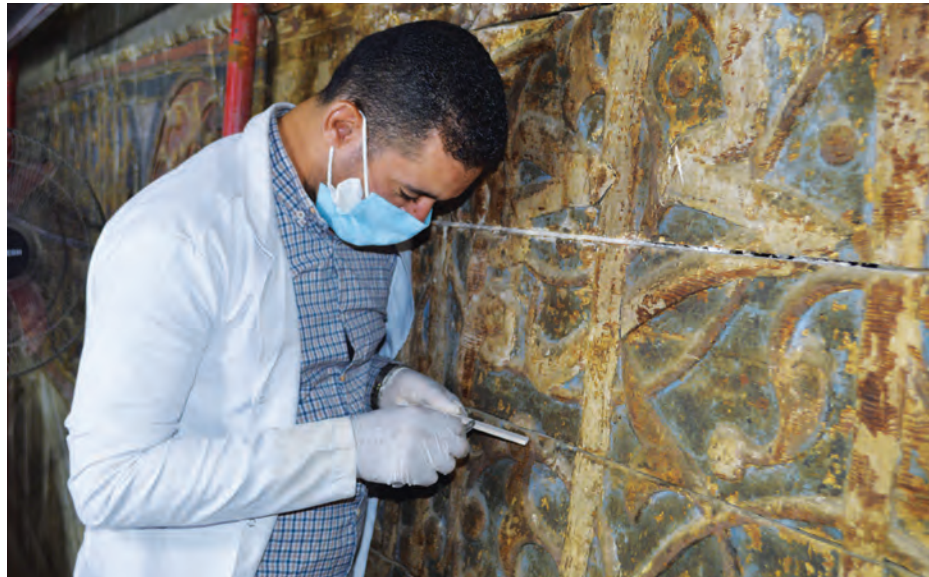
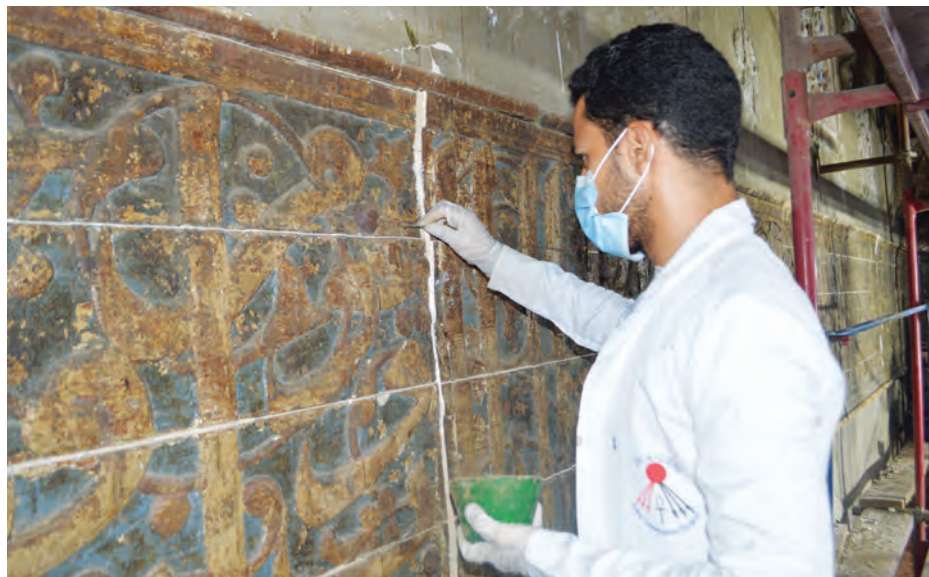
*Above:* Strengthening the base of the inscription band in the upper register of the qibla's upright wall (AKTC Conservation Team, 2020).

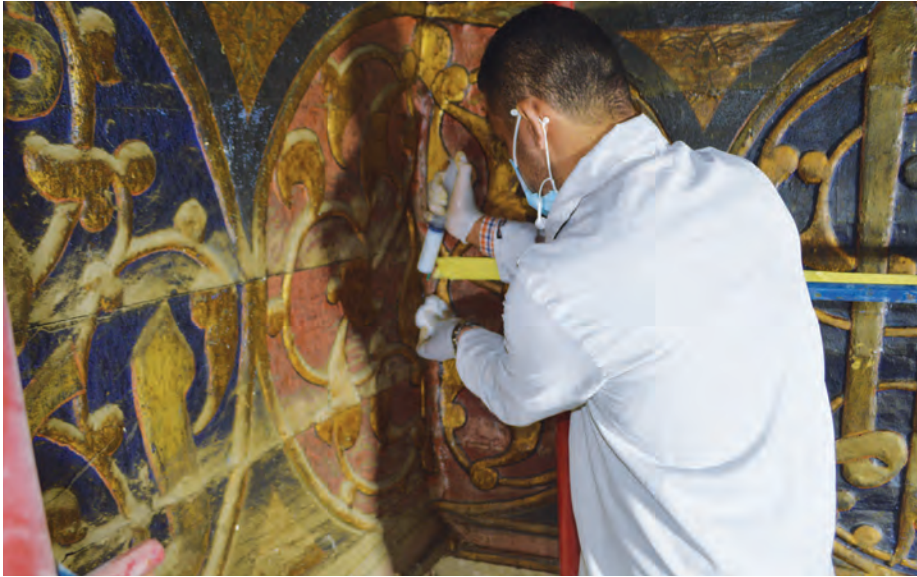
*Above:* Injections of adhesive to reattach peeling paint complement the use of a hot spatula to return the detached flakes to their original position (AKTC Conservation Team, 2020).

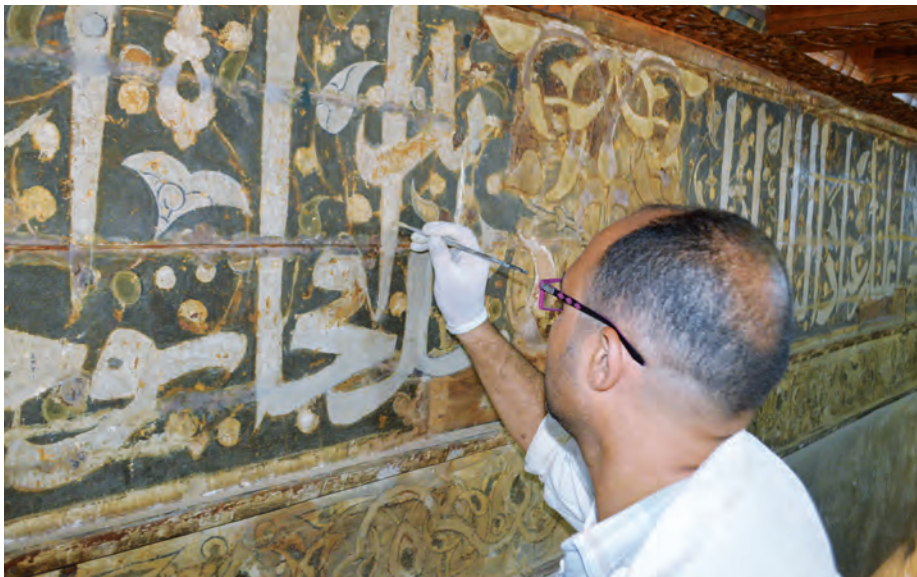
*Middle:* Limited retouching with reversible watercolour was necessary to provide visual continuity to gaps and lacunae in the painted decoration (AKTC Conservation Team, 2020).

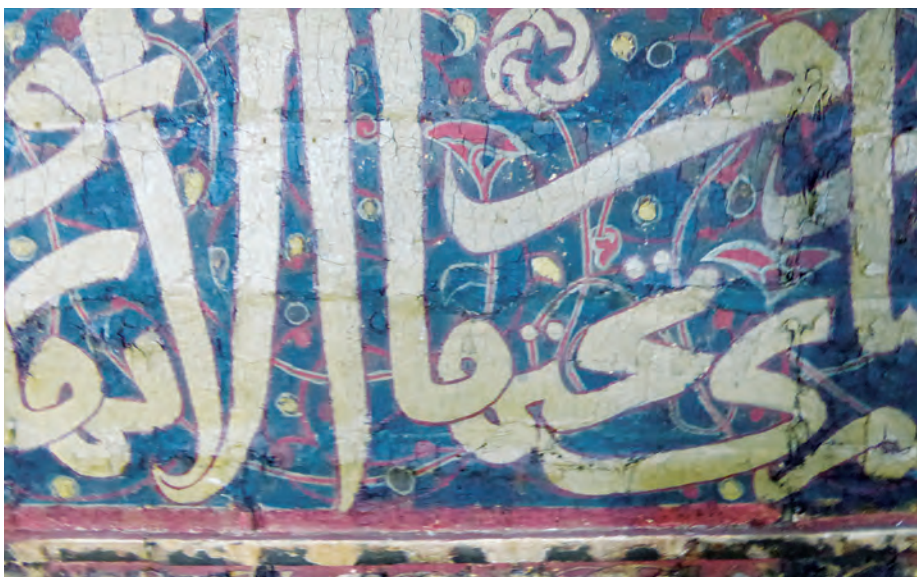
*Below:* Detail of the koranic inscription. Note the elegant flower pattern behind the letters (Christophe Bouleau, 2019).
