# AGA KHAN HISTORIC CITIES PROGRAMME

## THE CONSERVATION OF THE ALTINBUGHA AL-MARIDANI MOSQUE, CAIRO

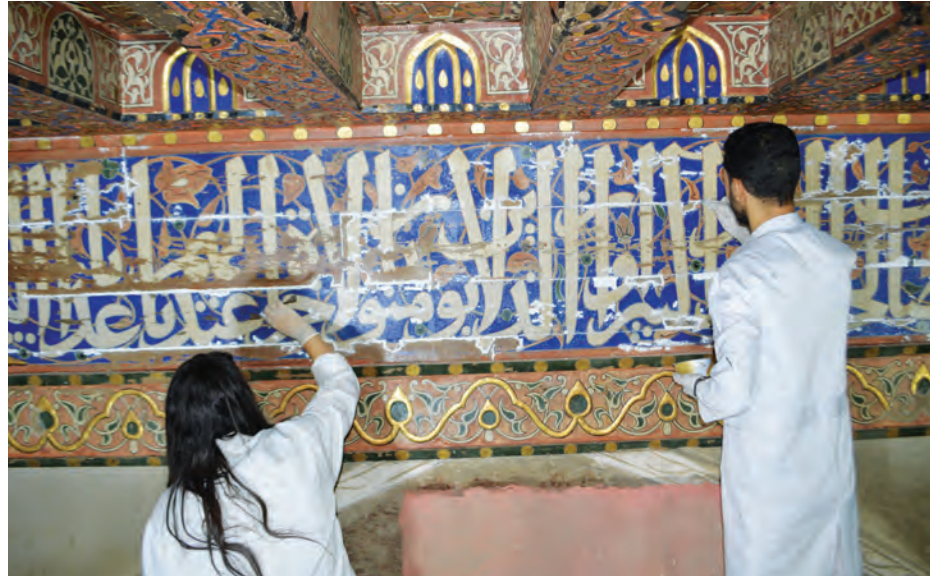
Above: Advanced retouching and gilding of the inscription band following the stabilisation of the timber planks and filling of gaps (AKTC Conservation Team, 2020).

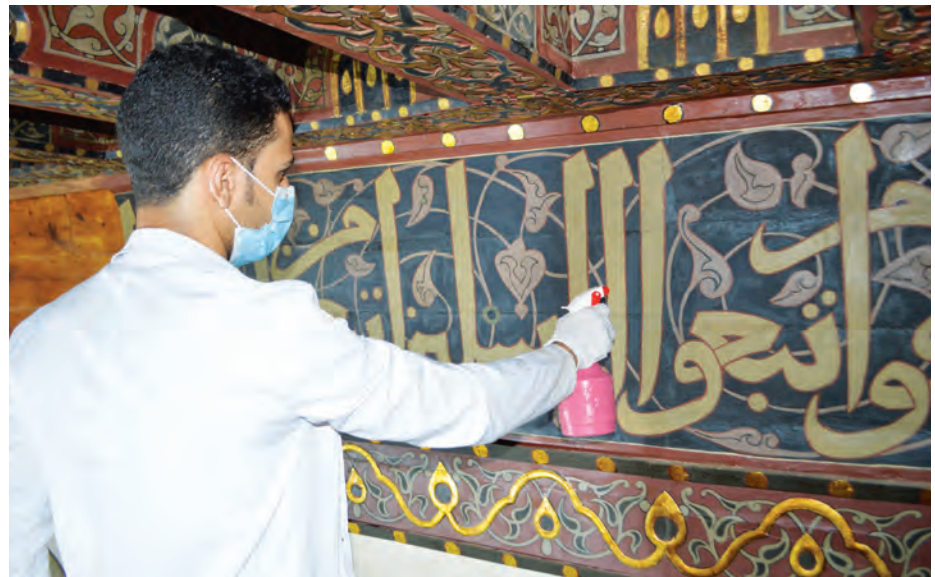
Middle: Applying a protective coat resistant to light and aging to the restored koranic inscription (AKTC Conservation Team, 2021).

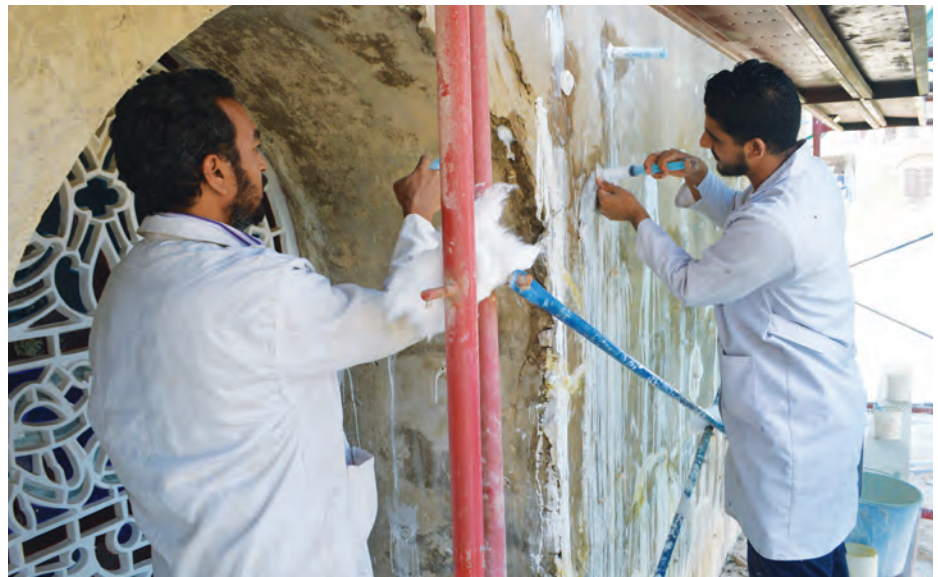
*Above Right: Apprentices grouting the exterior façade of al-Maridani (AKTC Conservation Team, 2020).*
