# Evaluating the Role of Internal Factors in the Damage and the Methods of Treatment of the Limestone of Emir Hasan Mosque in Akhmim, Sohag, Egypt

Elashmawy A. Abd-Elkareem

**How to cite this paper:** Abd-Elkareem, E.A. (2020) Evaluating the Role of Internal Factors in the Damage and the Methods of Treatment of the Limestone of Emir Hasan Mosque in Akhmim, Sohag, Egypt. *Open Journal of Geology*, 10, 1280-1295.  
<https://doi.org/10.4236/ojg.2020.1012064>

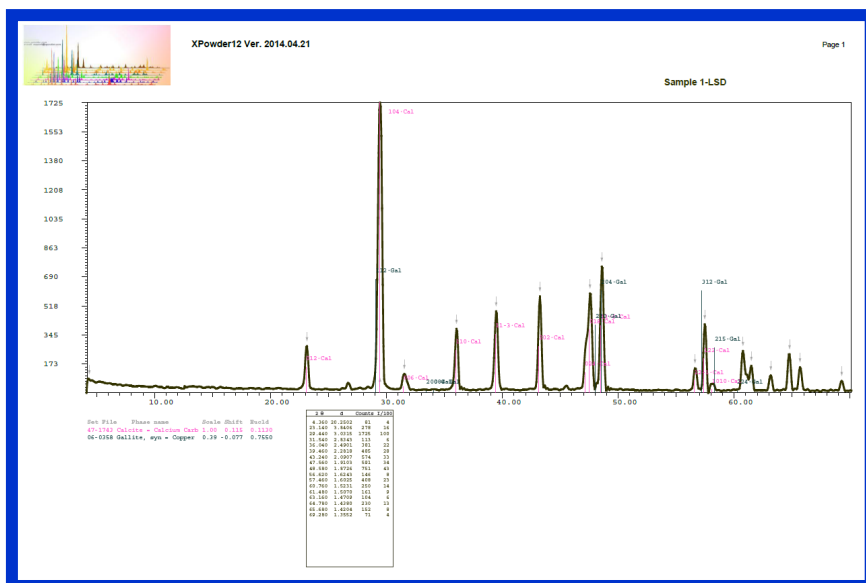
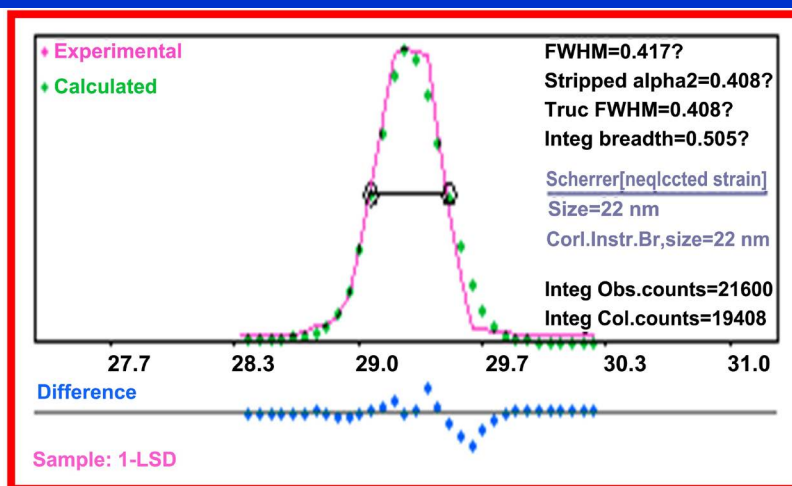
Figure 3. XRD pattern of the sample of Emir Hasan Mosque.

Calcite was found as the major compound in addition to the presence of secondary compounds, such as quartz and gypsum. The X-ray diffraction analysis did not reveal the presence of clay minerals or aluminum silicates obtained by the scanning electron microscope. It also showed the presence of soluble salts in small proportions, such as halite and chloride as a result of the damage to the limestone **Figures 3-5, Table 1, Table 2**.

Samples of the limestone of Emir Hasan Mosque, Akhmim consist of calcite (88.6% - 89.5%), gypsum (2.7%), quartz (2.4%), clay materials (1.5% - 7.8%), amorphous materials (3.9%), and cuspidine (1.2%) (**Table 1** & **Table 2**) and (**Figures 3-5**). Calcite units in this building are very close to the typical dimensions of calcite mineral in theory (**Figure 2**). The correlation of calcium with magnesium in calcite units is very low. Moreover, damage is manifested in the mosque, including peeling, erosion, loss of some stone parts, salty weathering, color change, and crusting due to some solid surface layers as a result of a change in composition (**Figure 1(b)**). The presence of a chemical or physical substance and color change may occur as a result of the growth of some microorganisms (**Figure 1(d)**). Thus, limestone loses the cohesion and bonding between its grains. There is dirt on the stone surface. The presence of clay particles or dust causes color change to the limestone surface of Emir Hasan Mosque. Groundwater has a great impact on limestone due to weak water and sanitation networks in the study area. Also, saline weathering is one of the most dangerous damaging effects on limestone through the efflorescence of salts and the formation

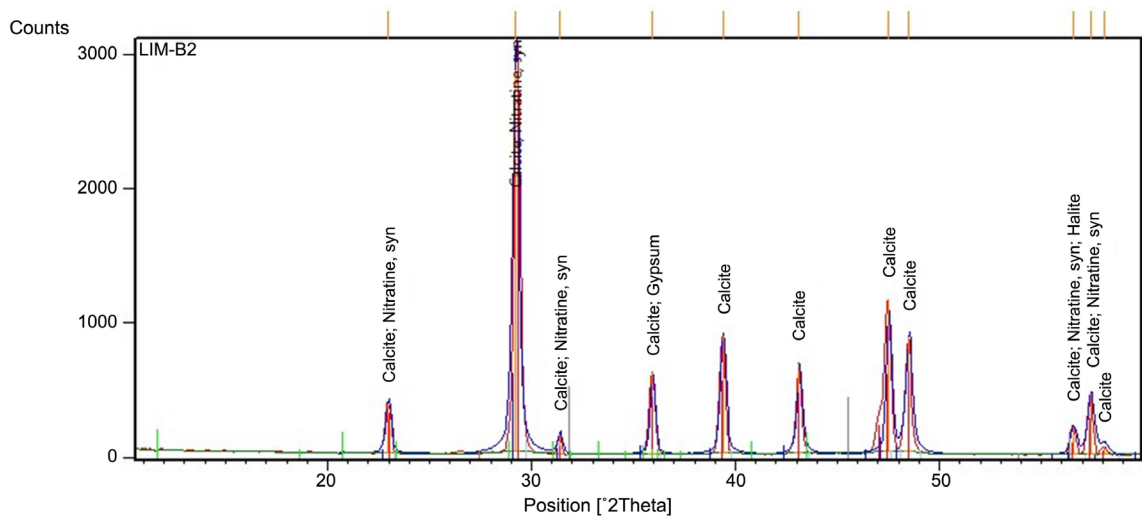
Figure 5. XRD pattern of the sample of Emir Hasan Mosque. Nitratine:  $\text{NaNO}_3$ .
