## SEISMIC SOIL-STRUCTURE INTERACTION OF A MASONRY STRUCTURE: SUNGURBEY MOSQUE

Original scientific paper

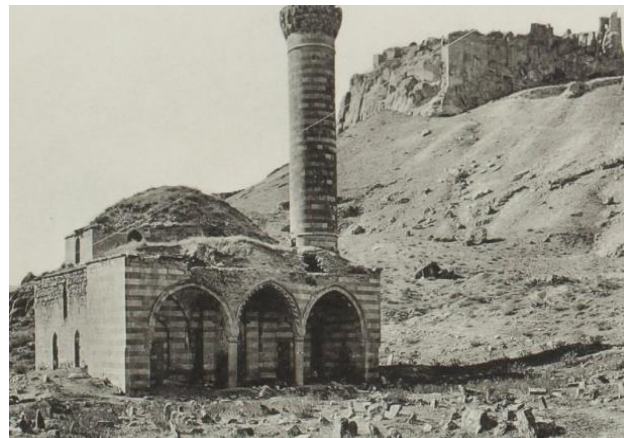
Figure 1. Before relocation of Sungur Bey [3].

It is stated on the inscription in the Harput museum that the mosque was built by Sungur Bey between 1572-1577. The mosque was originally built on slightly sloping

land on the northeastern skirts of the Pertek castle on the edge of the Murat River. (Figure 1) [2]. With the relocation decision, the mosque was rebuilt in Pertek District, at the exit of Elazığ highway, on a sloping land descending from north to south. (Figure 2). There is an elevation difference of 2.83 m between the north and south points of the land where the mosque is newly located.

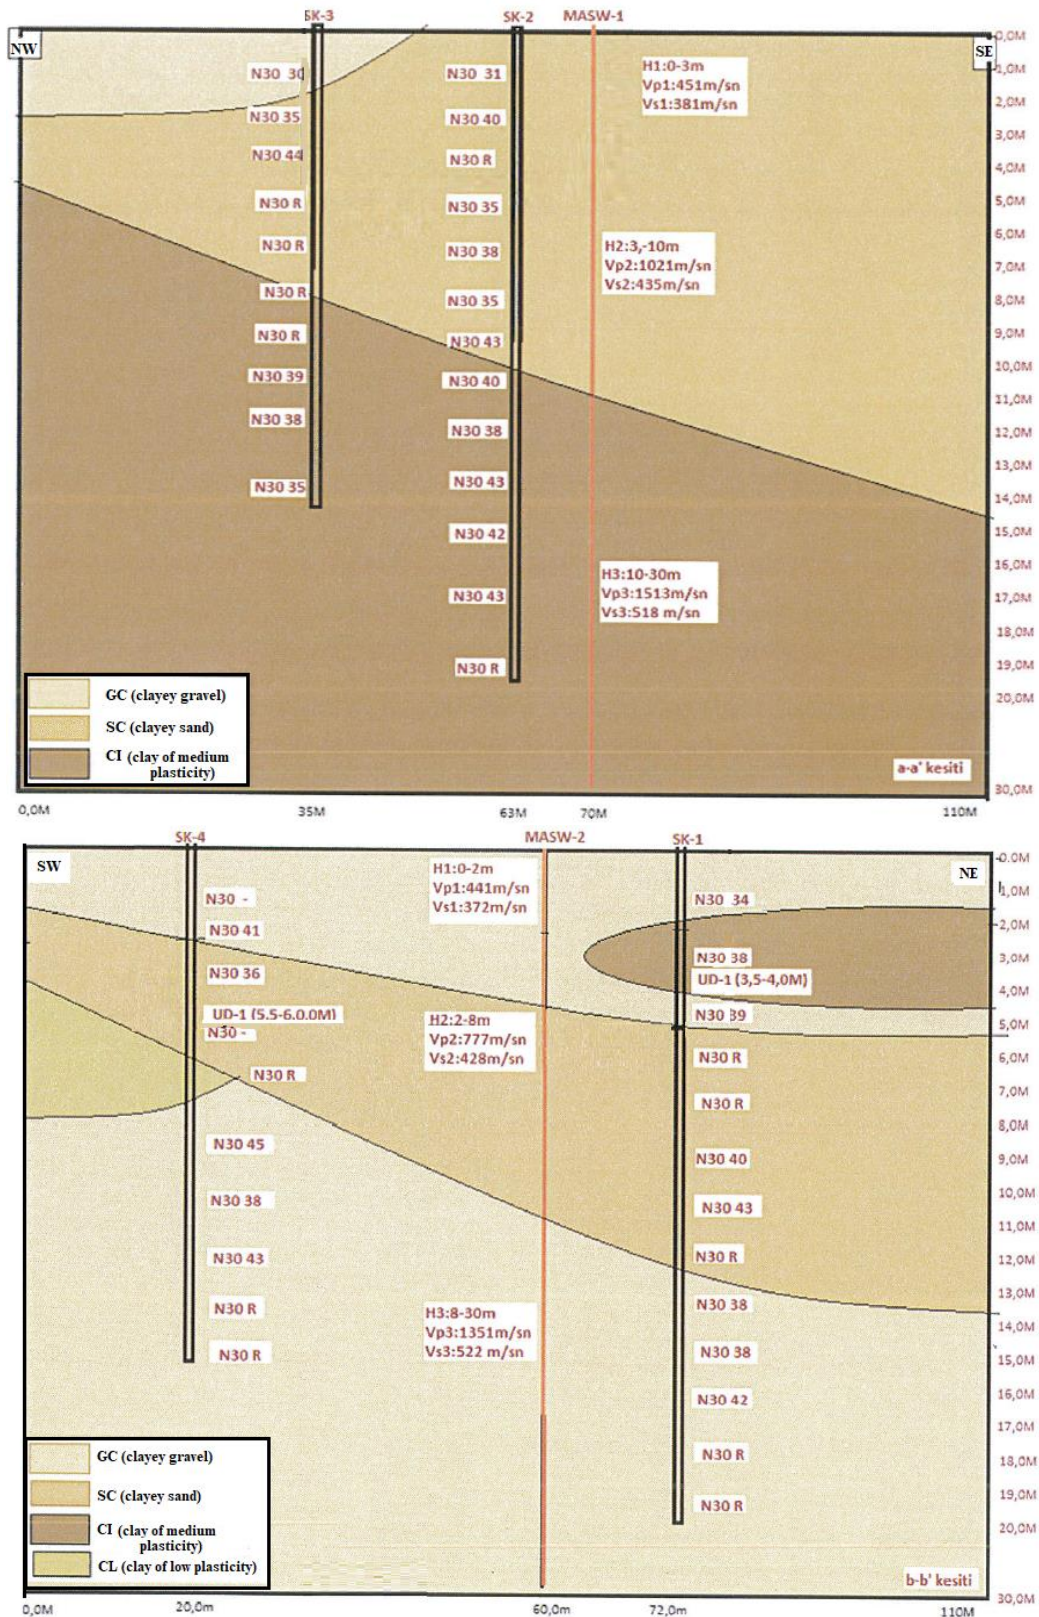
Figure 10. Idealized soil profile

In the investigation area, 4 boreholes with a depth of 20 m and 3 Multi Analysis Surface Wave (MASW) tests were carried out. As a result of the field investigations, artificial fill layers up to 0.50 m depth from the ground level and clayey gravel and clayey sand units at different levels up to 40 m depth were encountered. Gravel and sand contents differ in lateral and vertical directions. The groundwater level is below the bottom of the borehole.

The  $V_{s30}$  wave velocities of the Quaternary units in the study area were measured as low in the upper layers and high in the deeper layers. When  $V_s$  wave velocities are measured as 430 m/sec on average, soil class is defined as C according to the NEHRP soil classification system. The soil parameters are summarised in Table 1. The idealized soil profile with the SPT and MASW test results is depicted in Figure 10.

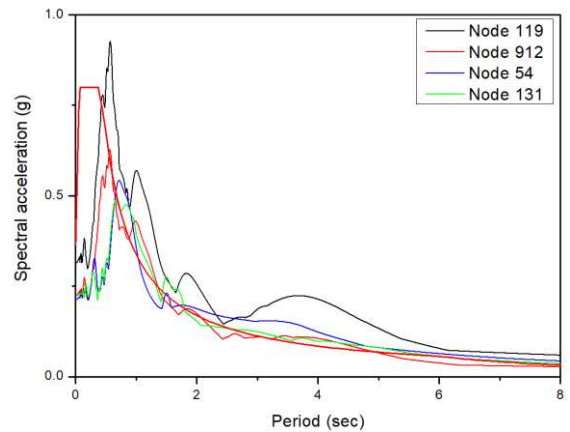
Figure 13. Response spectrum of various nodal points of structure and soil profile

Acceleration spectra were obtained as a result of analyzes for the base of the soil profile (i.e. Node 131), ground surface (i.e. Node 54), the top level of the main dome (i.e. Node 912), and minaret flag level (i.e. Node 119) defined for 5% damping ratio is given in Figure 13. While the spectral acceleration values at the level of the soil profile defined at a depth of 40 meters from the ground level were in the order of 0.50 g, this value was calculated as 0.55 g with an increase of 10% at the ground

level. If the investigation area is located on the bedrock or if the stiff soil layers are close to the surface, the effect of the local soil conditions is much smaller than the source effects. However, in such soft soil layers, earthquake waves are significantly affected by the properties of soil environment and significant increases in amplitudes may occur. The amplification effect observed here on earthquake waves is attributed to clay units with lower density and stiffness at different depths.

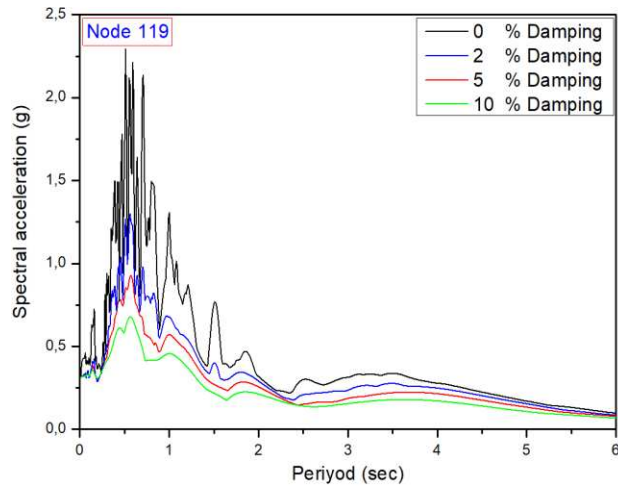
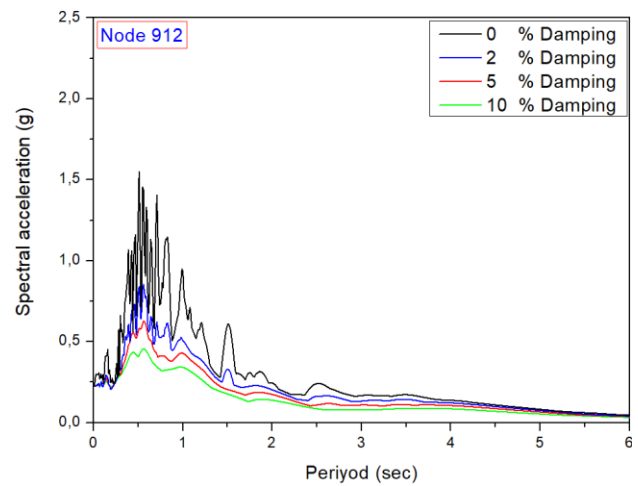
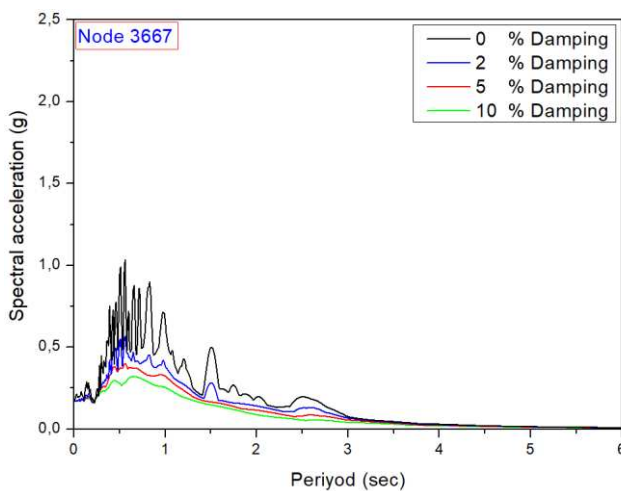
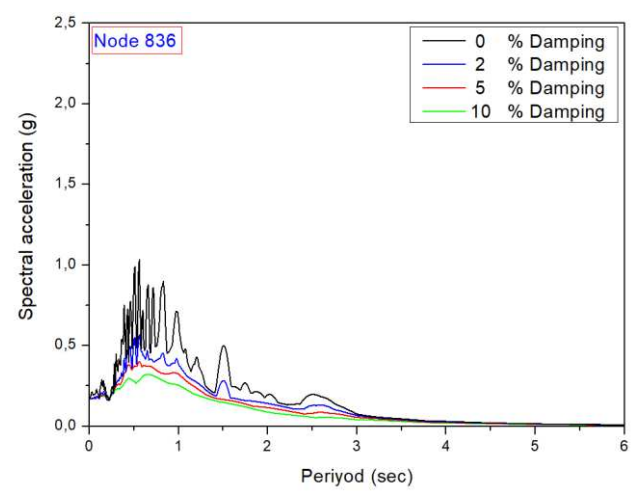
Figure 14. Response spectrum of selected nodal points on mosque model

mosque are given in Figure 14. The natural period of the considered nodes is around 0.5 sec. As the height of the selected nodes increases, the amplitude of the calculated spectral acceleration gets higher values at each damping level. The spectral acceleration for the Node 119 which represents the flag level of the minaret is calculated as 2.3g. Considering the whole masonry structure, it is likely that the acceleration values calculated at these levels at the end of the analyzes may normally cause destruction, especially for the minaret, which is vulnerable to damage in seismic conditions due to its height and structural features. According to the literature studies, minarets are at the limit of collapse in terms of tensile stresses. The main reason for this is that the tensile stresses are concentrated in the transition region of the minaret. Because in this region, the cross-sectional area is considerably reduced in the transition from square section to circular section [40]. In addition to these structural features of the minarets, the amplification effects due to soft soil conditions compel these structural elements to

damage in seismic conditions. In this case, it is assumed that the acceleration value calculated at the bottom of the soil profile is amplified as a result of soft clay layers.

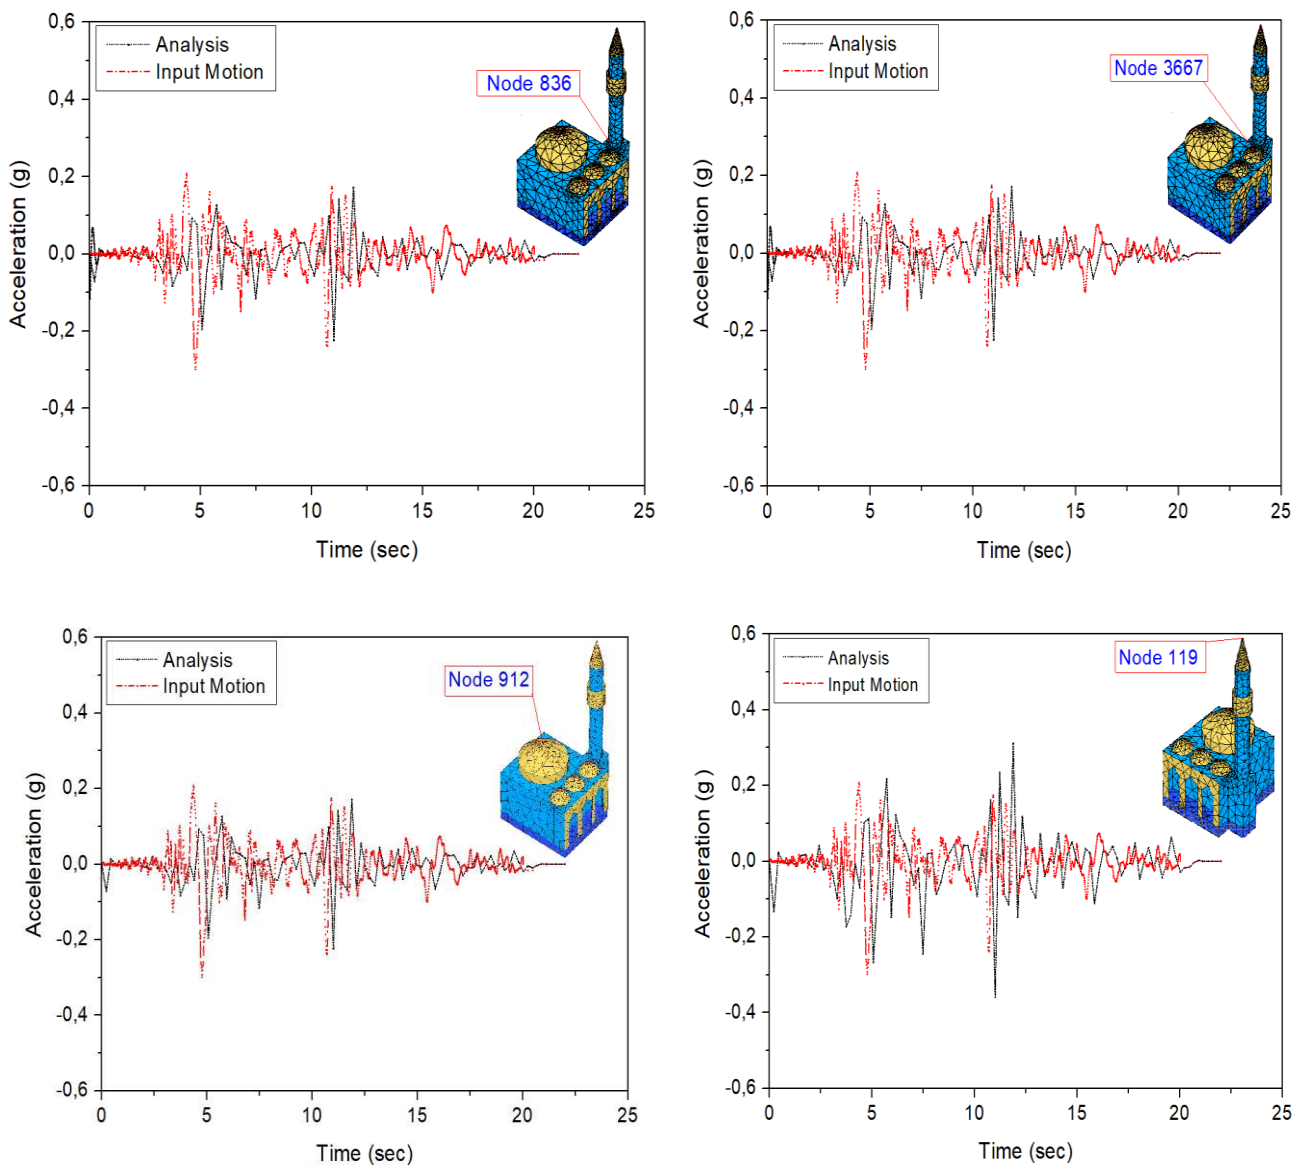
**Figure 15.** Acceleration time history of the selected nodal points

The numerical model of the structure is subjected to Sivrice 2020 earthquake and the measured acceleration time history for selected nodal points is presented in Figure 15. The nodal points were selected from different heights of the numerical model in order to measure the effect that occurs at different heights of the structure. The PGA value of the applied earthquake motion is 0,29 g (293

acceleration values increase as the considered nodal points get higher in terms of their elevation with respect to the base of the structure. The deflection observed on the minaret are attributed to the amplified accelerations along the cross-section.

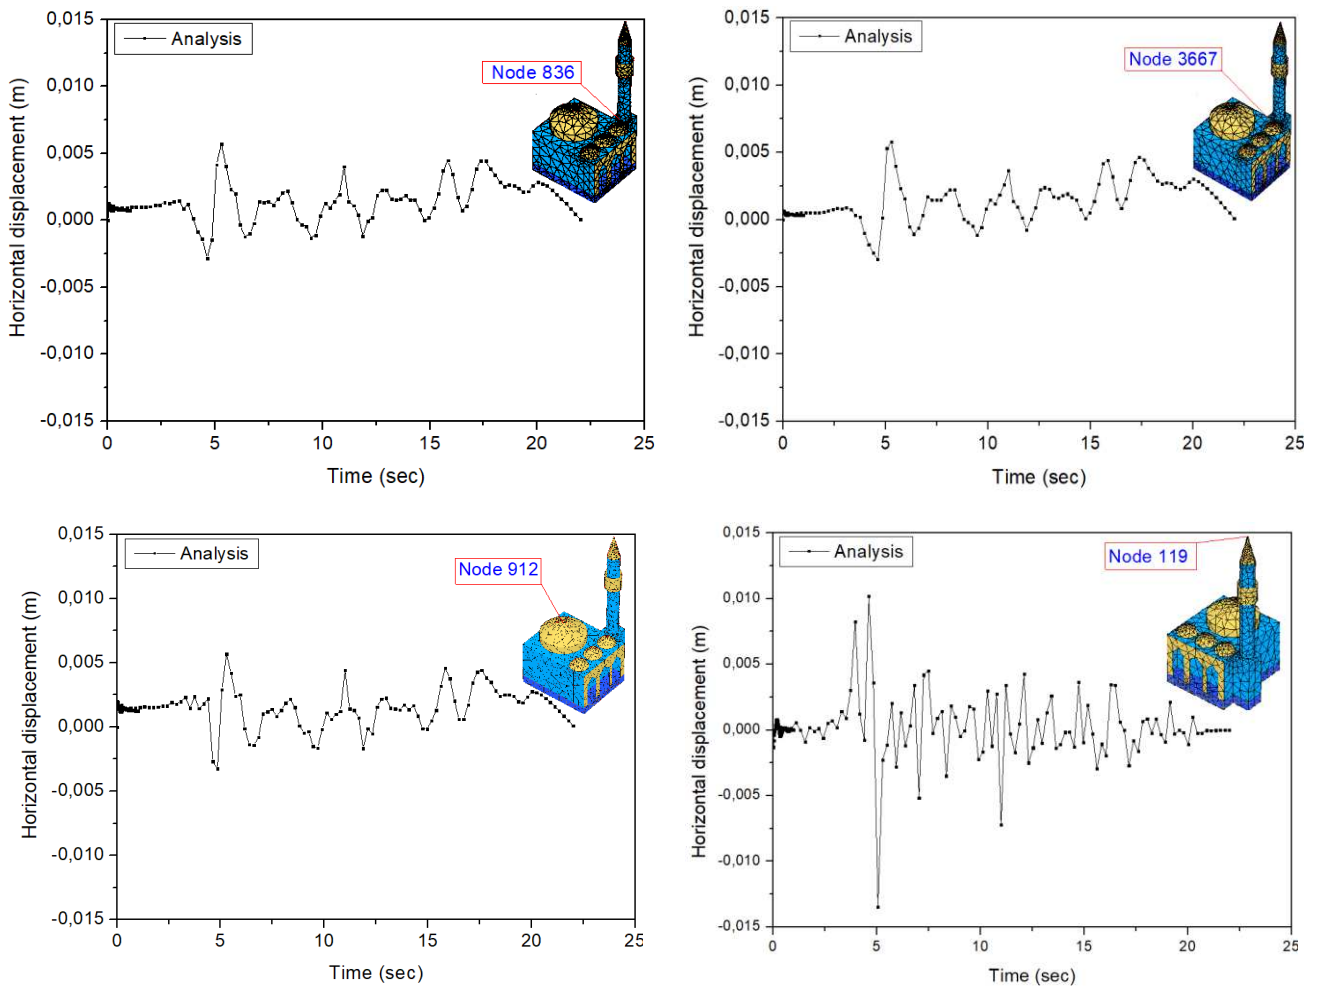
Figure 16. Displacement time history of selected nodal points

The displacement time history of the selected nodal points is demonstrated in Figure 16. The maximum lateral displacement for Nodes 836, 3667 and 912 is calculated lower than 1 cm. However, the maximum lateral displacement calculated at the flag level is measured as 13 cm. Indeed, total station measurements made in the field also confirm the lateral displacement (*i.e.* 11 cm) from the vertical axis at the flag level of the minaret, which was obtained from the numerical analysis. However, there is no clear information about whether the displacement immediately occurred after the Sivrice 2020 earthquake. What is clearly known about this is that the horizontal displacement in the minaret does not progress over time

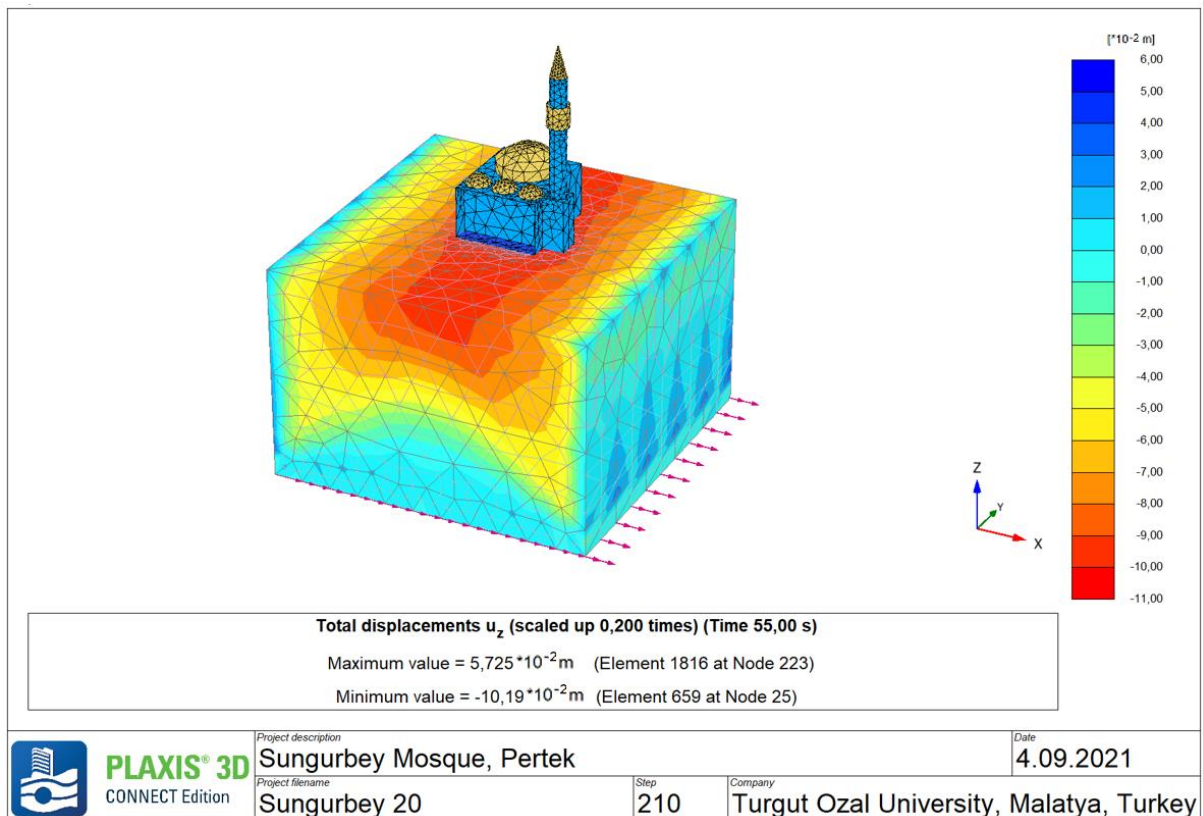
Figure 17. Total vertical displacement distribution of the numerical model

with the measurements made at intervals. Figure 17 demonstrates the geometry and FE discretization of the 3D model and the deformed mesh of the analyzed model. The maximum vertical displacement is obtained as 10 cm. The calculated vertical displacement can be considered as a cause of vertical cracks formed on the structural elements and their progression throughout its service life. The subsurface soil conditions of the mosque consist of multilayers of soft clay mixed with sand and gravel. The vertical displacement under seismic loading is attributed to the lower stiffness of soil layers. The increasing stiffness and shear strength of soil as a result of seismic shaking are referred to as influencing factors on seismic settlement. The earthquake shaking caused densification of soil having less relative density results as seismic settlement. The HS model, precisely because of this reason, is utilized for the investigation of soil behavior for small strain ranges.
