The Abbasid Mosque in Balkh

Aga Khan Trust for Culture – Afghanistan

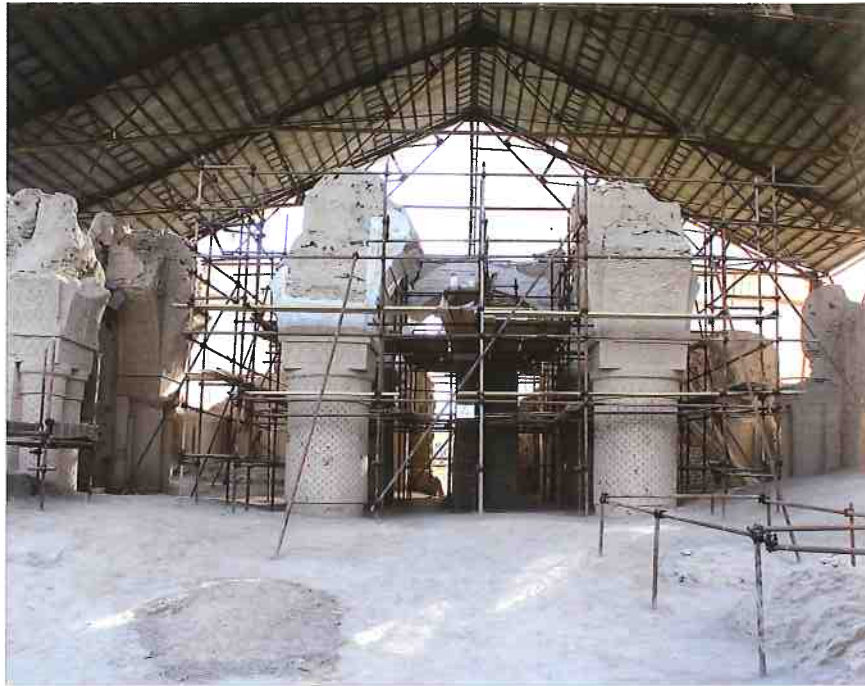
Fig.1 | In order to facilitate the consolidation work, the delicate remains of the No Gonbad Mosque were strengthened and a lightweight scaffolding structure was built as to enable access.

In 2009, experts visiting the site concluded that the two damaged arches spanning the remaining columns were in urgent need of structural repair and consolidation. In partnership with the Afghan authorities, DAFA, the World Monuments Fund, the Associazione Giovanni Secco Suardo and the University of Florence, the Aga Khan Trust for Culture (AKTC) initiated a multi-year conservation project aimed at stabilizing and safeguarding key sections of the remaining architecture of this

important monument. Following a two-year analysis and pilot study programme supported by the US Ambassadors Fund for Cultural Preservation, a comprehensive plan for structural retrofitting was prepared by AKTC and tested on a full-size replica of the columns and arches. This then received technical endorsement from the Afghan Government and project partners.

Funded by the US Embassy in Afghanistan, a team of Afghan and international experts and craftsmen led by the Aga Khan Trust for Culture (AKTC) has been meticulously implementing work on the structure since mid-2011. This has entailed the consolidation and repair of the unique stucco decoration, the structural repair and strengthening of the damaged masonry columns and arches, and modest enhancements to the surrounding landscape.

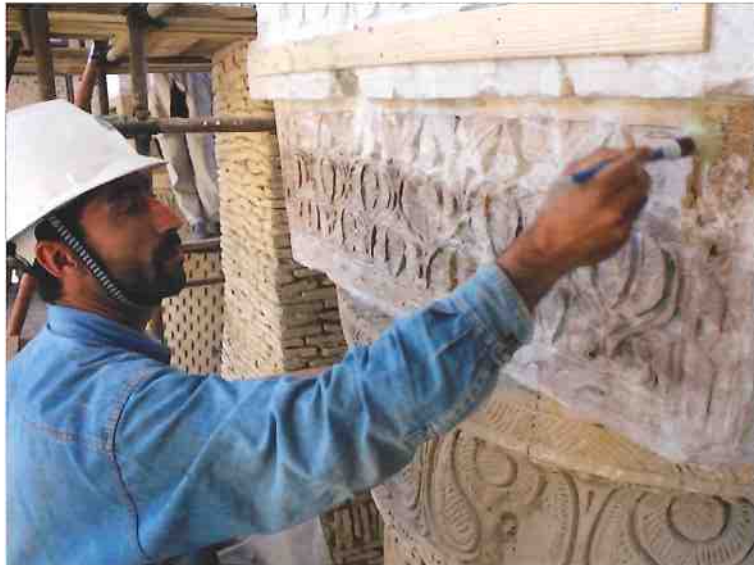
Fig. 2 | Before structural consolidation work could commence, the exquisite stucco decoration adorning the surfaces of the building had to be stabilized and protected.
