Selected Muslim Historic Monuments and Sites in Bulgaria

United States Commission for the Preservation of America's Heritage Abroad

SELECTED MUSLIM HISTORIC MONUMENTS AND SITES IN BULGARIA

2010

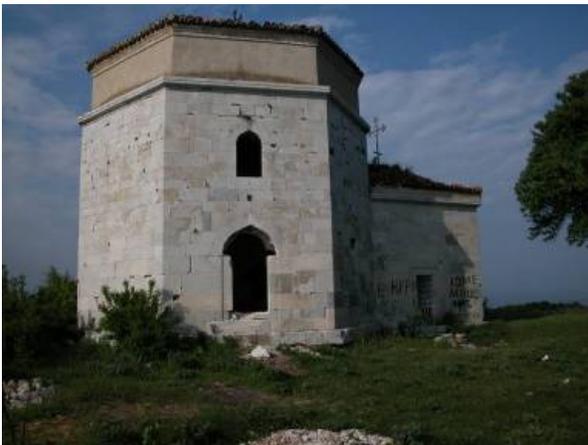
Lateral view of southern side of monument from the summit on which it is set. Note the fine quality and precision workmanship of the marble facing. Some cracks and missing pieces are evident but, otherwise, the exterior walls have survived the centuries well. The tambour atop the marble walls is made of rubble coated with plaster, a technique that helps us date the monument to the 15th century. The tambour was renewed during the restoration of the monument during the late 1960s.

The condition of the *türbe* is quite sound. There are some traces of dampness on the interior walls. As mentioned above, the sarcophagus and grave of the saint were broken open and gutted. The interior walls have recently been painted green and white. On the exterior, a number of marble blocks are broken or have been removed. On the southern side of the exterior, the marble facing is clean; on the northern side it is covered with lichen. On both sides, vegetation appears to be sprouting between the blocks in a number of places. The entranceway to the portico has been defaced with spray-paint graffiti. The *meydanevi*, however, is a complete ruin. Large sections of its eastern-most walls (i.e. those hanging over the precipice) remain standing.

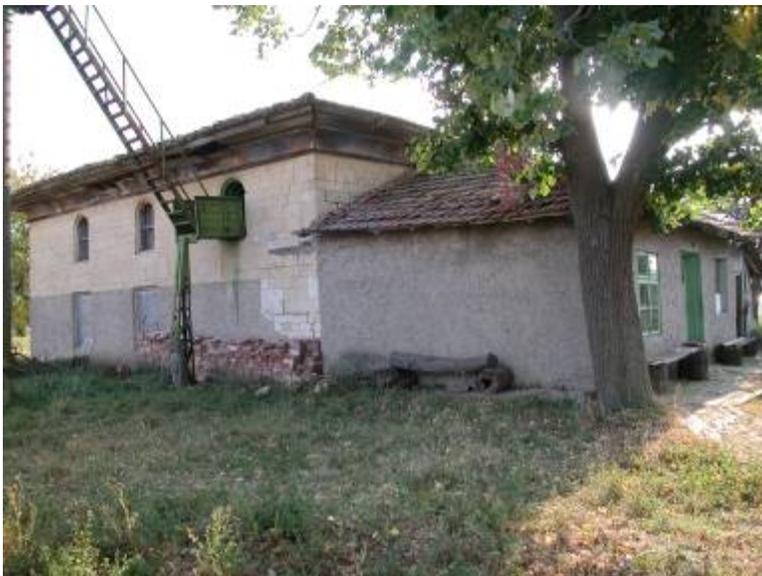
Examination of the exterior shows severe buckling of the walls, possibly due to a poor foundation and shifting soil, a common problem in northeast Bulgaria. Walls need to be reinforced, the gutters should be replaced, the roofing redone, and the foundation may need stabilization.

Oblique view from left. Note bricked-in portico, improvised access to minaret, cracks and buckling at left front corner, and laying of brick in an attempt to shore up wall.

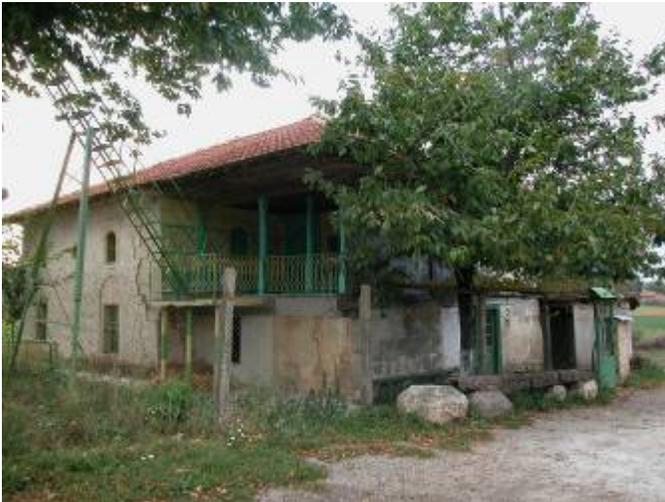
At first glance, the mosque appears to be in decent, albeit shabby, condition. A closer inspection of the walls reveals serious shifting of the stone blocks out of alignment. A very strong smell of dampness is present inside the mosque.

Exterior. Note shifting of stone blocks near the front of the left lateral wall of the sanctuary. Also note the inclined fireman's ladder-like stairway to the minaret. Minarets of many urban and rural mosques in Bulgaria were ordered torn down or were forcibly razed during two decades of officially directed and often popularly supported anti-Turkish and anti-Muslim campaigns during the 1970s and 1980s.

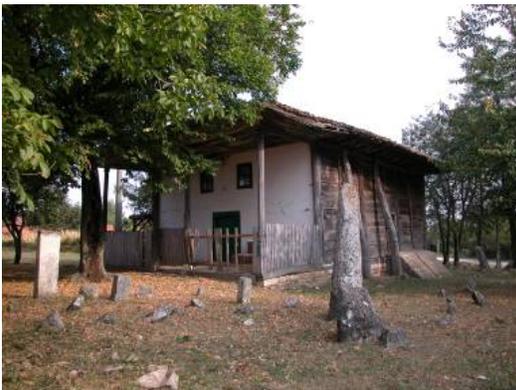
The interior walls show evidence of dampness. The brickwork at the foundation and the newly poured concrete buttresses suggest past and potential future instability of the walls, possibly due to shifting soil, which is a problem endemic to the region.

**Oblique view to front of mosque from right.
Remains of cemetery in foreground.**

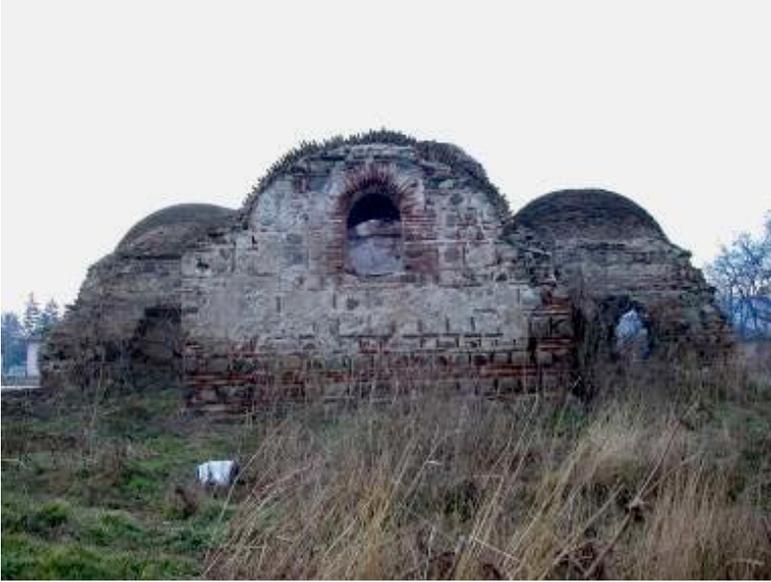
The monument is in terrible condition. It has been in an accelerated rate of decline in recent years, mostly in terms of the enlargement of wall openings and ongoing disintegration of the barrel-vault. For the moment, the façade appears sound despite signs of subsidence.

Rear view. At the center: the rear or *mihrab* wall of the mosque sanctuary. Note that its window opening is original. At the right: The left-hand chamber. Note large holes knocked through the walls of the chamber.

In the short run, priorities include cleaning its interior and immediate surroundings, and that the monument be fenced in and covered to protect it from rain and snowfall, and the intentional and accidental depredations of trespassers. Cleaning away shrubs and grass would ensure that roots cause no additional damage to the brickwork.

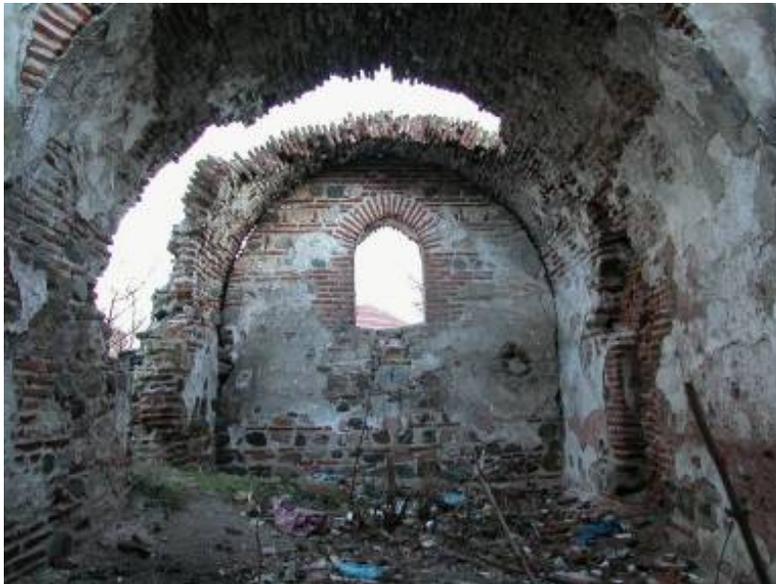
Interior. The sanctuary. Note the partially collapsed state of the barrel-vault and the buckling of what remains of the left-hand side of the vault at its juncture with the *mihrab* wall.

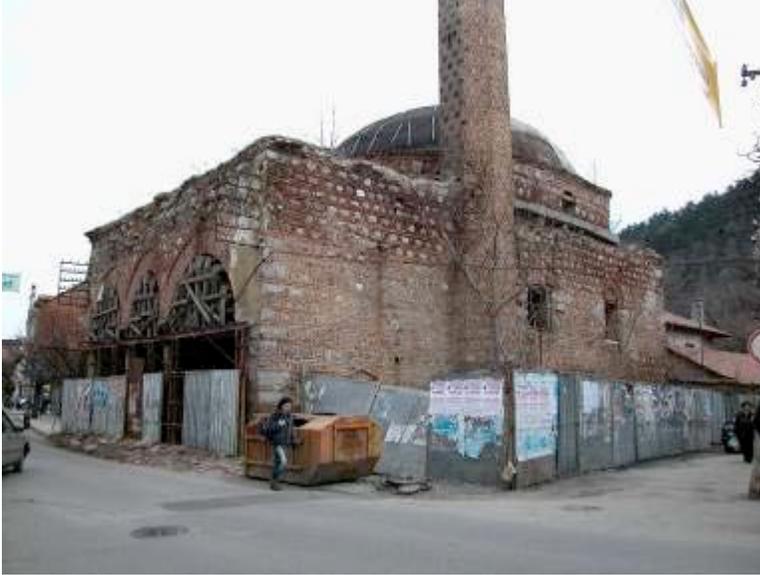
The monument is in very poor condition. Uneven subsidence and vibrations of passing traffic have led to unstable walls that in turn have compromised the integrity of the dome. The masonry is deteriorating and crumbling. The building would need a major restoration, including a possible injection of concrete foundation under the building and the creation of a lightweight concrete shell to support the dome.

Oblique view from right. Mosque fronts on the main traffic thoroughfare running through Kyustendil.

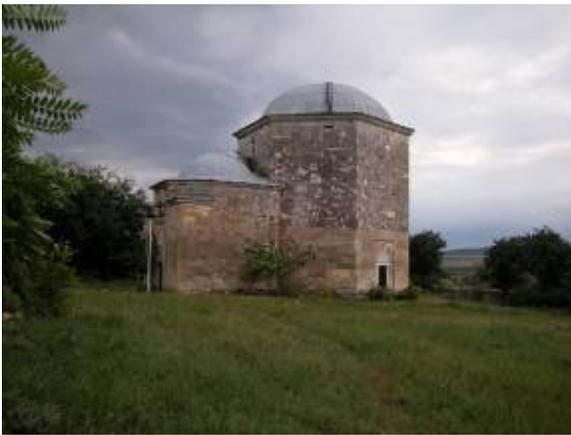
Türbe of Ak Yazili Baba. Note enclosed portico with setbacks at left and right to form an irregularly-shaped hexagonal transition drum between dome and walls. Also note the tall heptagonal main chamber and its lack of transitional drum. Also interesting is the difference between the fine ashlar at the lower levels of the walls of the main chamber and the rougher stonework above.

The condition of the mausoleum has deteriorated rapidly over the last decade. The exterior stonework shows extreme exfoliation and the interior dome and walls show signs of dampness and water damage. Intervention is needed to prevent this well-preserved monument from deteriorating rapidly. The ceremonial hall would benefit from being cleaned and conserved, and possibly by recreating its original (seven-faceted) conical wooden roof over the main hall and a similar roof over the vestibule.

2. Türbe Ak Yazılı Baba. This important monument requires urgent work to prevent ongoing water damage and exfoliation. The former *meydanevi* (meeting hall) at the site is also worthy of consideration.

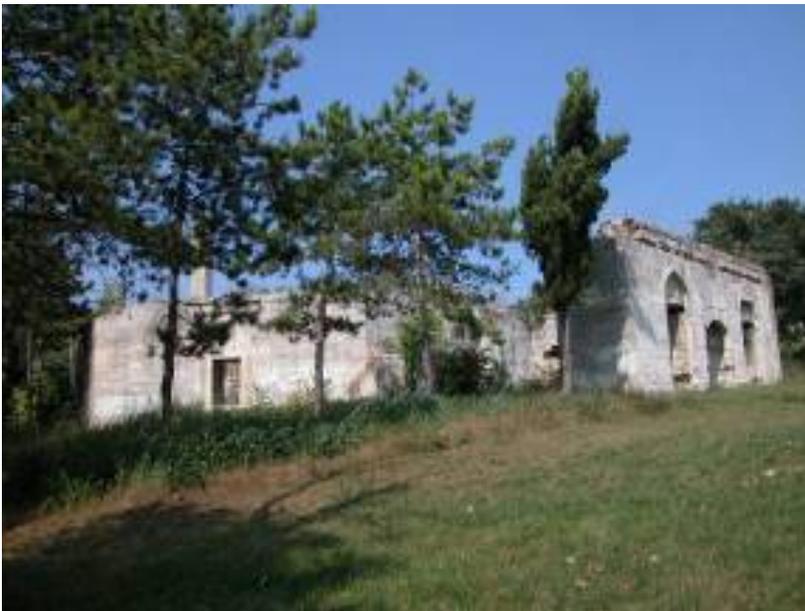
The *meydan evi* (a hall for devotional ceremonies) is roofless and derelict, but the presence of an improvised stage and scattered chairs and lights indicates that it is also being used for performances. Recent restoration work was performed on the lead paneling of the mausoleum dome, but as interior dampness indicates, it was not successful. There are cracks in the interior walls that appear to have been unsuccessfully patched, as seepage is still evident. A sign at the site reports that the fencing that surrounds it to keep out grazing livestock was recently rebuilt by the Beautiful Bulgaria Project, a joint program of the UNDP and Bulgarian Ministry of Labor to provide work and training through the restoration of architecturally worthwhile façades. The site is a Bulgarian “Monument of Culture.” The owner is probably the Ministry of Culture via the regional museum in the nearby town of Kavarna (Asen Salkin, director).

The *Meydan Evi*. Façade of the enclosed entrance gallery is visible at the far right; the remains of the seven-sided minaret-like chimney of the hearth of the main chamber is visible behind the tree at the left. Originally, the main chamber had been covered by a high conical wooden roof and the vestibule by a similar roof. These roofs were destroyed and the chimney of was damaged long ago, possibly (this requires verification) by a Russian artillery bombardment during the Russo-Turkish war of the 1870s. At the time, Russian and Bulgarian artillery indeed considered it sport to bombard minarets of mosques.

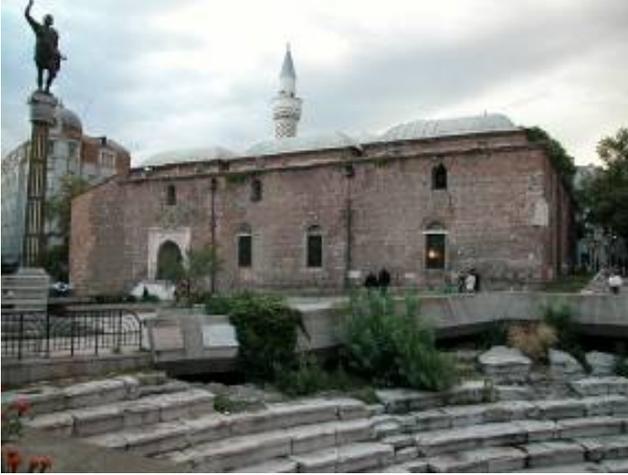
The building is superficially in good condition, but it faces some severe structural problems. Subsidence of the front right pier and right lateral wall has led to severely cracked arches and domes. Due to the sloping landscape, the mosque was built on an earthen works terrace and this increases its vulnerability. Cracks in the structural elements and domes of the mosque appeared during the 1928 earthquake at the city of Harmanli. The next threatening event took place in the 1970s, when Bulgarian archeologists uncovered and permanently exposed a Roman amphitheater adjacent to the mosque. This led to subsidence of the terrace and resultant instability of walls and piers at the right side of the mosque.

This angle shows part of the excavated Roman amphitheater. Excavation exacerbated a subsidence problem that threatens the structural integrity of the mosque. The execution of the excavation during the 1970s may have been as much as a political statement to diminish the stature of a “Turkish” monument as it was scientific in its motivation.

4. Muradiya (Cumaya) Camii, Plovdiv. This important early Ottoman monument set in the very center of Plovdiv suffers from cracks in its domes and walls that are of more than cosmetic significance. The structural integrity of the monument has been severely damaged by earthquakes and, worse, by the irresponsibly conceived and implemented excavations of adjacent Roman ruins.

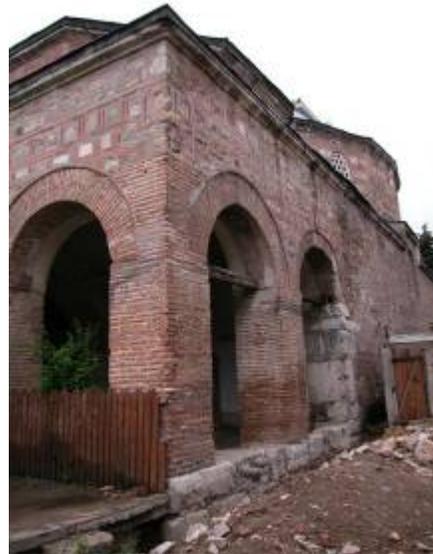
Close-up of piers. Note that the piers are of brick. Also note the high-quality of the cloisonné work and that the portico and sanctuary are of a single piece. Signs of excavation work are visible in the foreground.

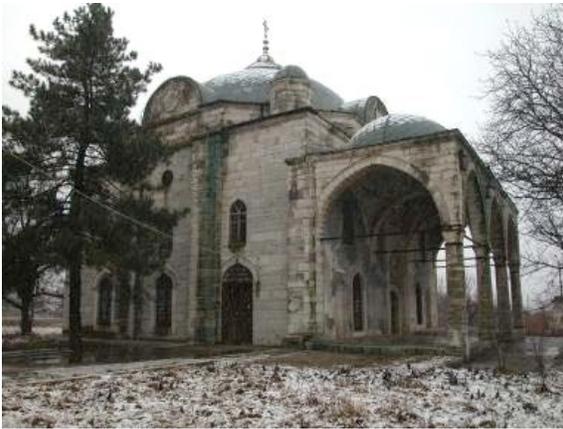
Oblique view from side. Note the doorway cut into right-most of the three ground-level windows on the left of the building. Also note apparent vulnerability to seepage of buttressing piers on lateral wall.

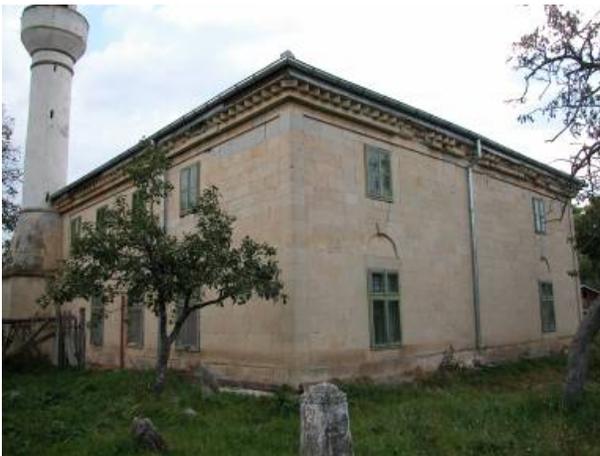
Oblique view, right and *qibla* walls. Note placement of stones to create pediments and architraves in relief. Also note recently emplaced gutters and drain pipes.
